**Central Kowloon Route**

**Yau Ma Tei East**

**Contract No. HY/2014/08**

## Environmental Permit No. EP-457/2013/C

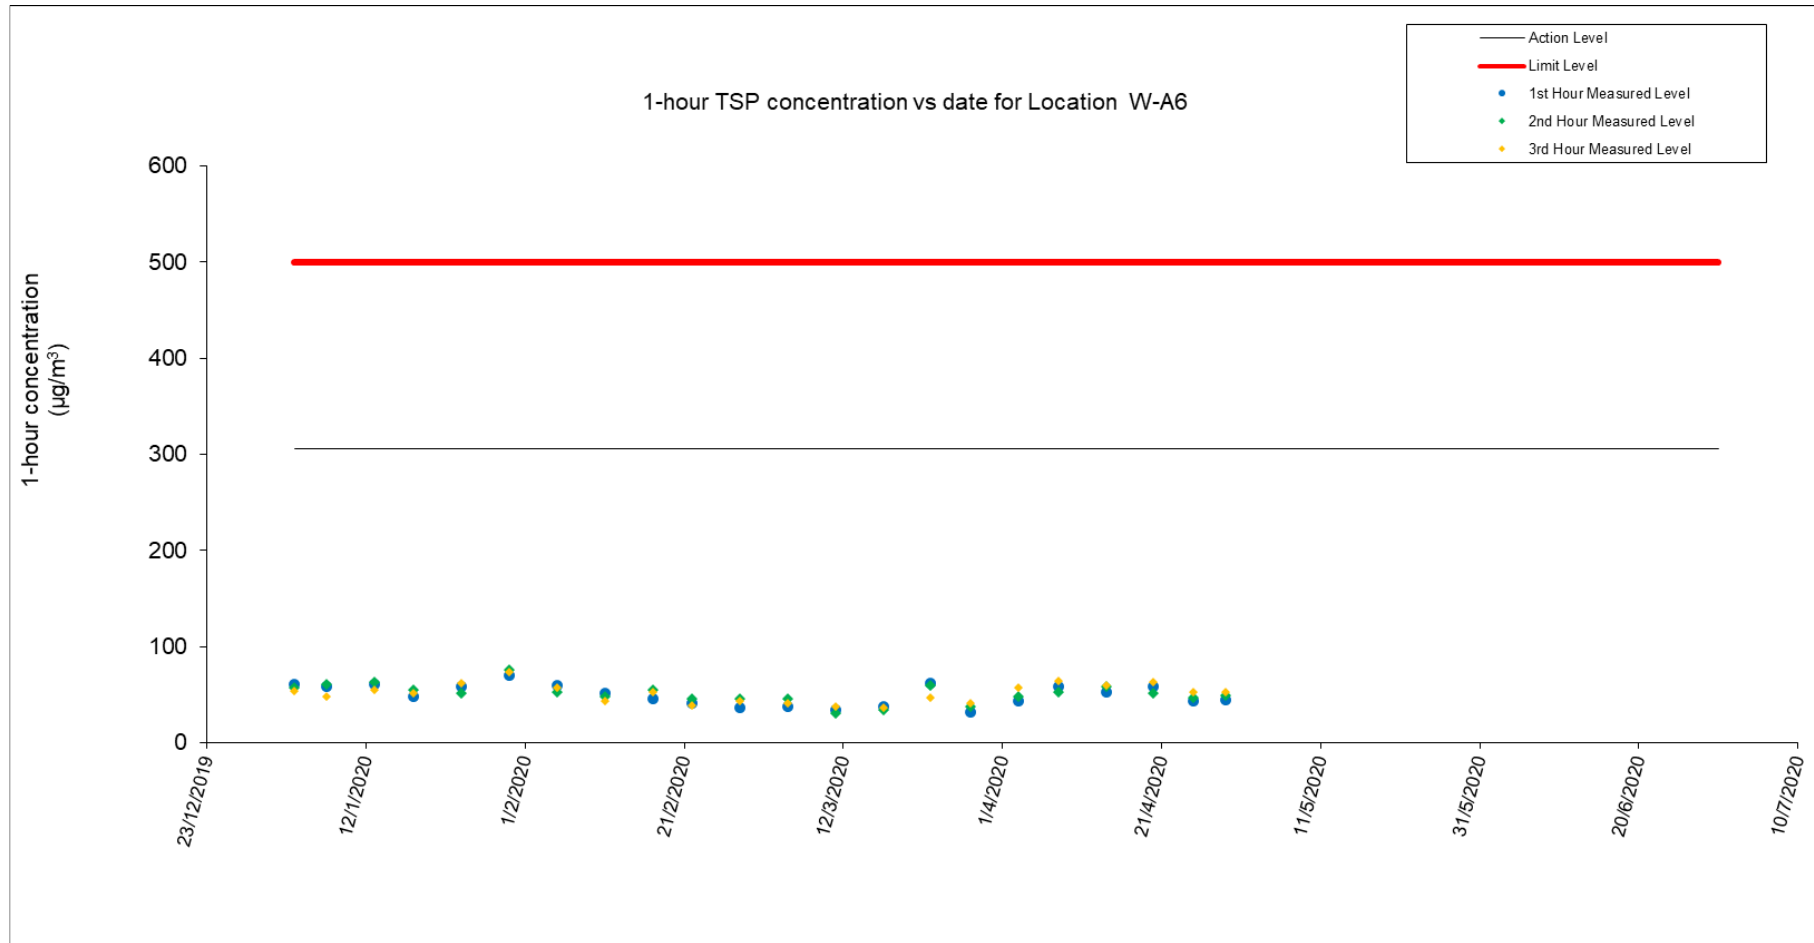
Figure 2: Graphical Illustration of Measured 1-hour TSP ( $\mu\text{g}/\text{m}^3$ ) Levels at W-A6

Location: Man Cheong Building (W-A6)  
Monitoring date: 3, 8, 14, 20, 25, 29 April 2020  
Parameter : TSP 1-hour  
Other Factors Nearby traffic

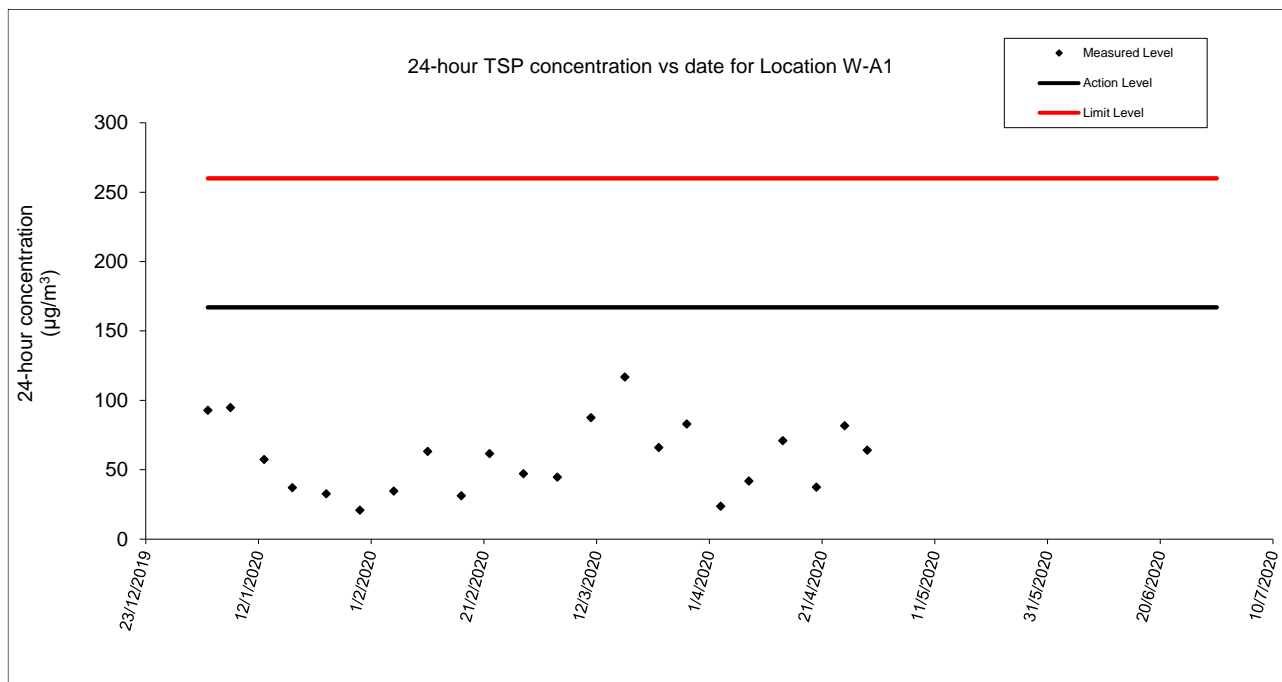
Figure 3: Graphical Illustration of Measured 24-hour TSP ( $\mu\text{g}/\text{m}^3$ ) Levels at W-A1

Location: Yau Ma Tei Catholic Primary School (Hoi Wang Road) (W-A1)  
 Monitoring date: 3, 8, 14, 20, 25, 29 April 2020  
 Parameter : TSP 24-hour  
 Other Factors Nearby traffic, construction work from West Kowloon Government Offices

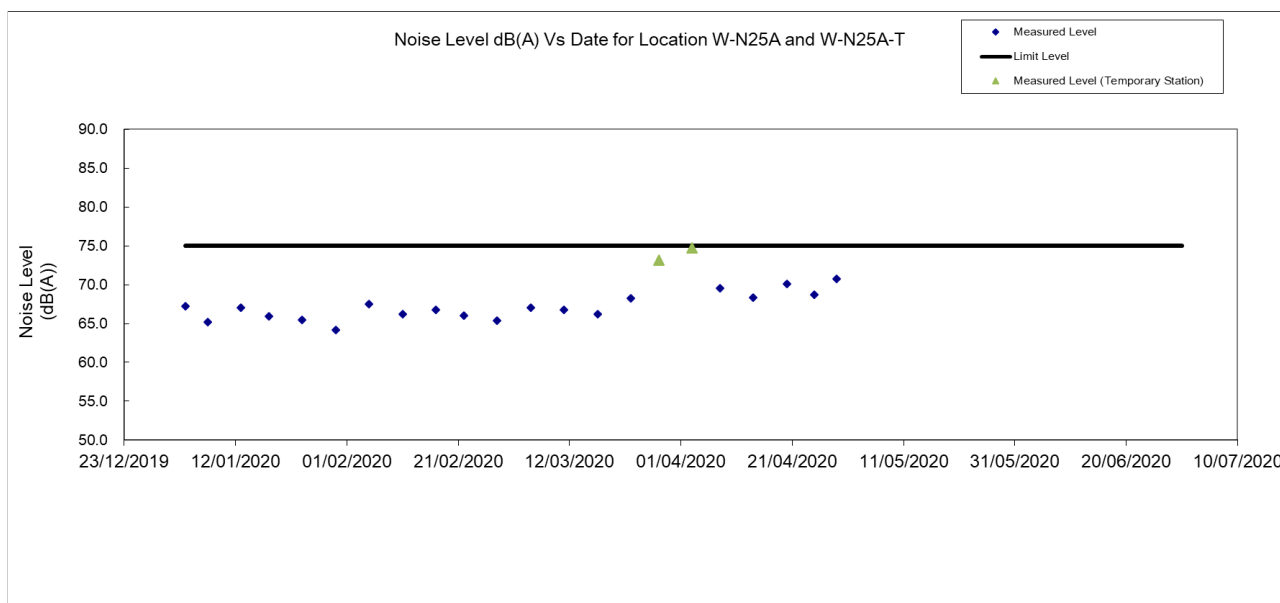
Figure 3: Graphical Illustration of Measured Noise Levels at W-N25A

Remark: Noise monitoring station at Prosperous Garden Block 1 (W-N25A) was temporarily suspended from 24 March 2020 to 6 April 2020 due to a case of novel coronavirus infection at the Prosperous Garden Block 4. A temporary alternative noise monitoring location, W-N25A-T was used on 3 April 2020. A correction of +3dB(A) was made to the free field measurement for W-N25A-T.

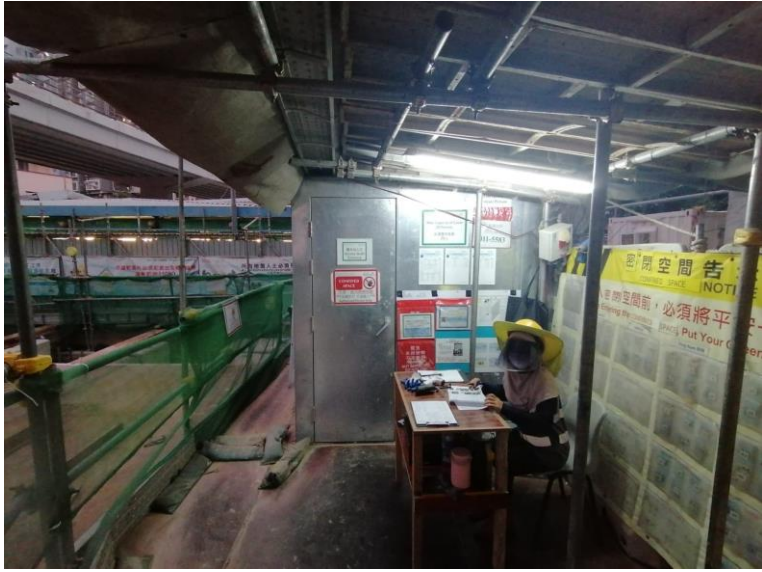
**Figure B1: Closure of Exterior Door**

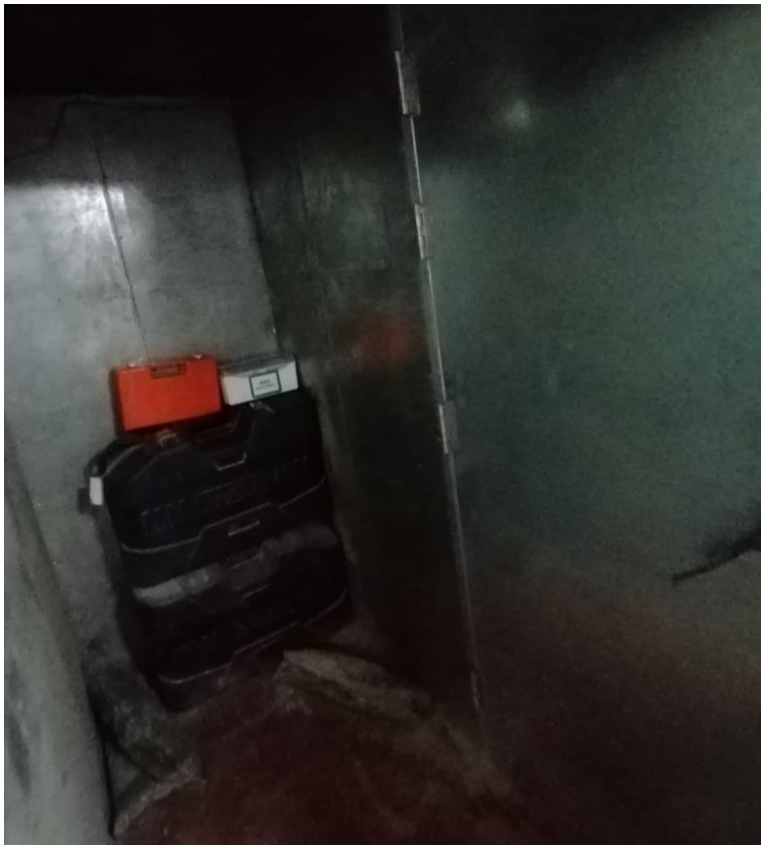
**Figure B2: Closure of Interior Door**

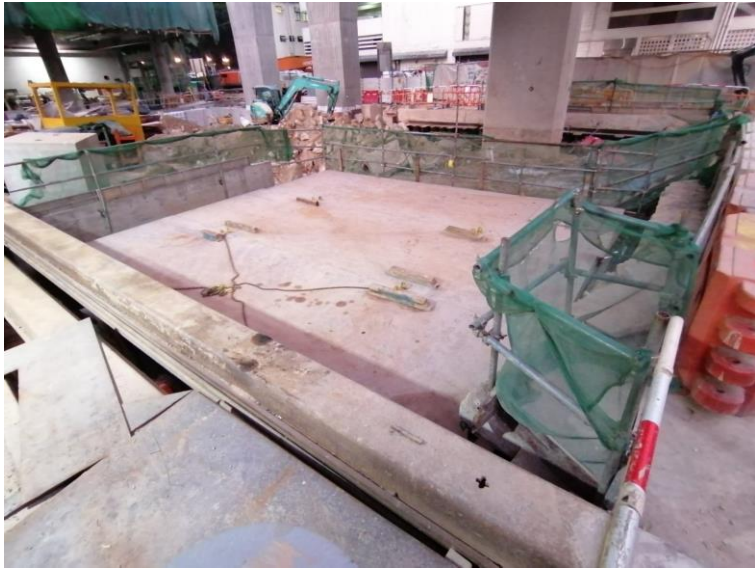
**Figure B3: Closure of Acoustic Panel**

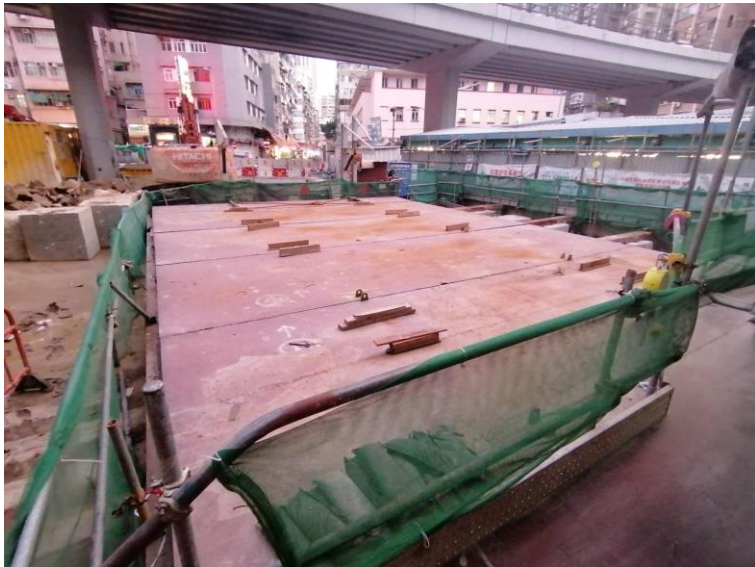
**Figure B4: Closure of Acoustic Panel**
