**Central Kowloon Route**

**Yau Ma Tei East**

**Contract No. HY/2014/08**

### Independent Environmental Checker Verification

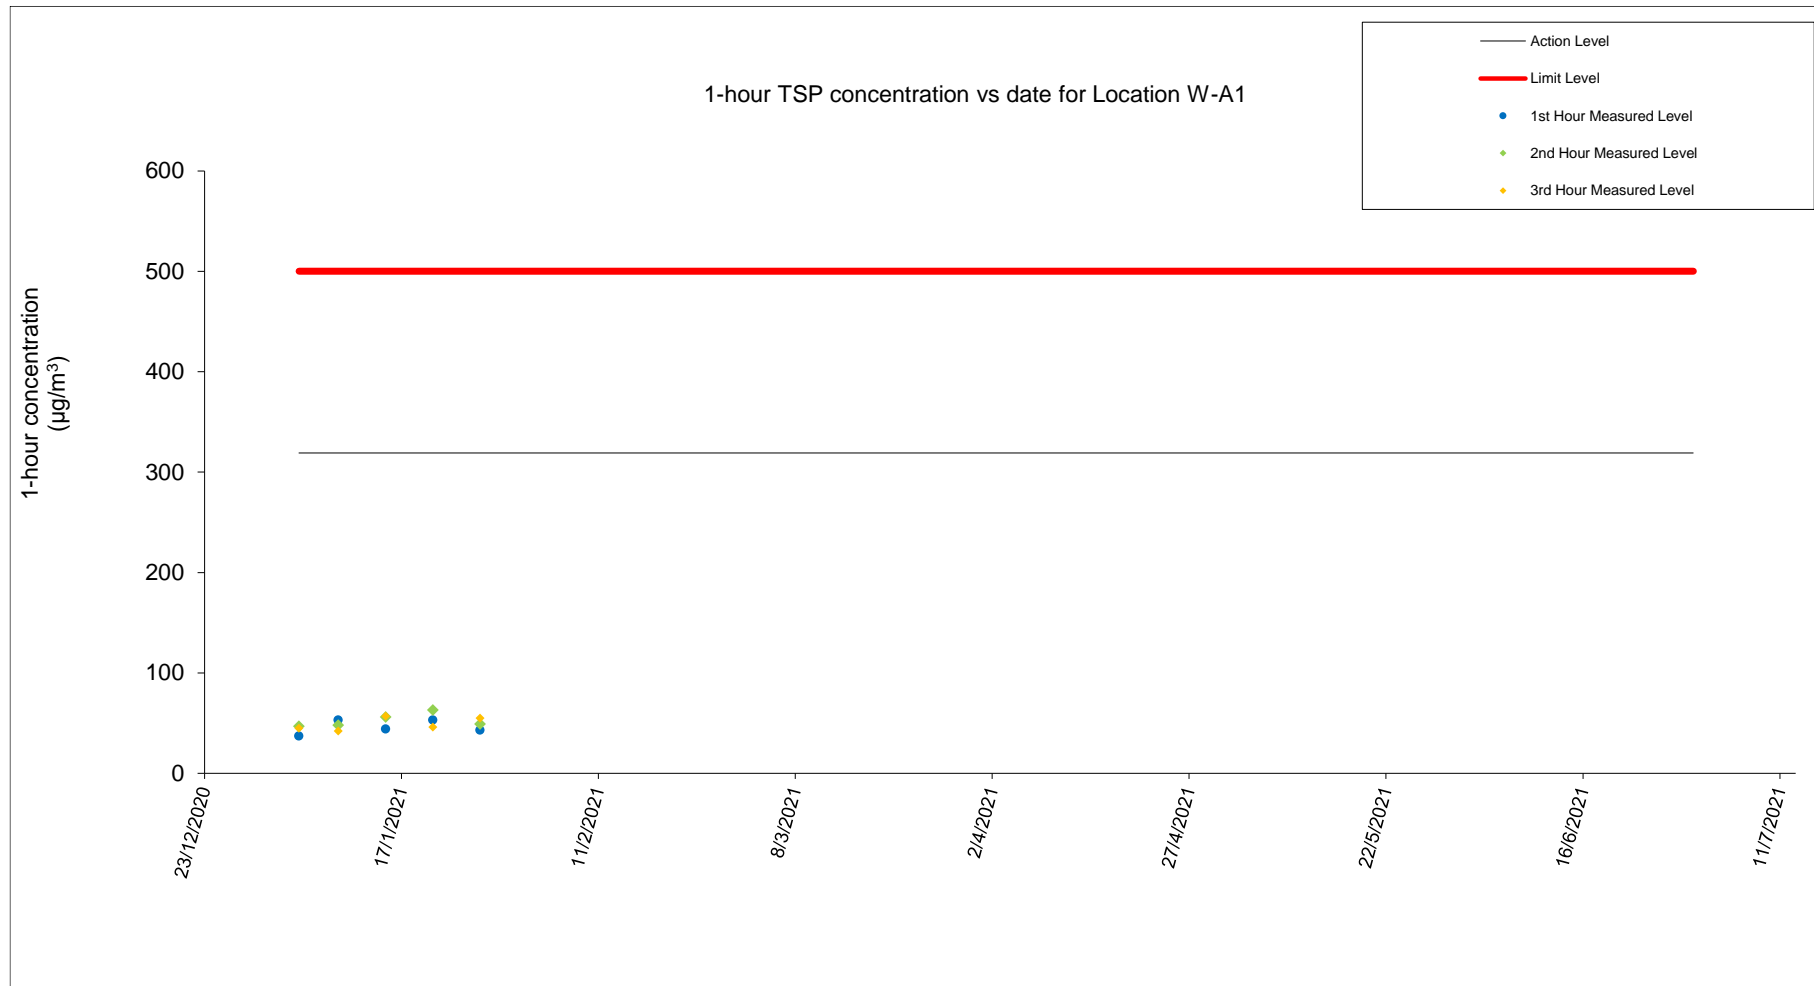
Figure 1: Graphical Illustration of Measured 1-hour TSP ( $\mu\text{g}/\text{m}^3$ ) Levels at W-A1

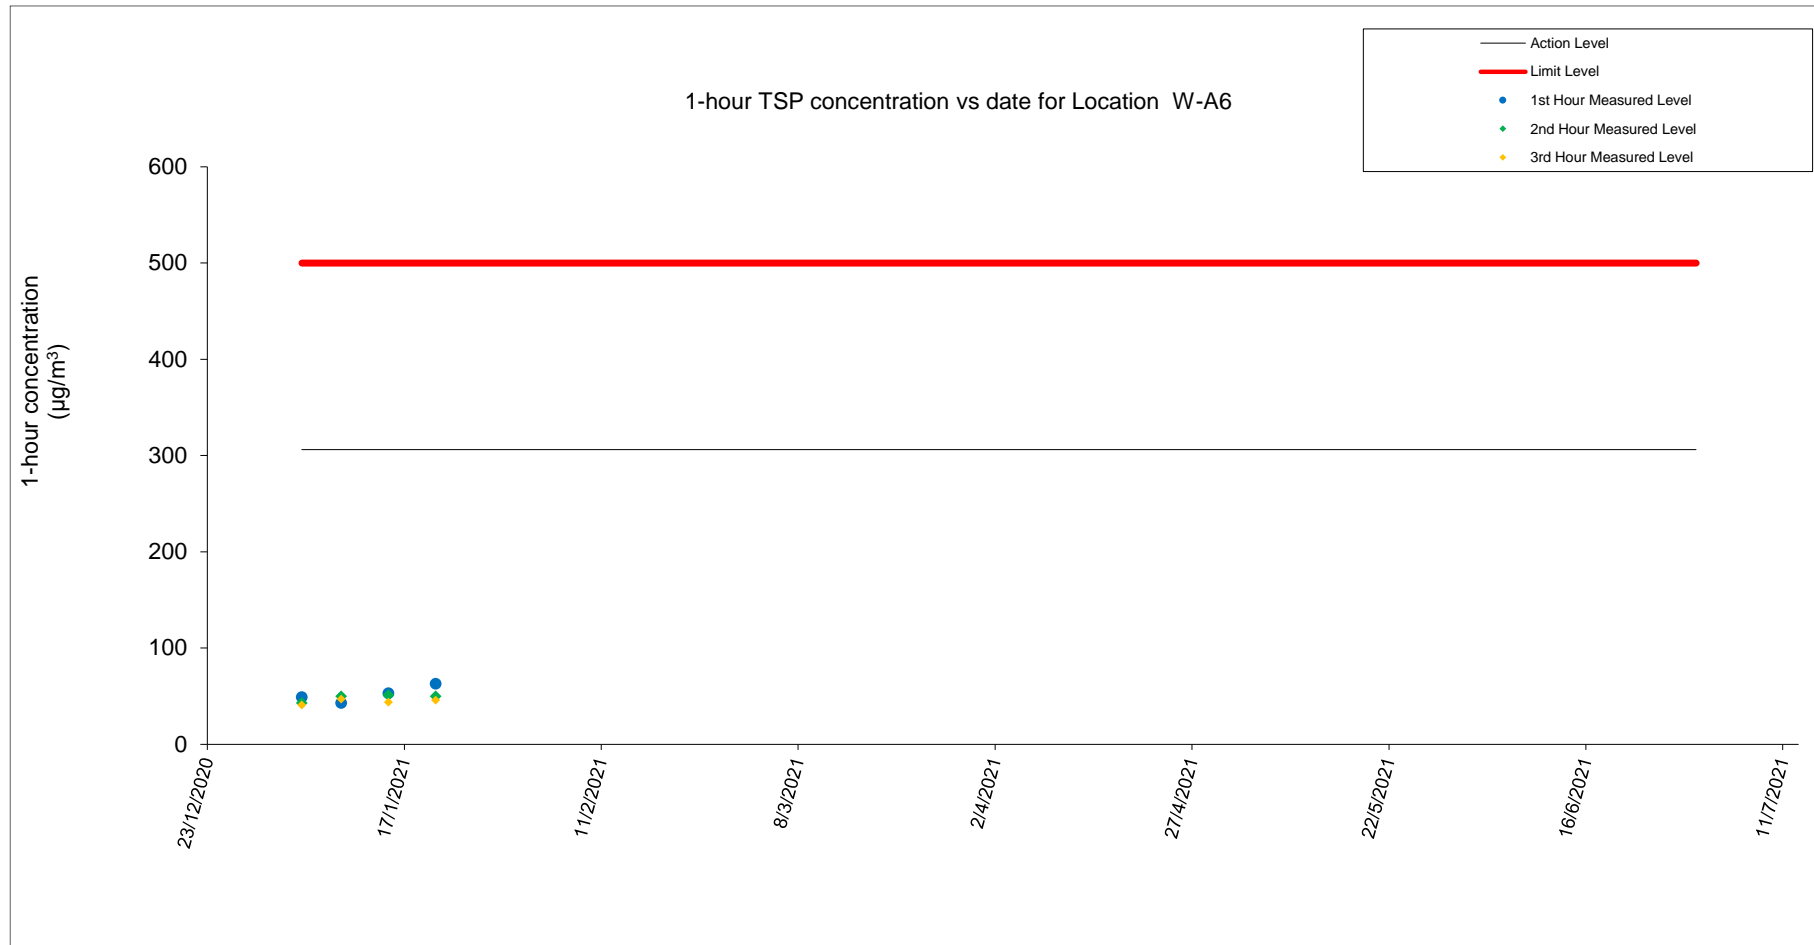
Figure 2: Graphical Illustration of Measured 1-hour TSP ( $\mu\text{g}/\text{m}^3$ ) Levels at W-A6

Remark: 1-hour TSP monitoring at W-A6 was temporarily suspended from 27 January 2021 to 9 February 2021 as this station was located inside the specified area.

^Remark: 1-hour TSP monitoring at W-A6 was temporarily suspended from 27 January 2021 to 9 February 2021 as this station was located inside the specified area of lock down due to COVID-19.

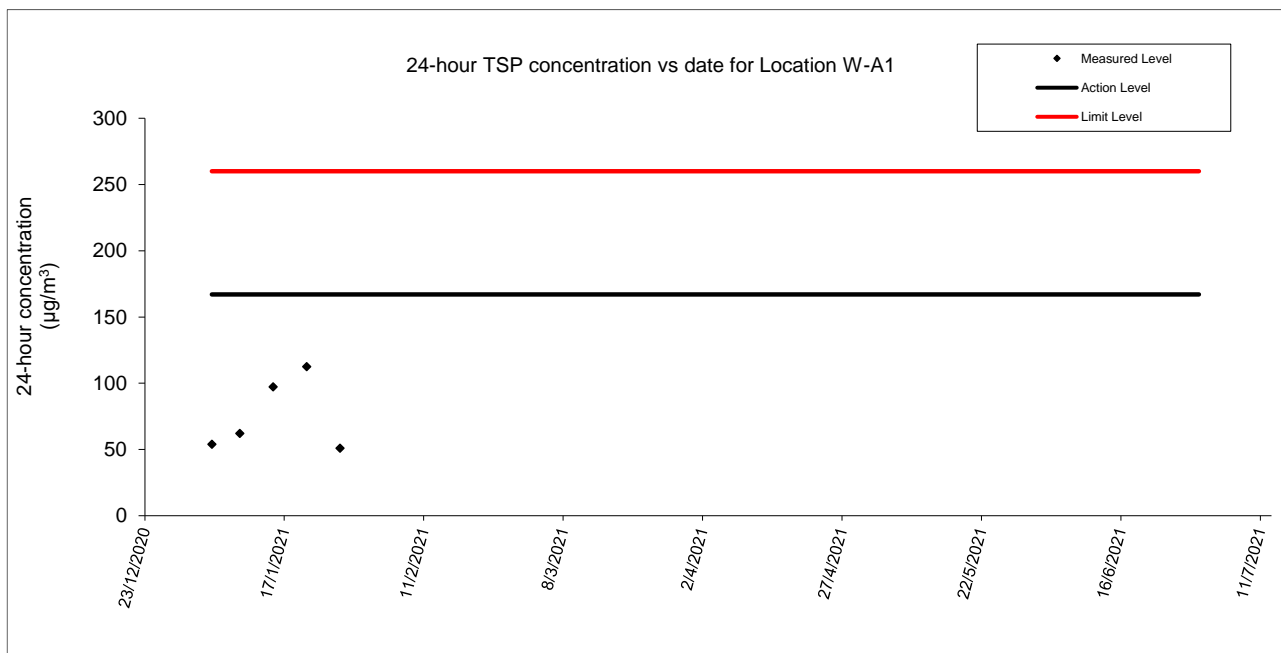
Figure 3: Graphical Illustration of Measured 24-hour TSP ( $\mu\text{g}/\text{m}^3$ ) Levels at W-A1

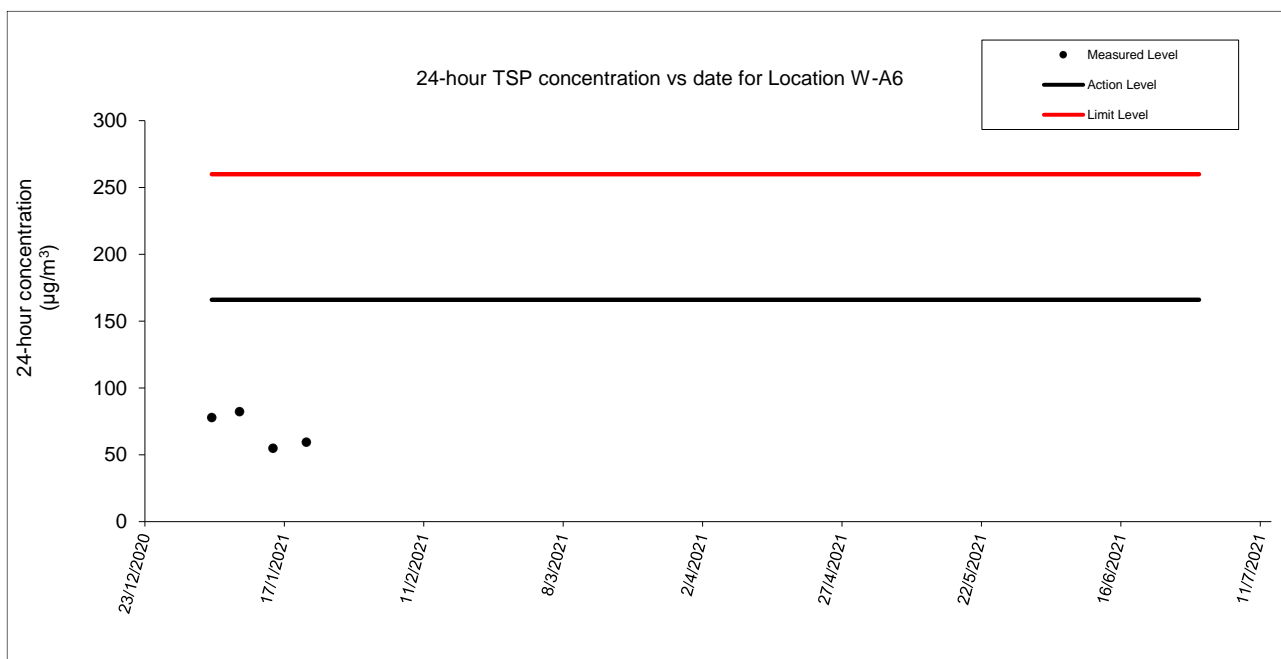
Figure 4: Graphical Illustration of Measured 24-hour TSP ( $\mu\text{g}/\text{m}^3$ ) Levels at W-A6

Remark: 24-hour TSP monitoring at W-A6 was temporarily suspended from 27 January 2021 to 9 February 2021 as this station was located inside or in proximity to the specified areas.

^Remark: 24-hour TSP monitoring at W-A6 was temporarily suspended from 27 January 2021 to 9 February 2021 as this station was located inside the specified area of lock down due to COVID-19.

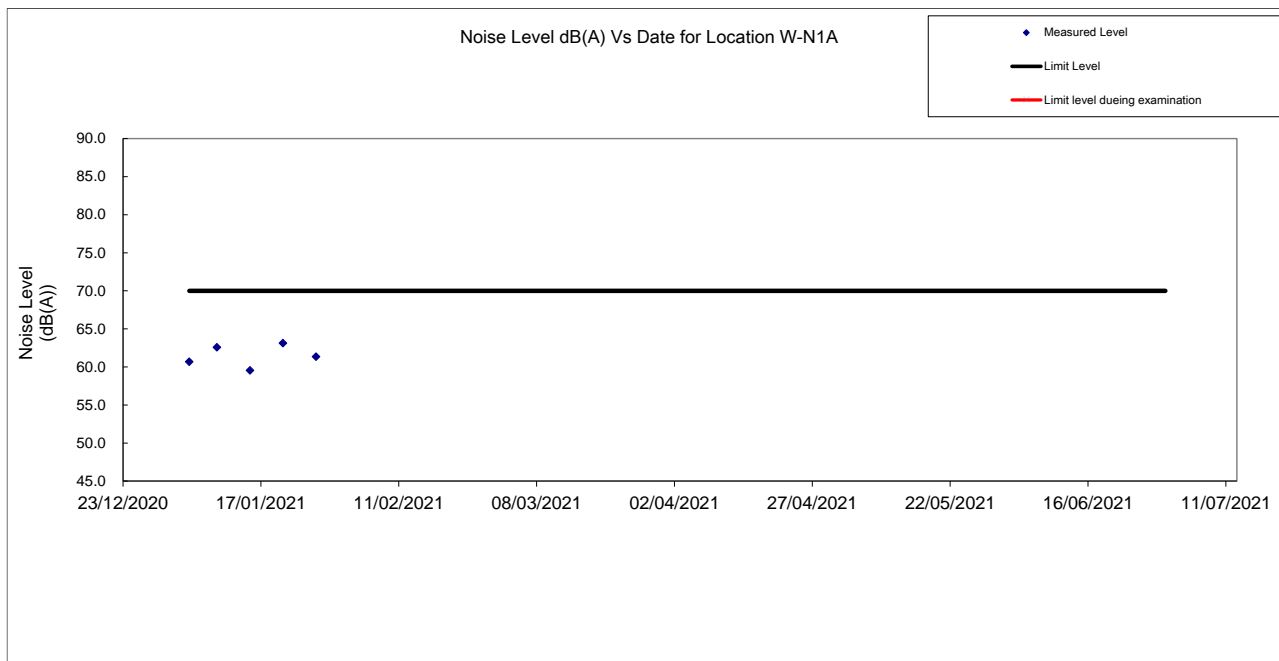
Figure 1: Graphical Illustration of Measured Noise Levels at W-N1A

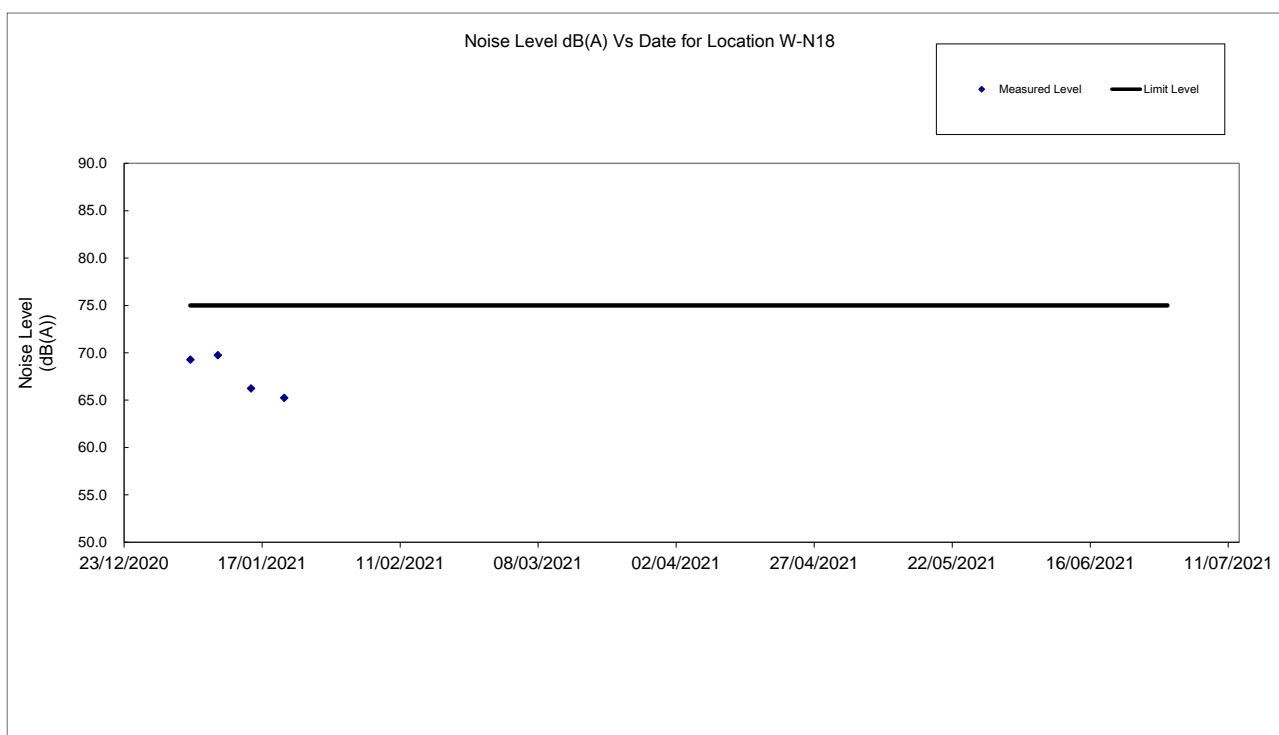
Figure 2: Graphical Illustration of Measured Noise Levels at W-N18

Remark: Noise monitoring at W-N18 was temporarily suspended from 27 January 2021 to 9 February 2021 as this station was located inside the specified area.

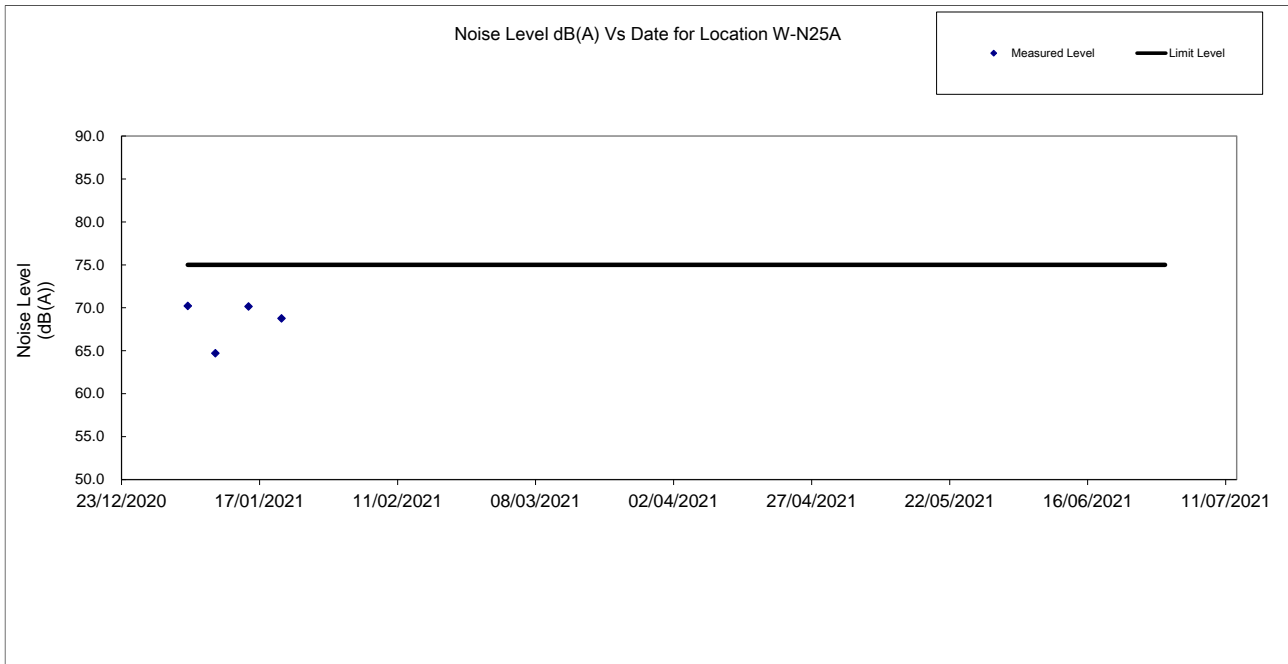
Figure 3: Graphical Illustration of Measured Noise Levels at W-N25A

Remark; Noise monitoring at W-N25A/W-N25A-T were temporarily suspended from 27 January 2021 to 9 February 2021 as these stations were located inside or in proximity to the specified areas.

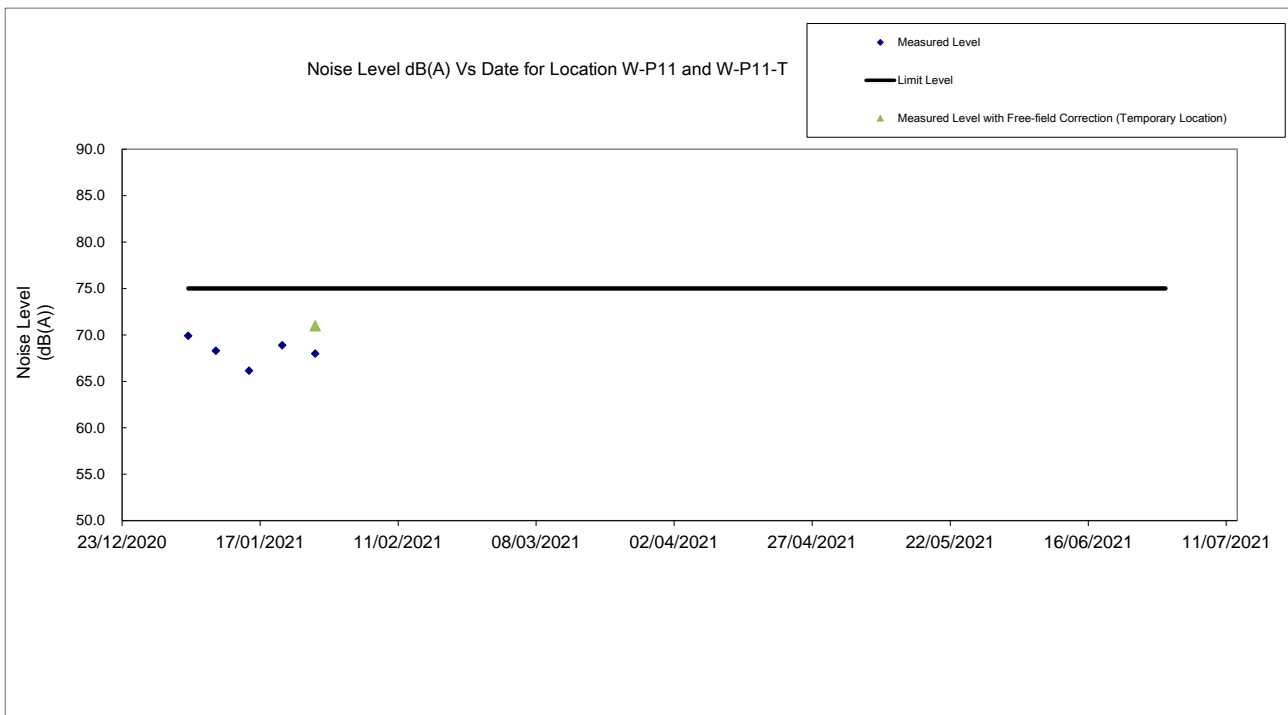
Figure 4: Graphical Illustration of Measured Noise Levels at W-P11

Remark: Noise monitoring at the Coronation Tower 1 (W-P11) was temporarily suspended on 27 January 2021 due to a case of novel coronavirus infection at the Coronation Circle on 17 January 2021. A temporary alternative noise monitoring location, W-P11-T was used on 27 January 2021. A correction of +3dB(A) was made to the free field measurement for W-P11-T.

^Remark: Noise monitoring at the Coronation Tower 1 (W-P11) was temporarily suspended on 27 January 2021 due to a case of novel coronavirus infection at the Coronation Circle on 17 January 2021. A temporary alternative noise monitoring location, W-P11-T was used on 27 January 2021. A correction of +3dB(A) was made to the free field measurement for W-P11-T.
