Central Kowloon Route

Yau Ma Tei East

Monthly EM&A Report No. 60

(Period from 1 to 31 March 2023)

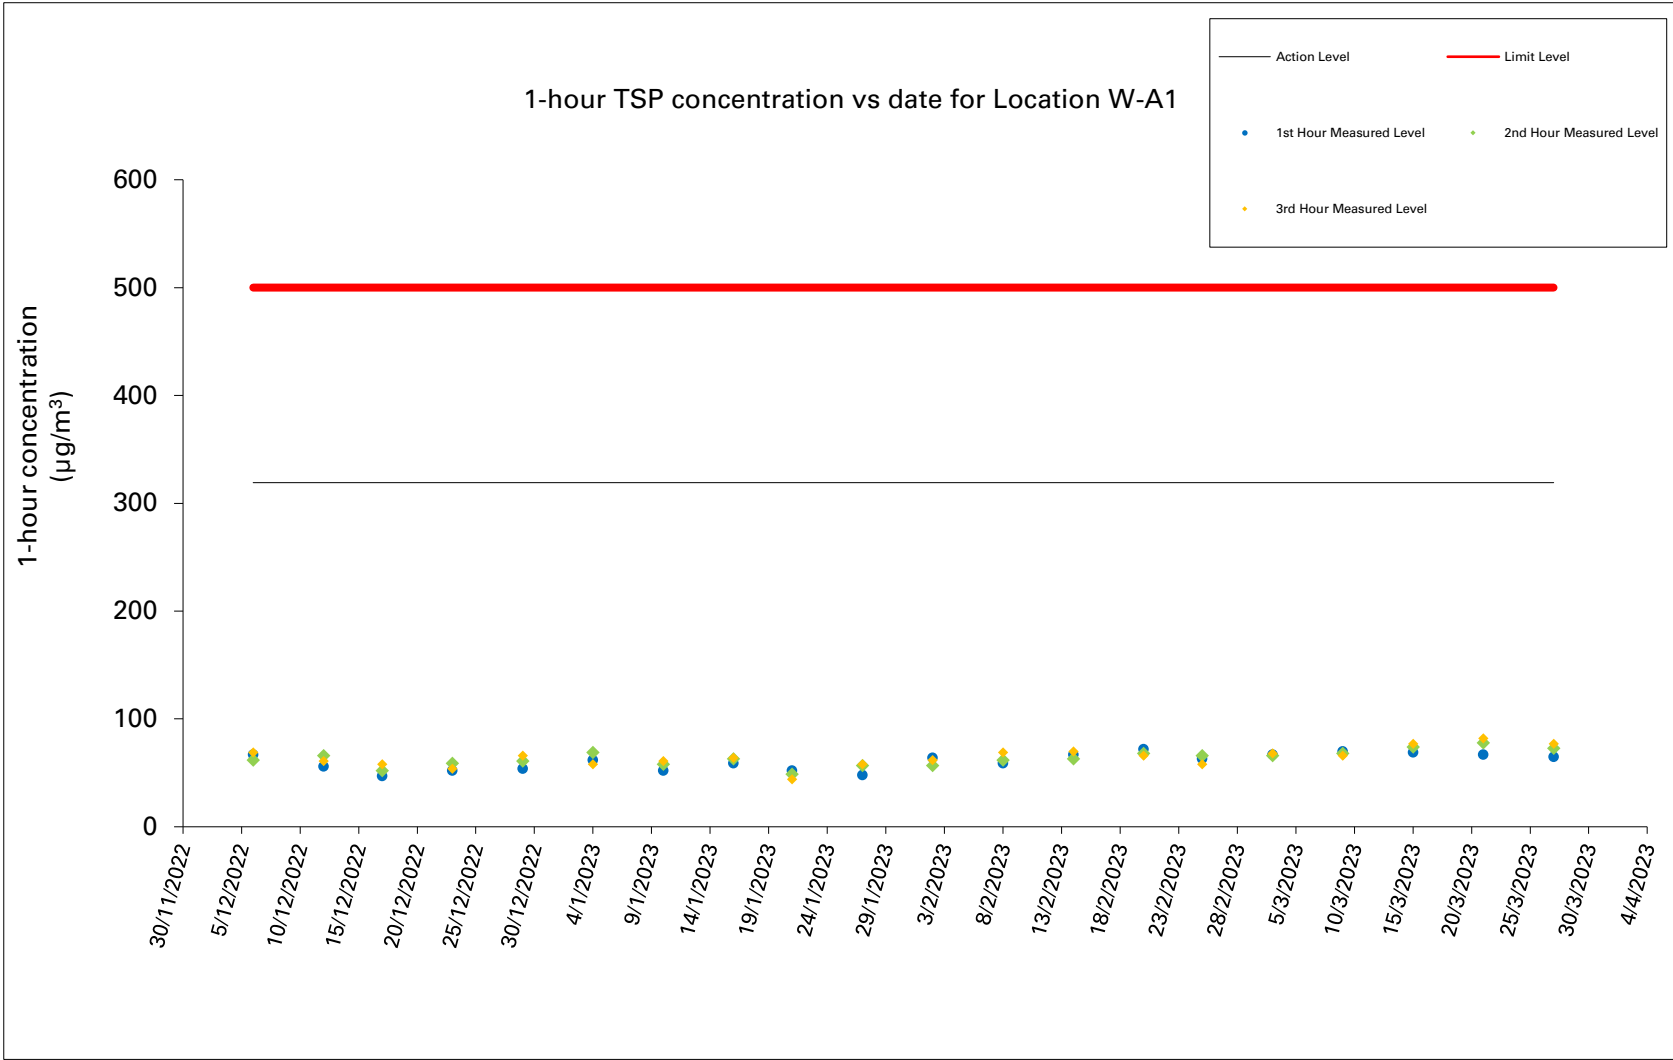
Figure 1: Graphical Illustration of Measured 1-hour TSP ($\mu\text{g}/\text{m}^3$) Levels at W-A1

Location: Man Cheong Building (W-A6)
Monitoring date: 3, 9, 15, 21 and 27 March 2023
Parameter : TSP 1-hour
Other Factors Nearby traffic

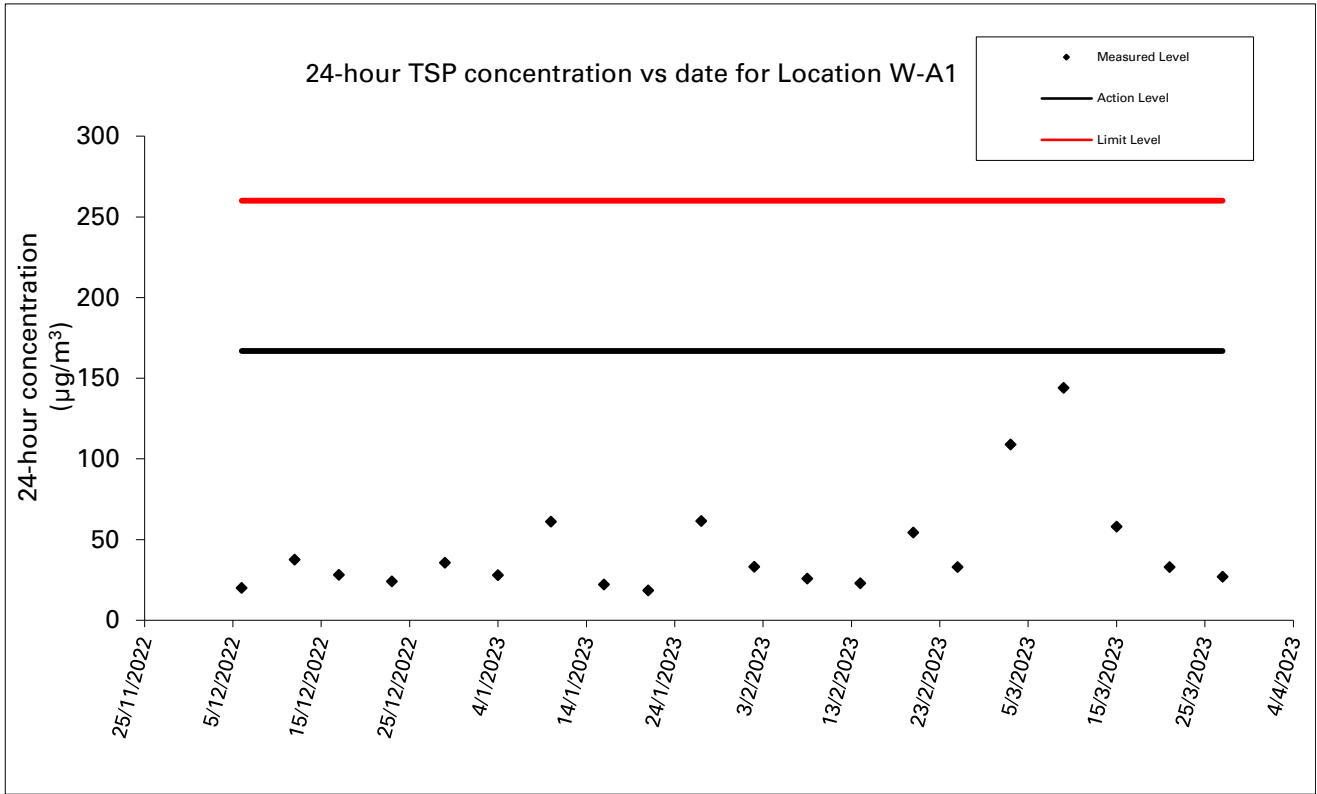
Figure 3: Graphical Illustration of Measured 24-hour TSP ($\mu\text{g}/\text{m}^3$) Levels at W-A1

Location: Yau Ma Tei Catholic Primary School (Hoi Wang Road) (W-A1)
 Monitoring date: 3, 9, 15, 21 and 27 March 2023
 Parameter : TSP 24-hour
 Other Factors Nearby traffic

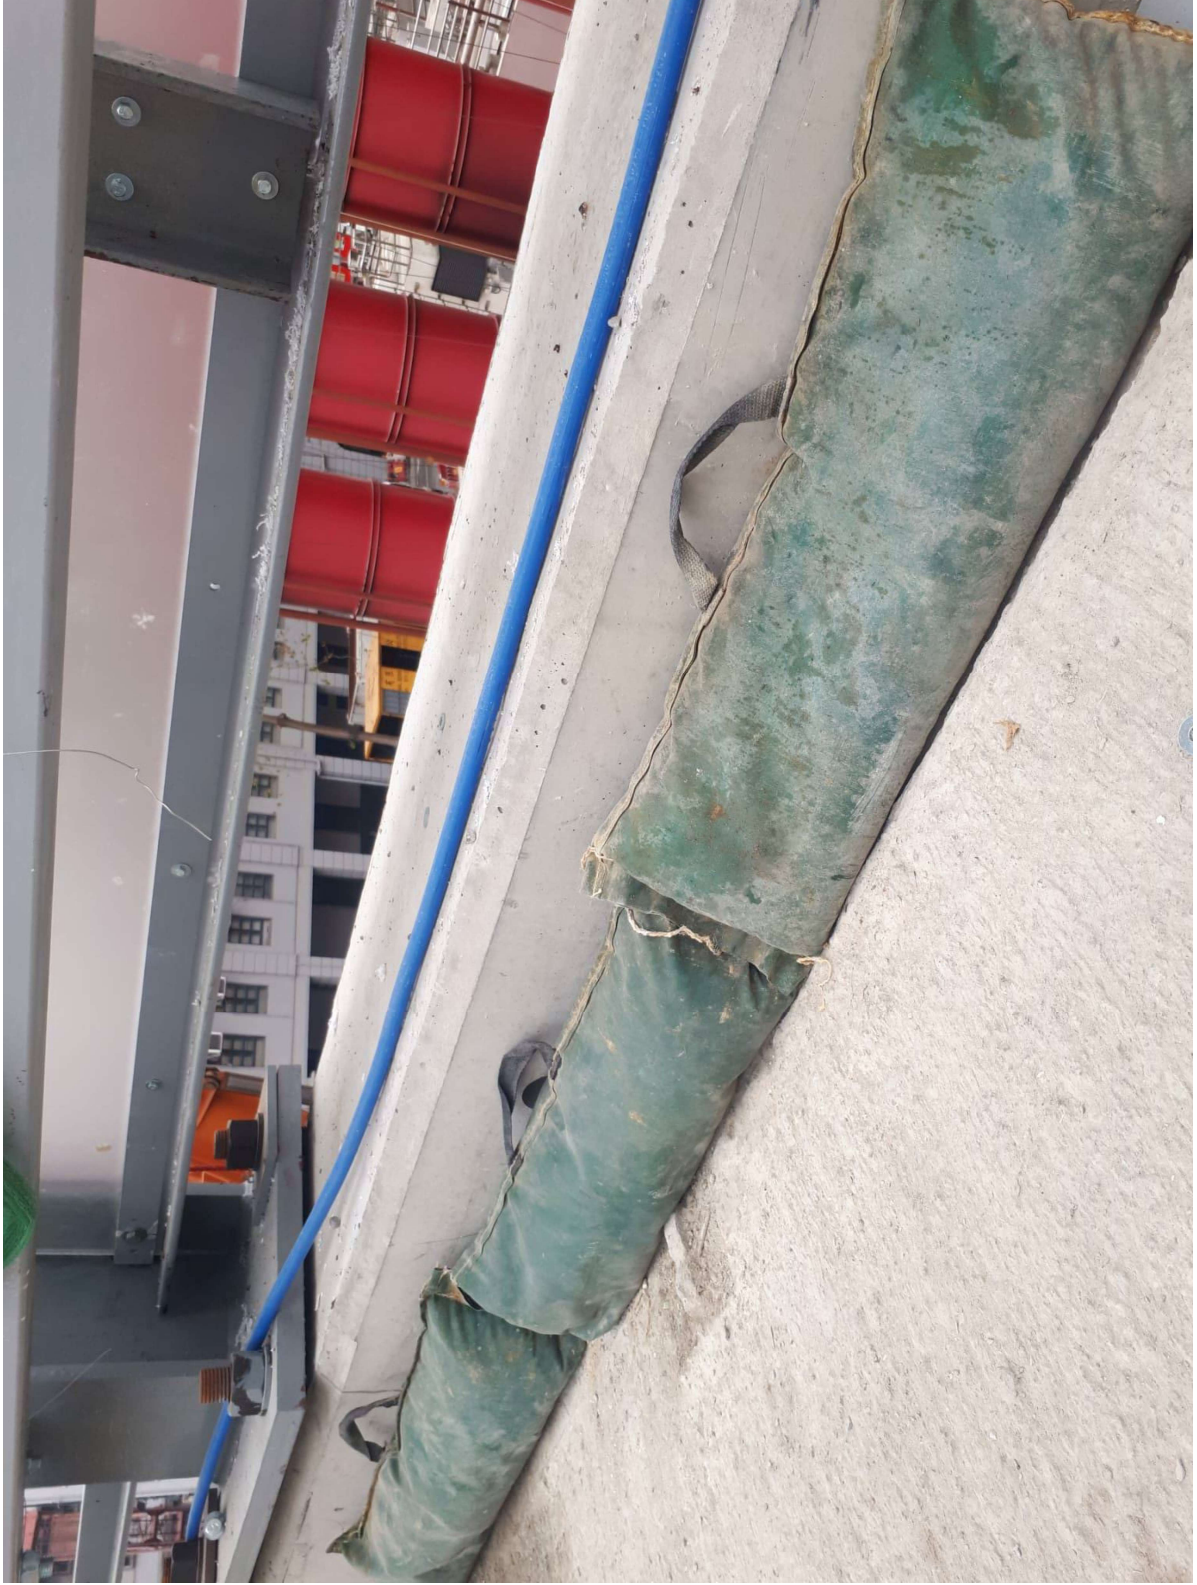
Remark 2: Bund along the bridge to prevent surface runoff outside the construction site
