Central Kowloon Route

Yau Ma Tei East

Contract No. HY/2014/08

Monthly EM&A Report No. 43

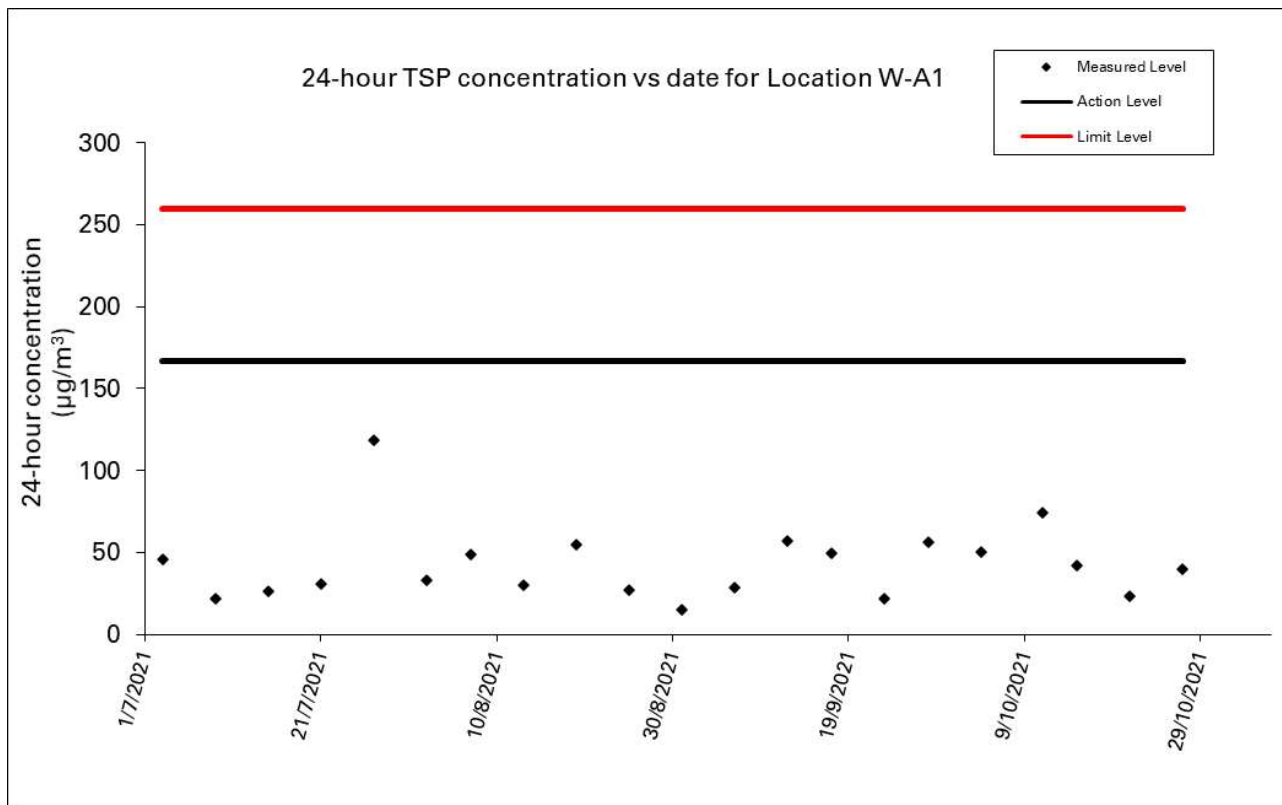
Figure 3: Graphical Illustration of Measured 24-hour TSP ($\mu\text{g}/\text{m}^3$) Levels at W-A1

Location: Yau Ma Tei Catholic Primary School (Hoi Wang Road) (W-A1)
 Monitoring date: 4, 11, 15, 21 and 27 October 2021
 Parameter : TSP 24-hour
 Other Factors Nearby traffic

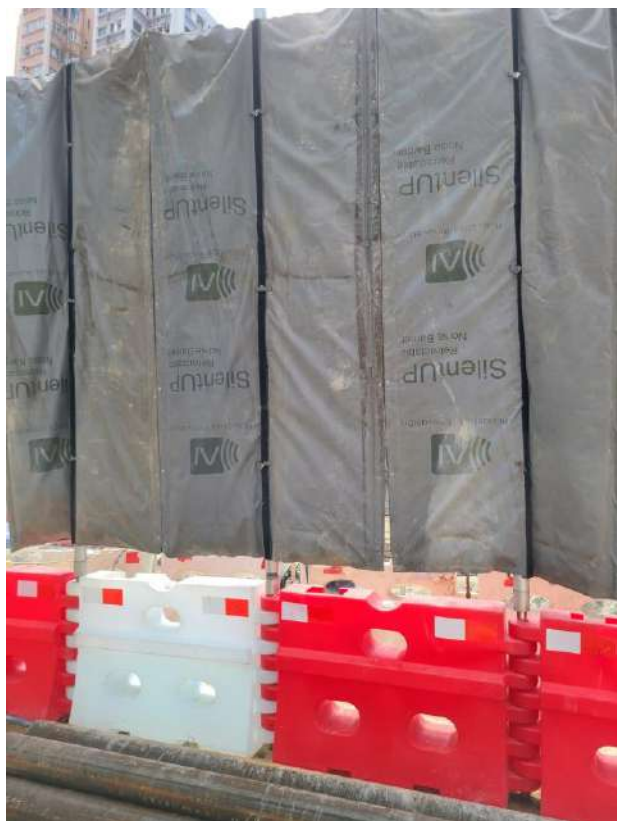
Figure A1 Noise barrier mat erected along site boundary

Actions taken / to be taken	The Contractor had followed EM&A Manual strictly to implement mitigation measures in order to minimize nuisance to the public. Noise barrier mat had been erected by the Contractor to reduce impact from the drilling and breaking machines. Supporting photo is provided in Appendix A.
Remarks	<p>PME used in Zone B2 and C from 11 to 21 October 2021 during daytime:</p> <ul style="list-style-type: none"> ● Generator x1 ● Mobile crane x2 ● Excavator x1 <p>Construction works carried out in Zone B2 and C from 11 to 21 October 2021 during daytime:</p> <ul style="list-style-type: none"> ● D-wall trimming <p>Works locations: (next page.)</p>
Prepared by	Katrina Chui
Date	26 October 2021
