Central Kowloon Route

Yau Ma Tei East

Contract No. HY/2014/08

Monthly EM&A Report No. 6

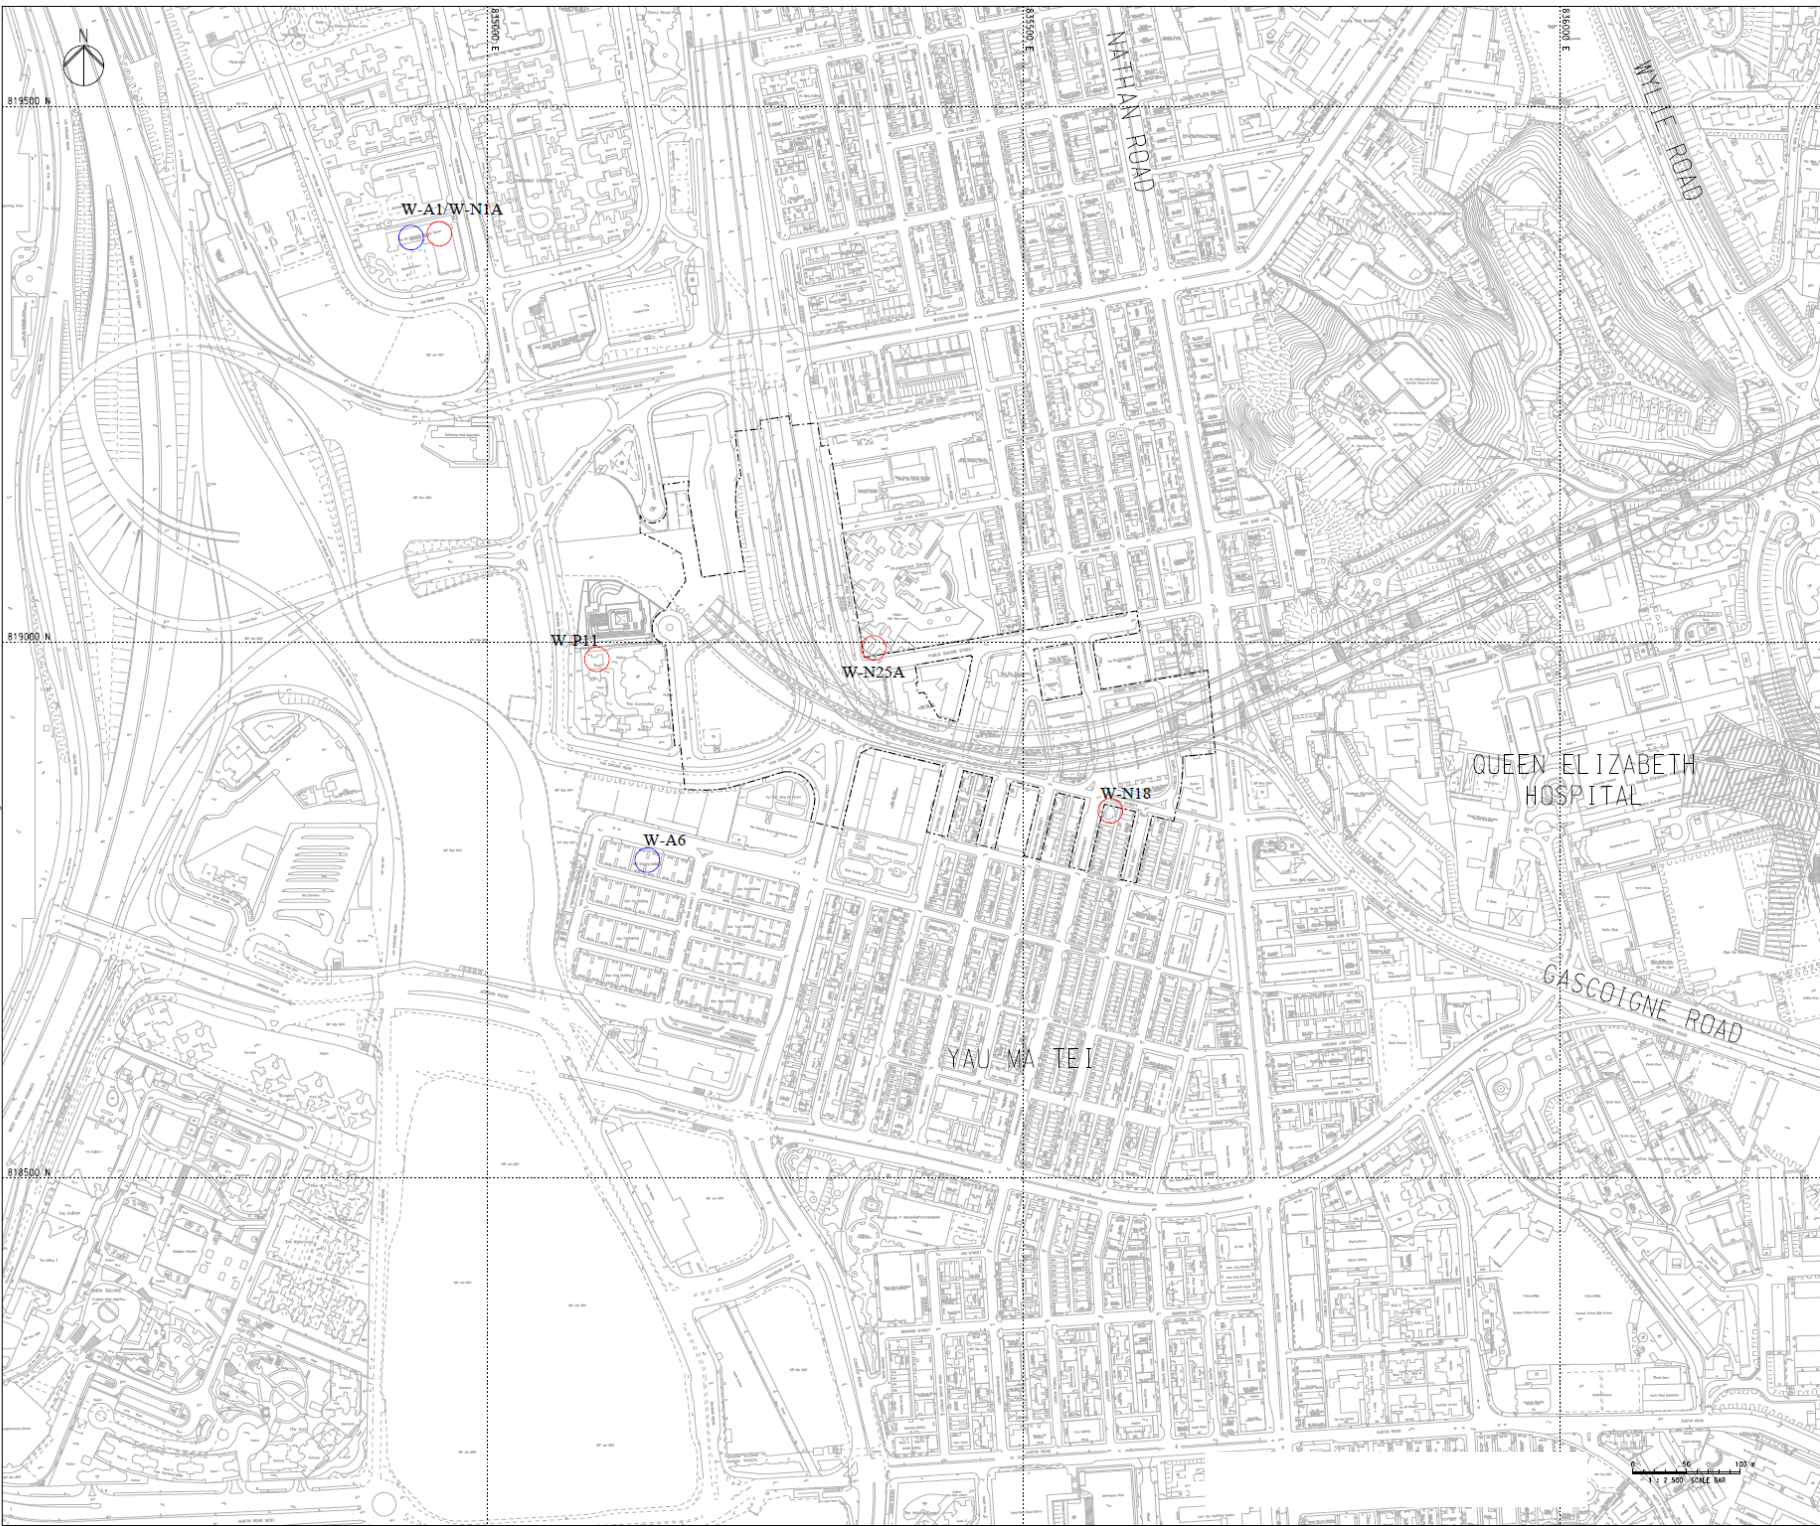
Location Plan of Noise and Air Quality Monitoring Station

- 3.4.1. During the site visit, both of the original proposed dust monitoring locations were rejected due to the condition at The Coronation was not favorable for monitoring and the access was declined by the management office of Hong Kong Community College (HKCC) of PolyU. Two alternative air monitoring stations Yau Ma Tei Catholic Primary School (Hoi Wang Road) and Man Cheong Building had been proposed by ET and approved by IEC. 2 designated air monitoring locations were identified and agreed with IEC and EPD. Details of air monitoring stations are described in Table 3.3. The location plan of air quality monitoring stations is shown in Appendix K.

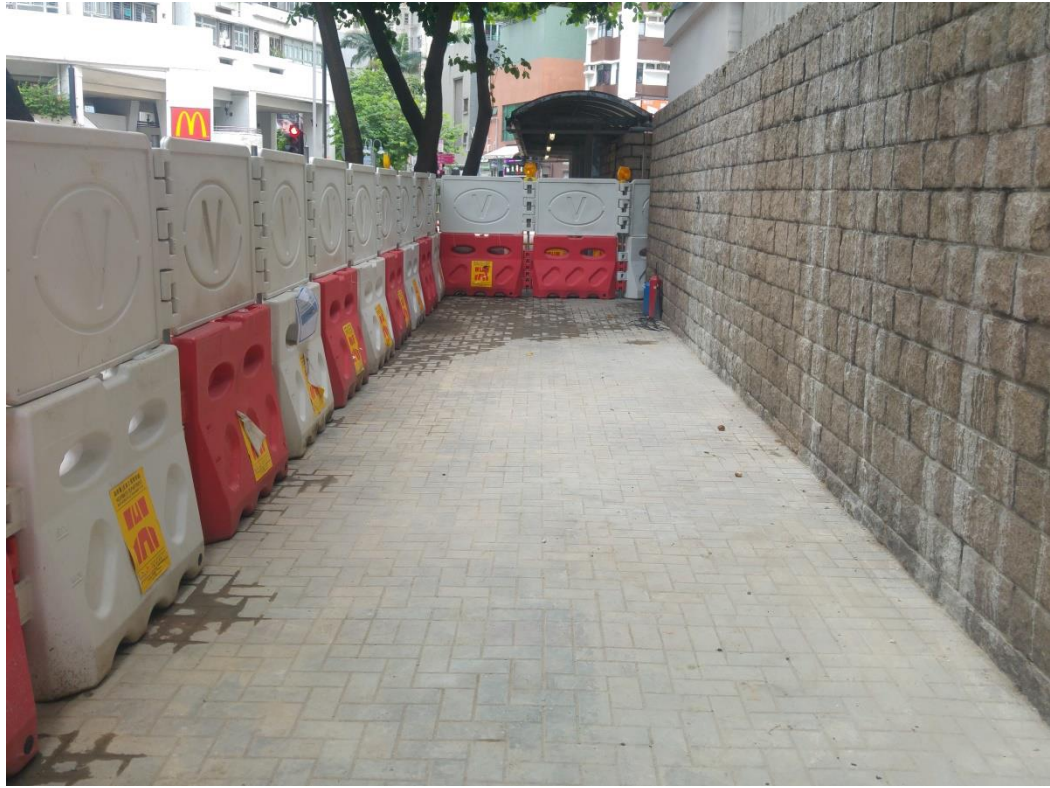
| Investigation finding | The investigation on 7 September discovered the stink to be odour of burning diesel coming from a generator at Methadone Clinic (Portion 7). PME and site condition for other works present in the site were checked with no abnormal findings. |
| Remarks | <p>Generator with malodour removed from Methadone Clinic (Portion 7) on 12/9:</p> |

| Actions taken / to be taken | <p>The generator with malodour concern was promptly stopped operation on 7 September and removed from site on 12 September, which would be replaced by another one with better environmental performance in the future shall generator be needed. The new generator will also be located away from the pedestrian road to reduce possible nuisance to the public in the future.</p> <p>Malodour was found absent in the next joint site inspection carried out on 13 September 2018.</p> |
