Works Contract HY/2014/07 – Central Kowloon Route – Kai Tak West

Graphical Presentation of Water Quality Monitoring Results

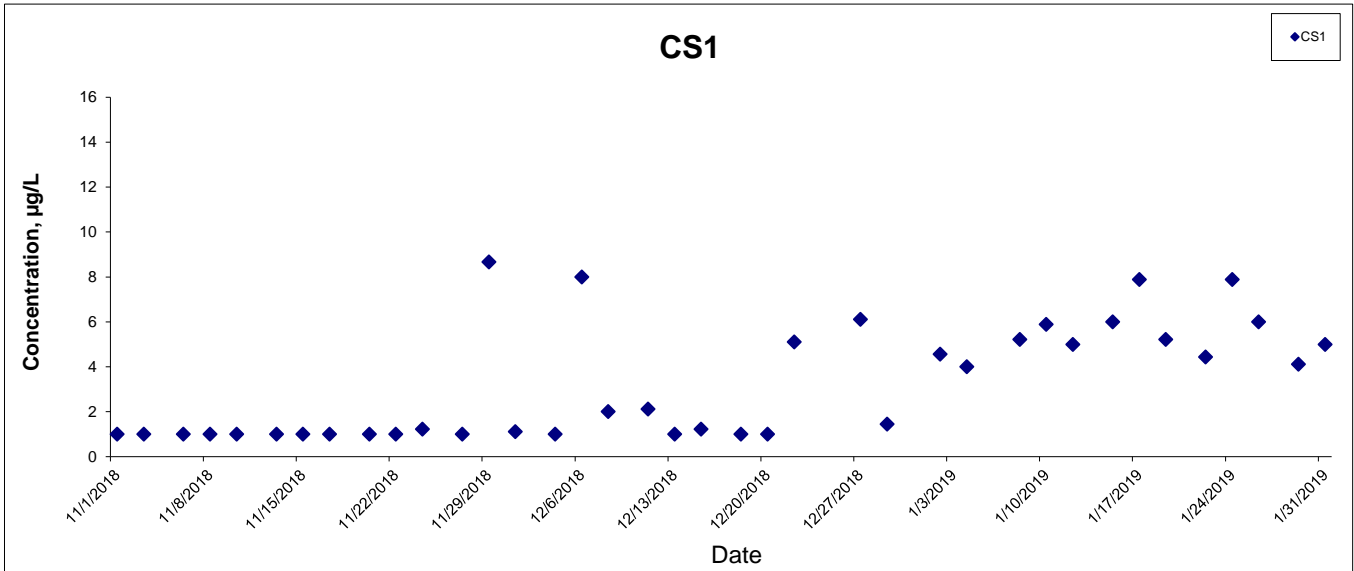
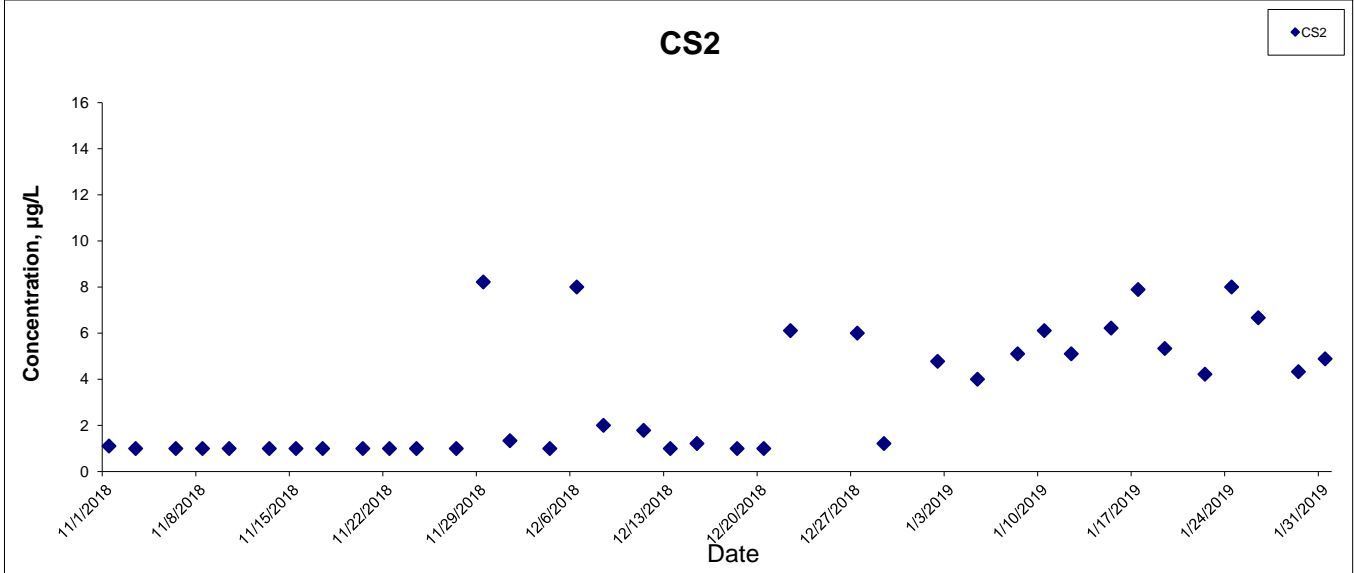
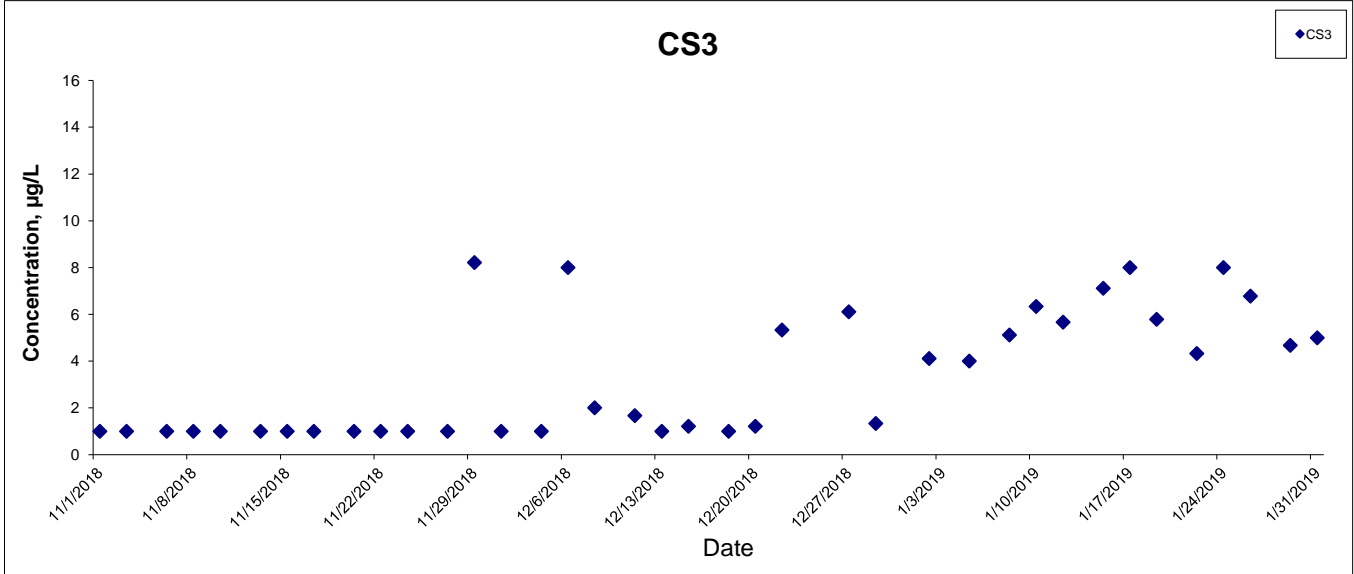
Copper (Depth-averaged) at Mid-Ebb Tide

Remarks: In accordance with Section 7.9 of the EM&A Manual, the detection limit for copper is 1.00µg/L.

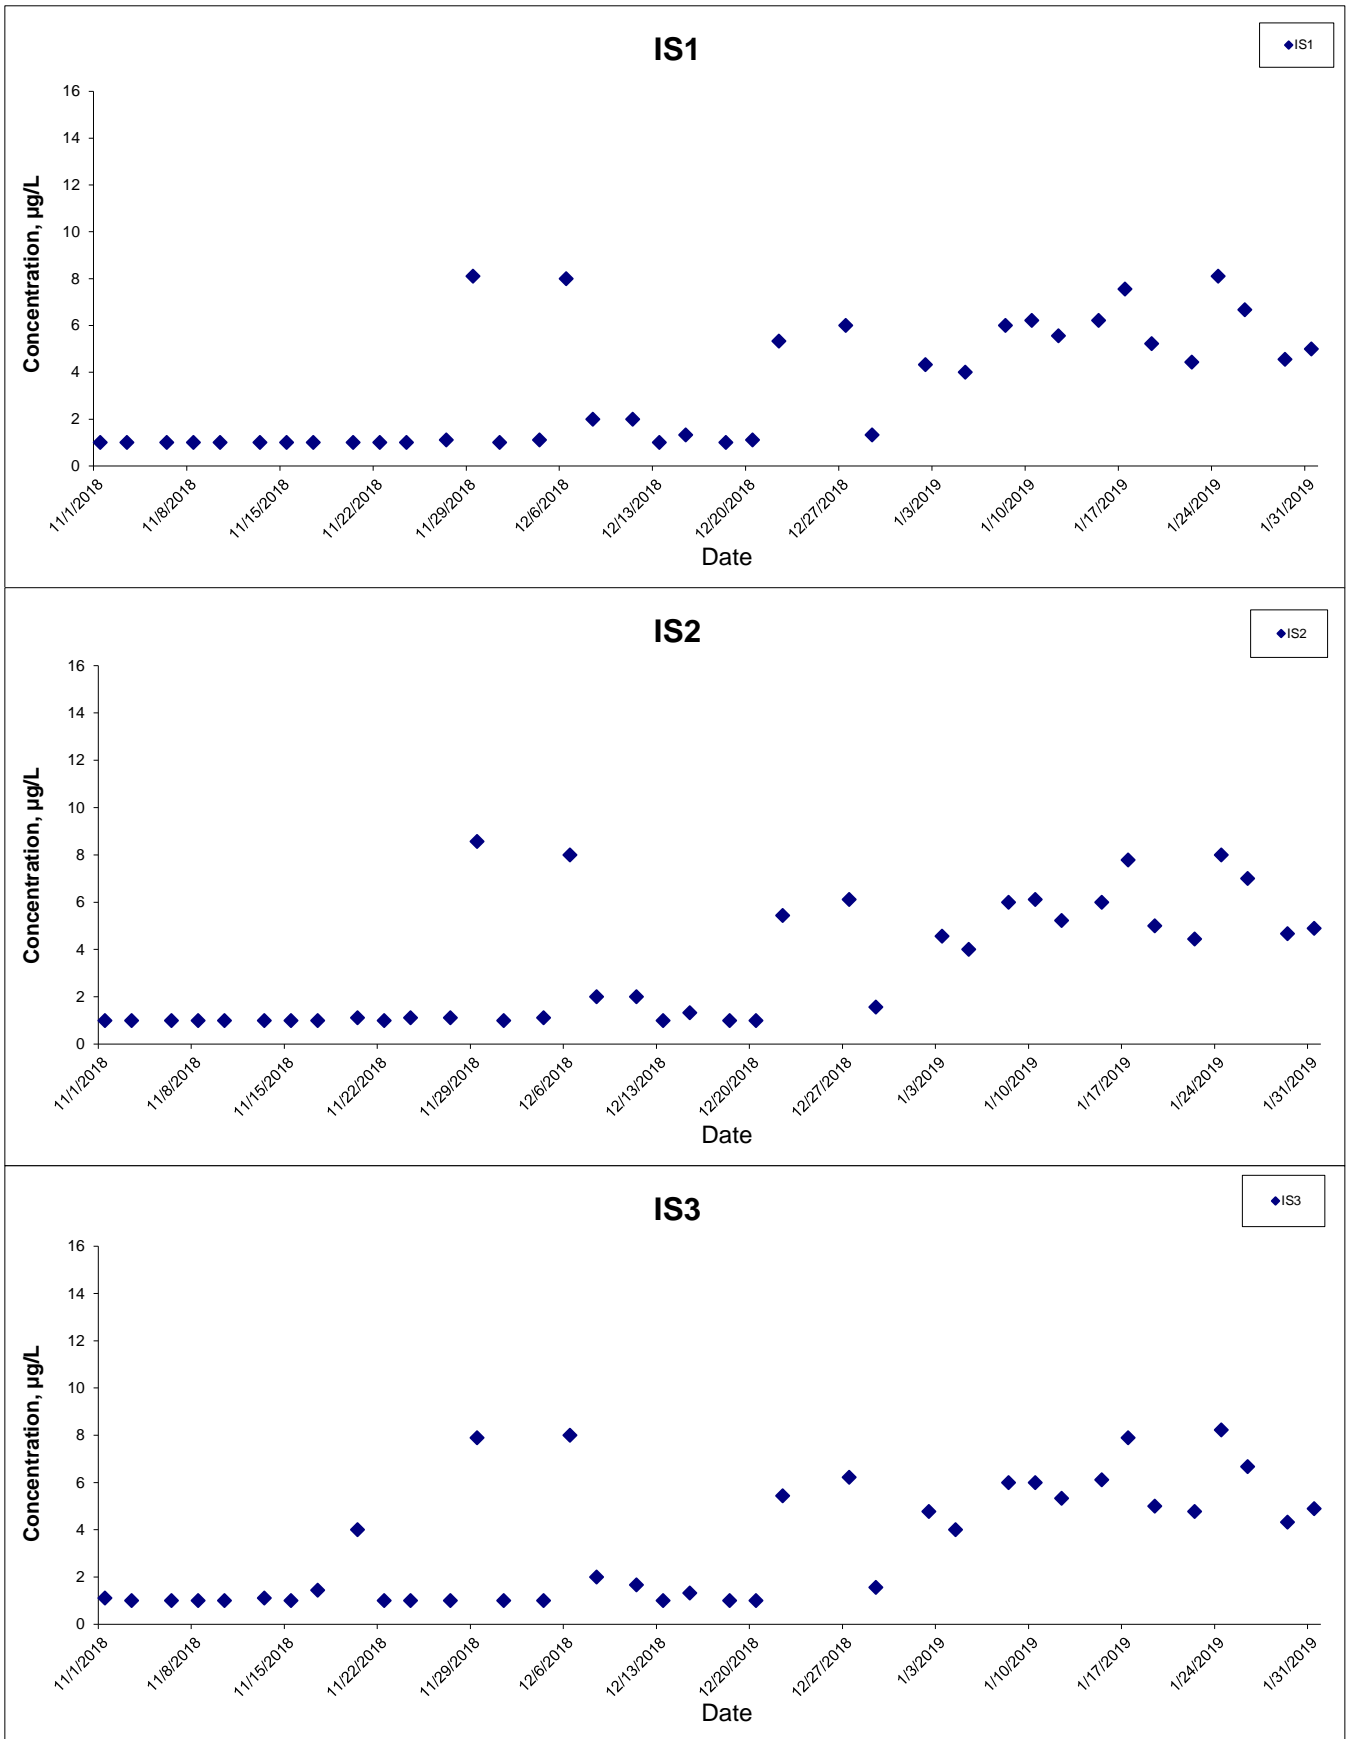
Copper (Depth-averaged) at Mid-Ebb Tide

Remarks: In accordance with Section 7.9 of the EM&A Manual, the detection limit for copper is 1.00µg/L.

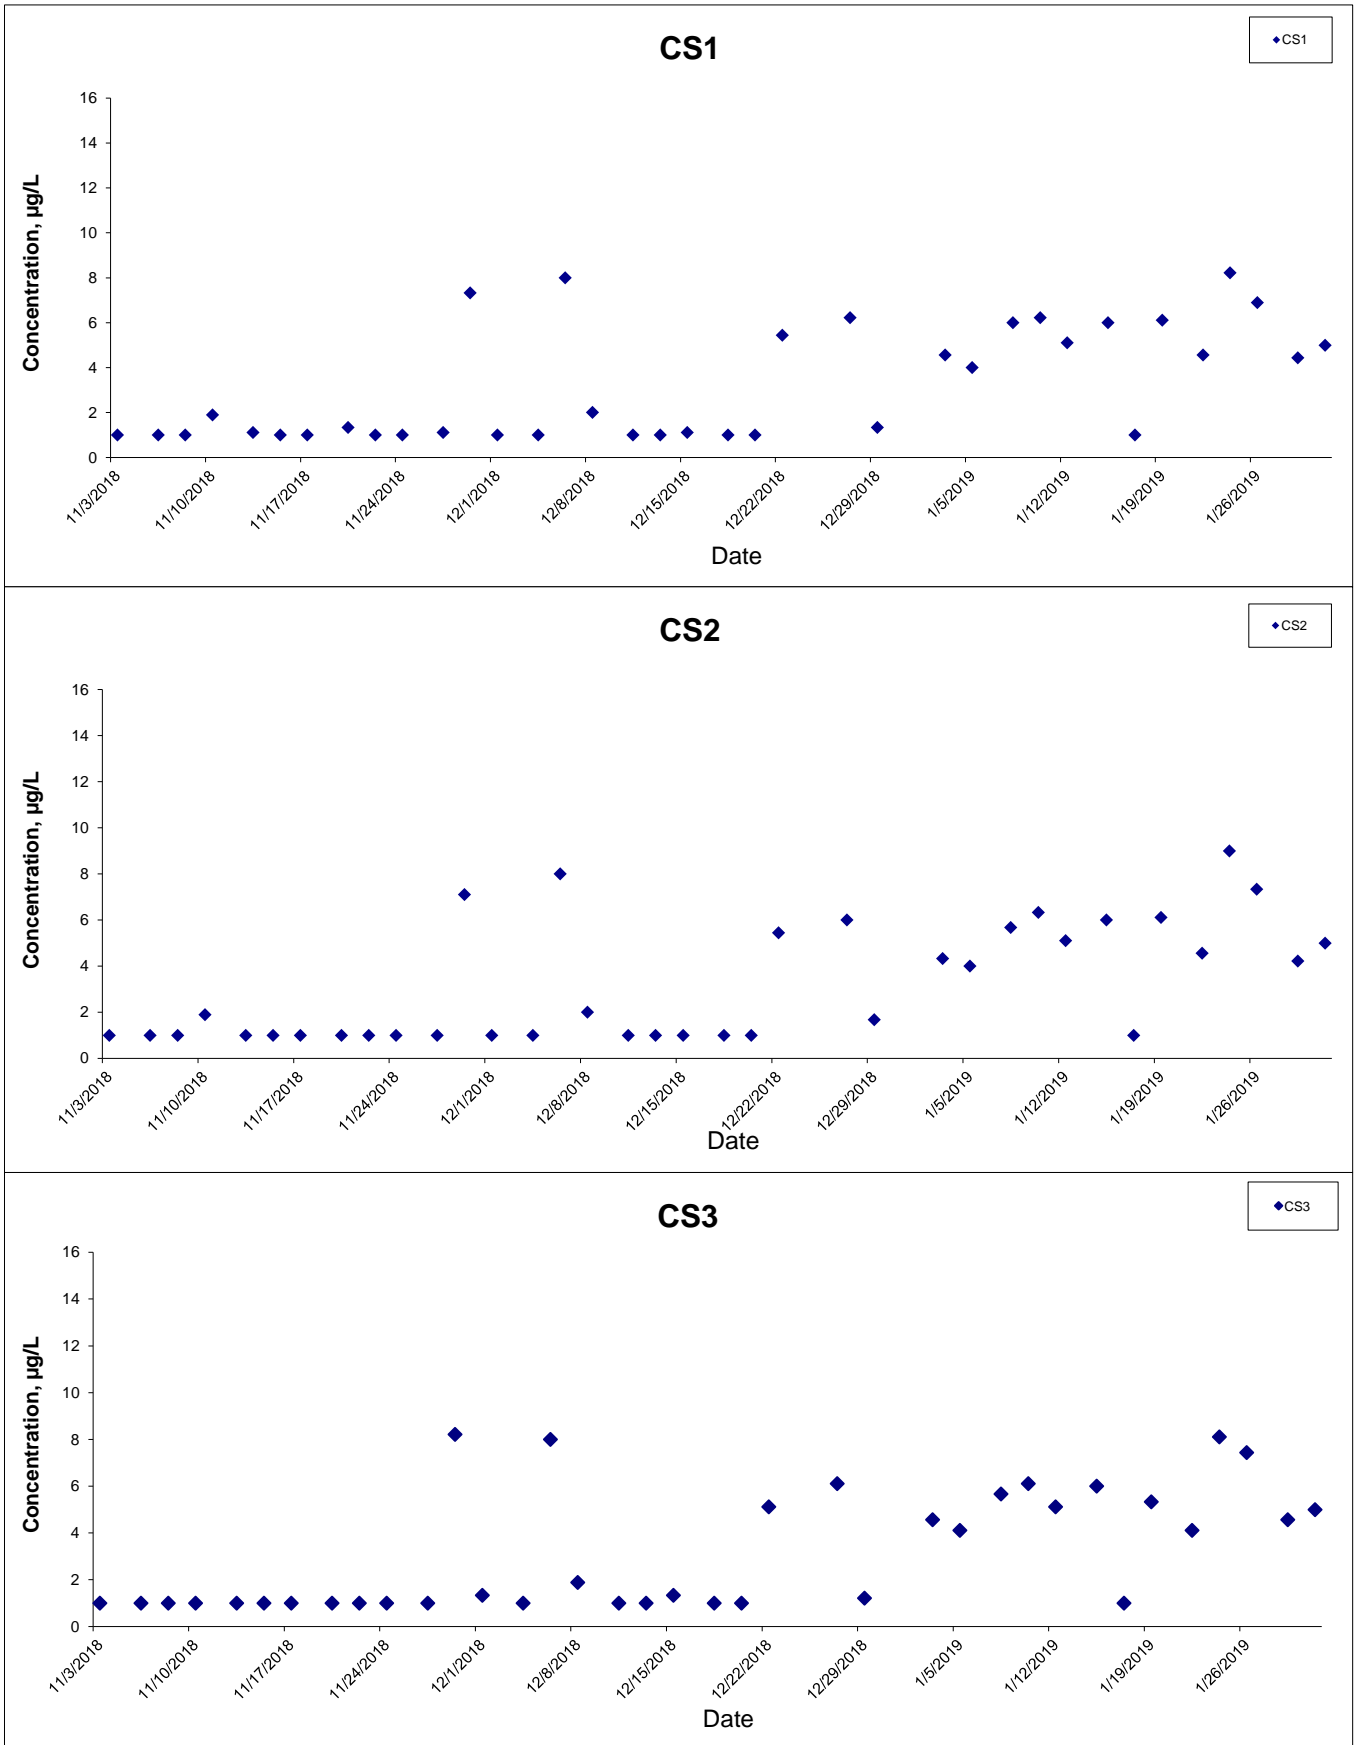
Copper (Depth-averaged) at Mid-Flood Tide

Remarks: In accordance with Section 7.9 of the EM&A Manual, the detection limit for copper is 1.00µg/L.

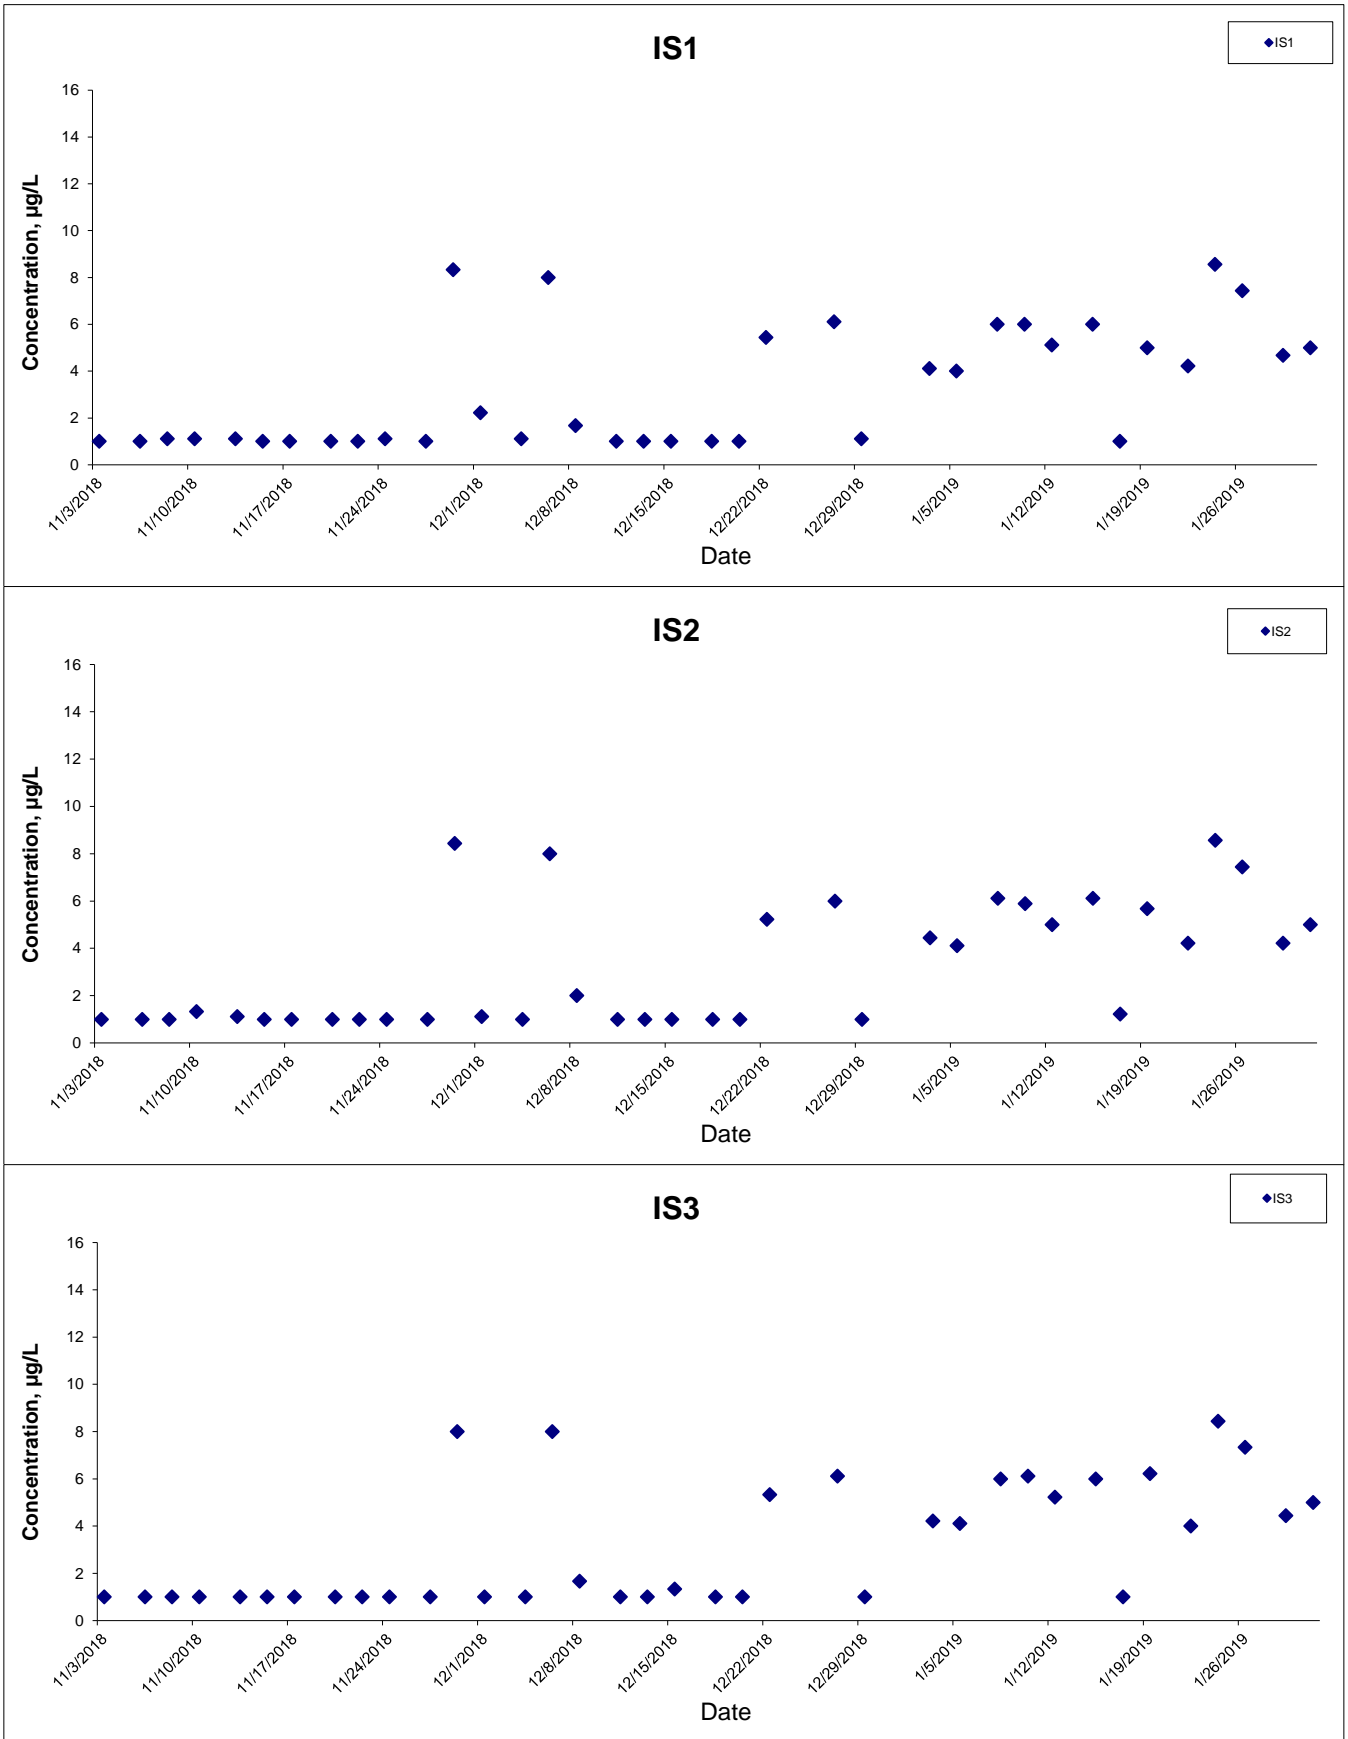
Copper (Depth-averaged) at Mid-Flood Tide

Remarks: In accordance with Section 7.9 of the EM&A Manual, the detection limit for copper is 1.00µg/L.
