Works Contract HY/2014/07 – Central Kowloon Route – Kai Tak West

Graphical Presentation of Water Quality Monitoring Results

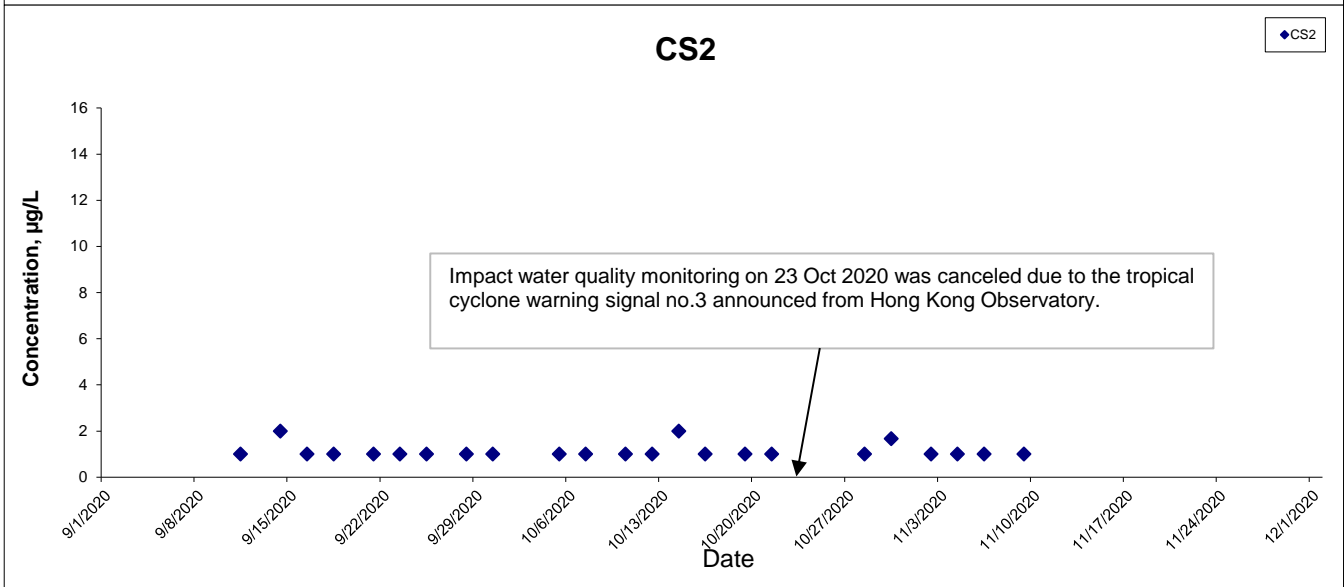
## Copper (Depth-averaged) at Mid-Ebb Tide

Remarks: In accordance with Section 7.9 of the EM&A Manual, the detection limit for copper is 1.00µg/L.

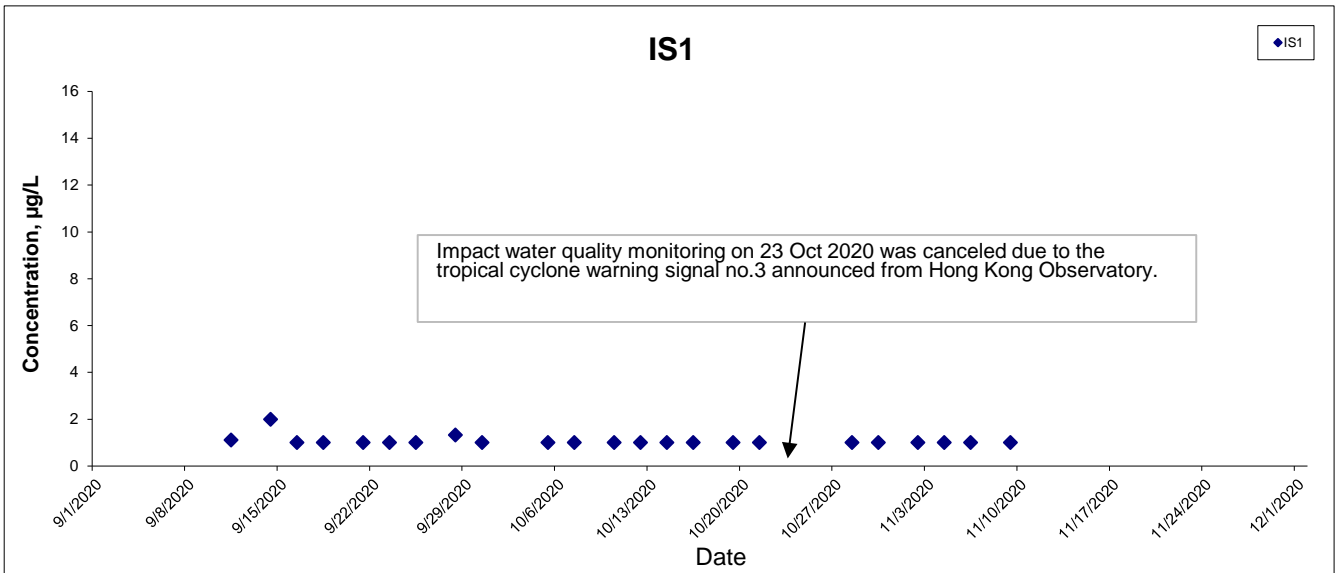
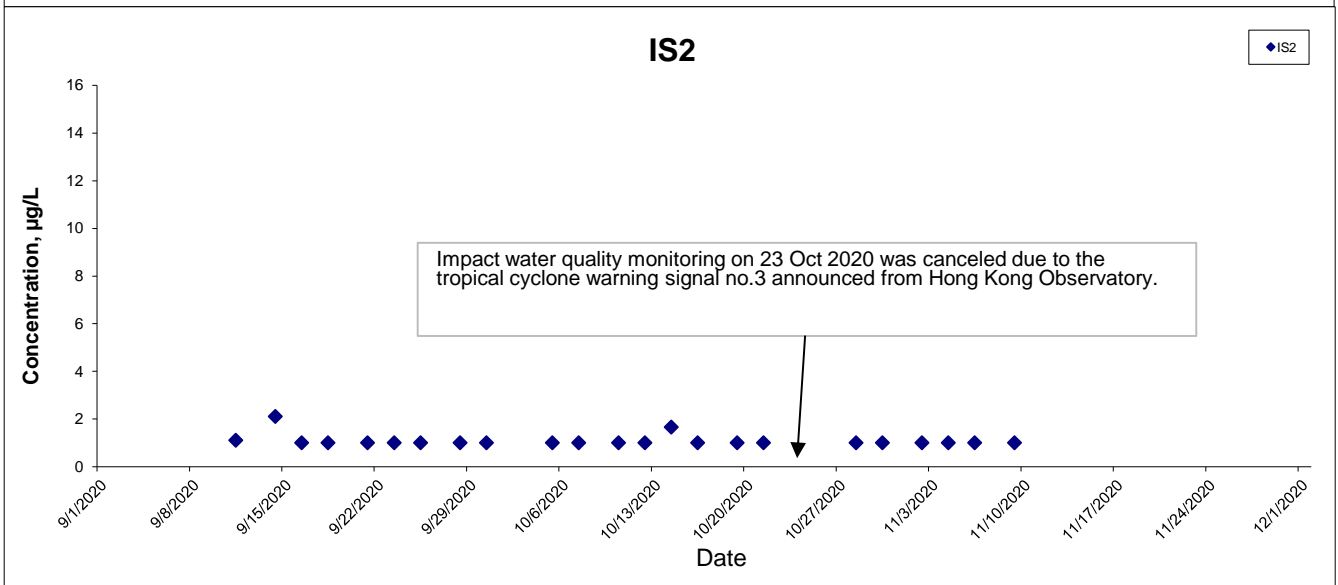
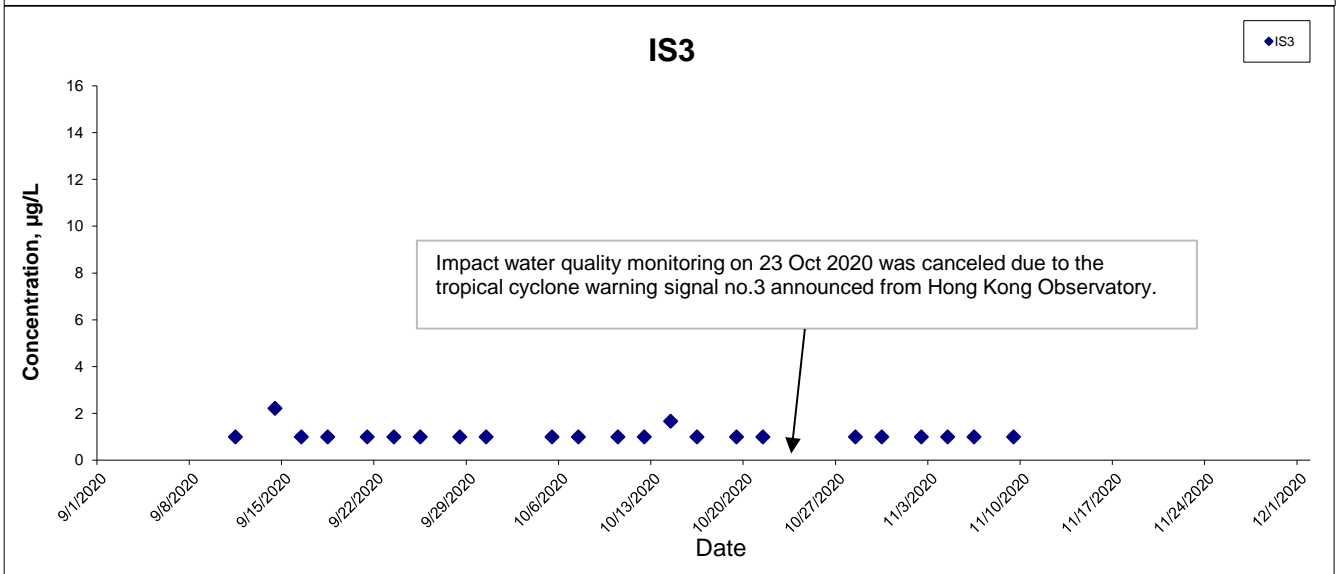
## Copper (Depth-averaged) at Mid-Ebb Tide

Remarks: In accordance with Section 7.9 of the EM&A Manual, the detection limit for copper is 1.00µg/L.

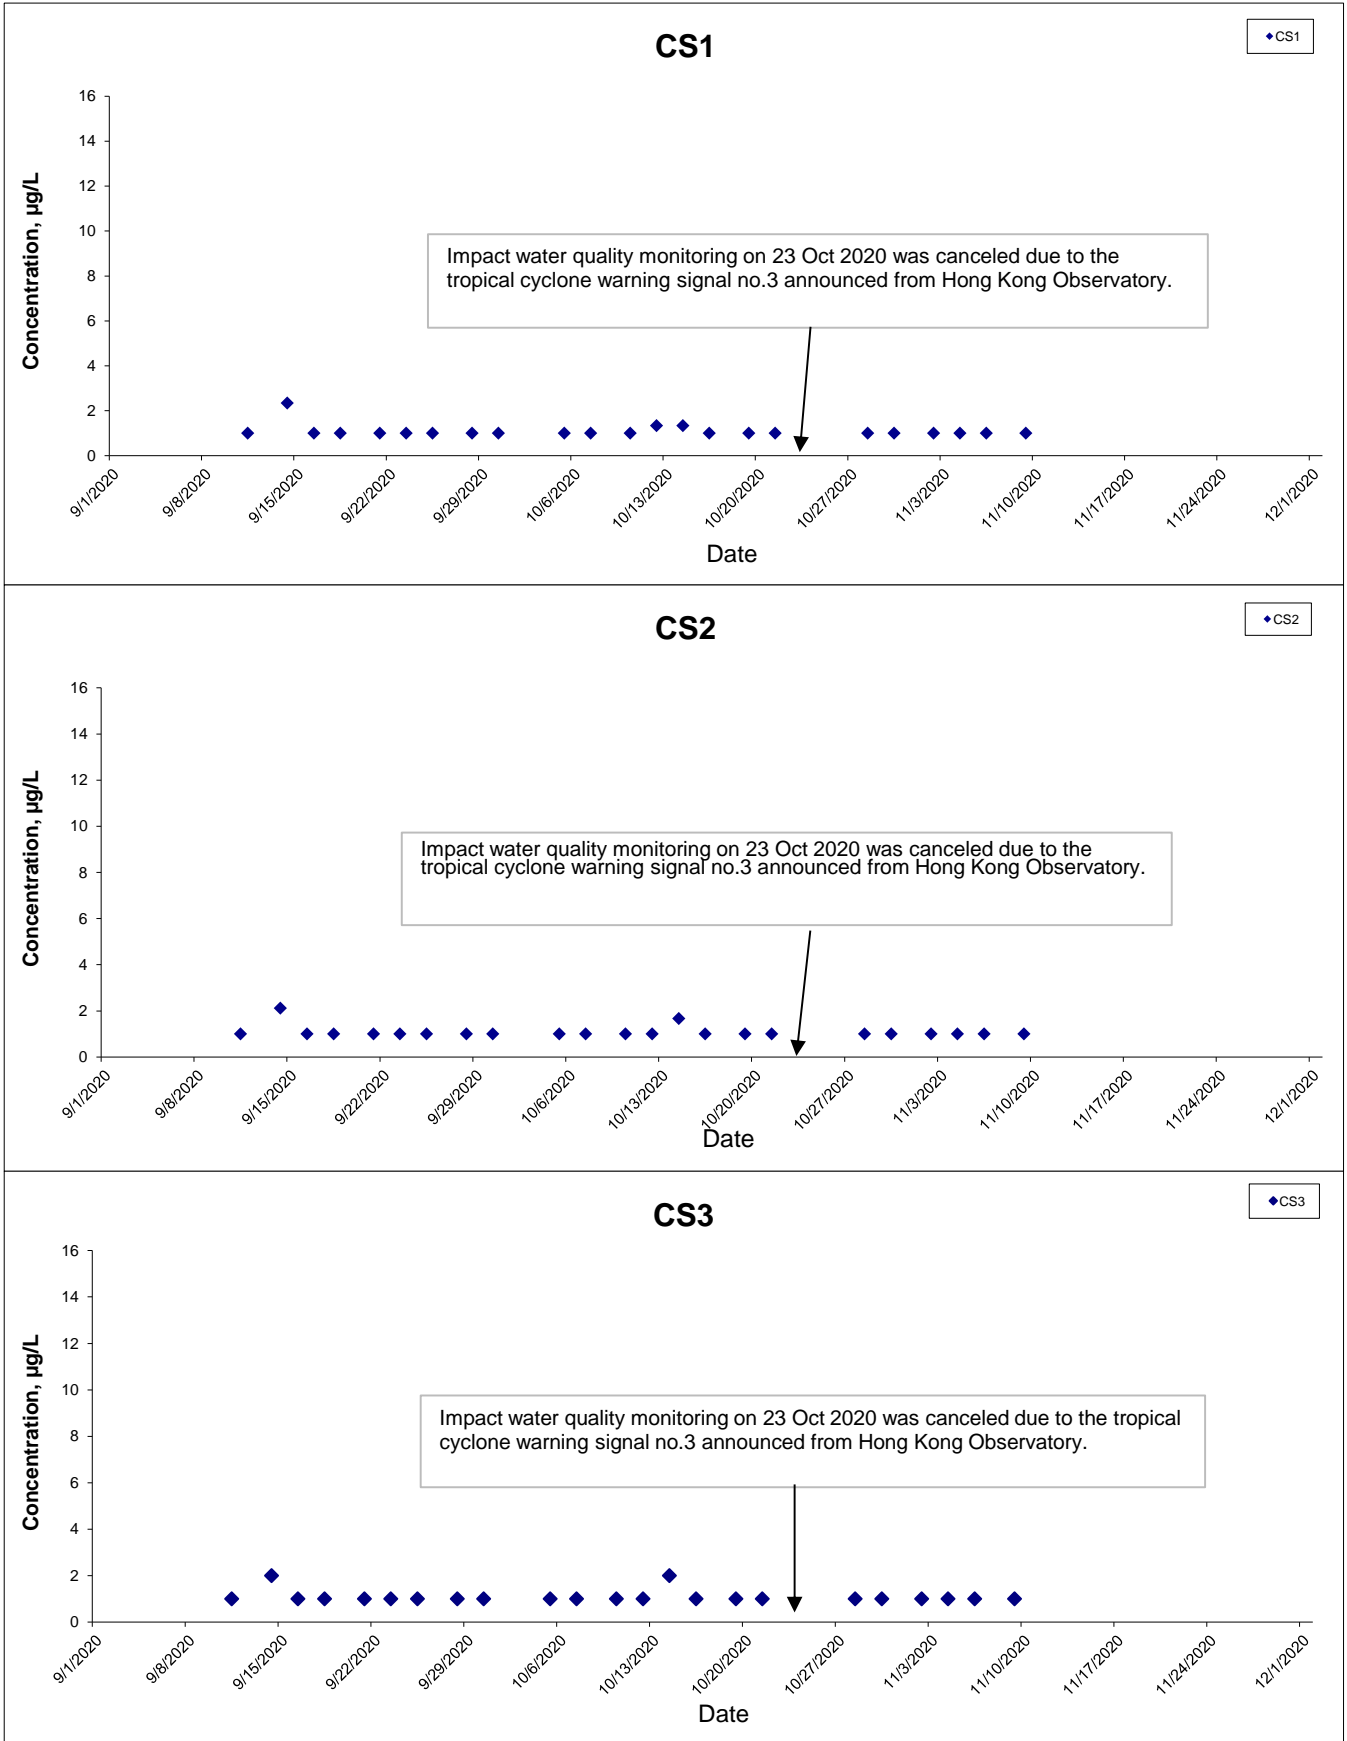
## Copper (Depth-averaged) at Mid-Flood Tide

Remarks: In accordance with Section 7.9 of the EM&A Manual, the detection limit for copper is 1.00µg/L.
