Central Kowloon Route

Yau Ma Tei East

Contract No. HY/2014/08

Monthly EM&A Report No. 79

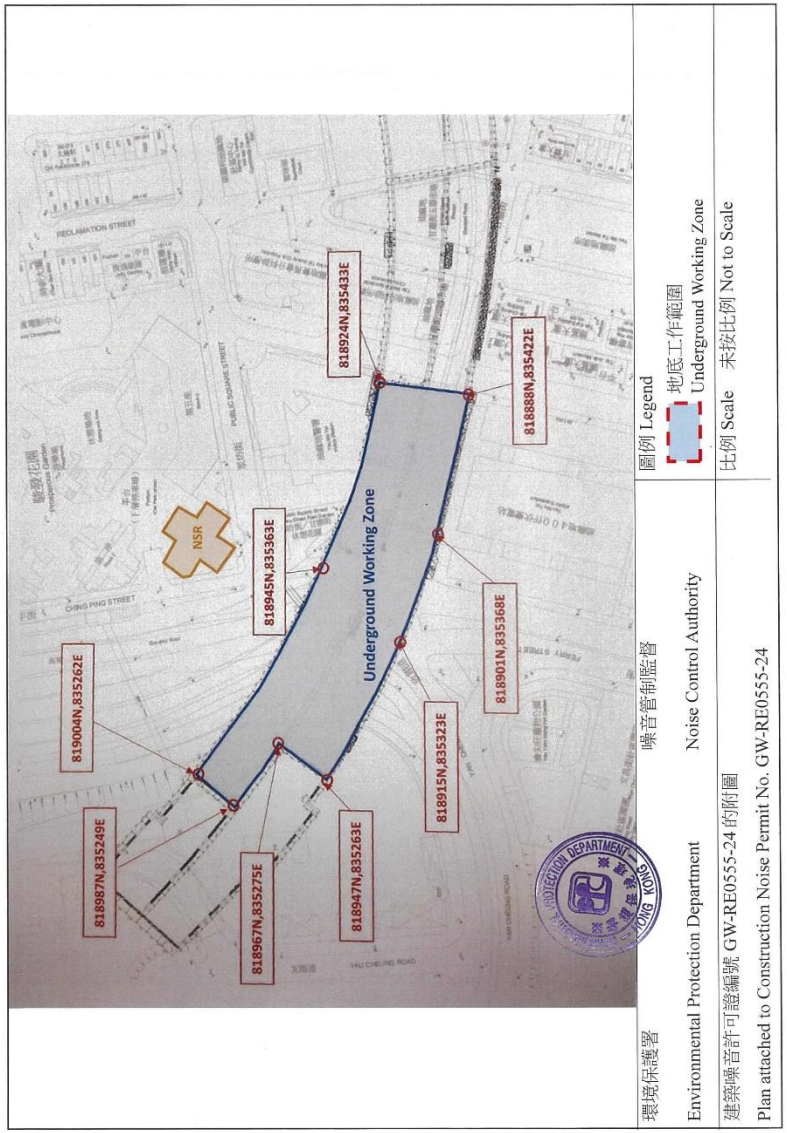
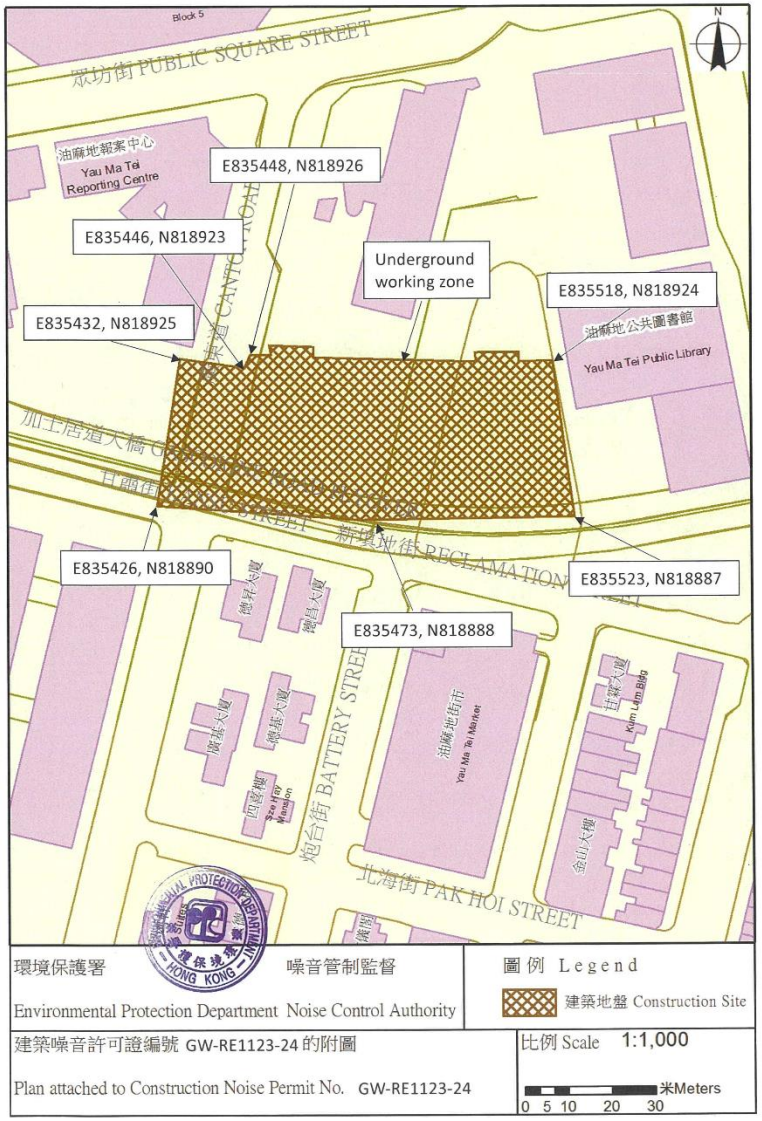
Remark 1: Working Zone of GW-RE0555-24, GW-RE1123-24

Actions taken / to be taken	The Contractor had followed EM&A Manual and the granted CNP strictly to implement mitigation measures in order to minimize nuisance to the public. In view of public concerns, the following additional remedial measures are taken: • In case of unscheduled emergency works required to address safety concern, make use of EPD reporting system for emergency works and report the works immediately; • In case of emergency repairing required, make use of any noise mitigation measures and control of the tools use to avoid excessive noise emissions when feasible and applicable; • Provide training to frontline staff to ensure their understanding and awareness of EPD's reporting system for emergency works; • Carry out site inspection to ensure all PMEs are well-maintained and in proper function to avoid excessive noise; • Provide training to workers of using PME carefully to minimize noise; • Reschedule the operation time of the noisy equipment to less sensitive hours if possible; and • The Contractor is reminded to consider the use of temporary movable noise barrier when feasible and applicable.

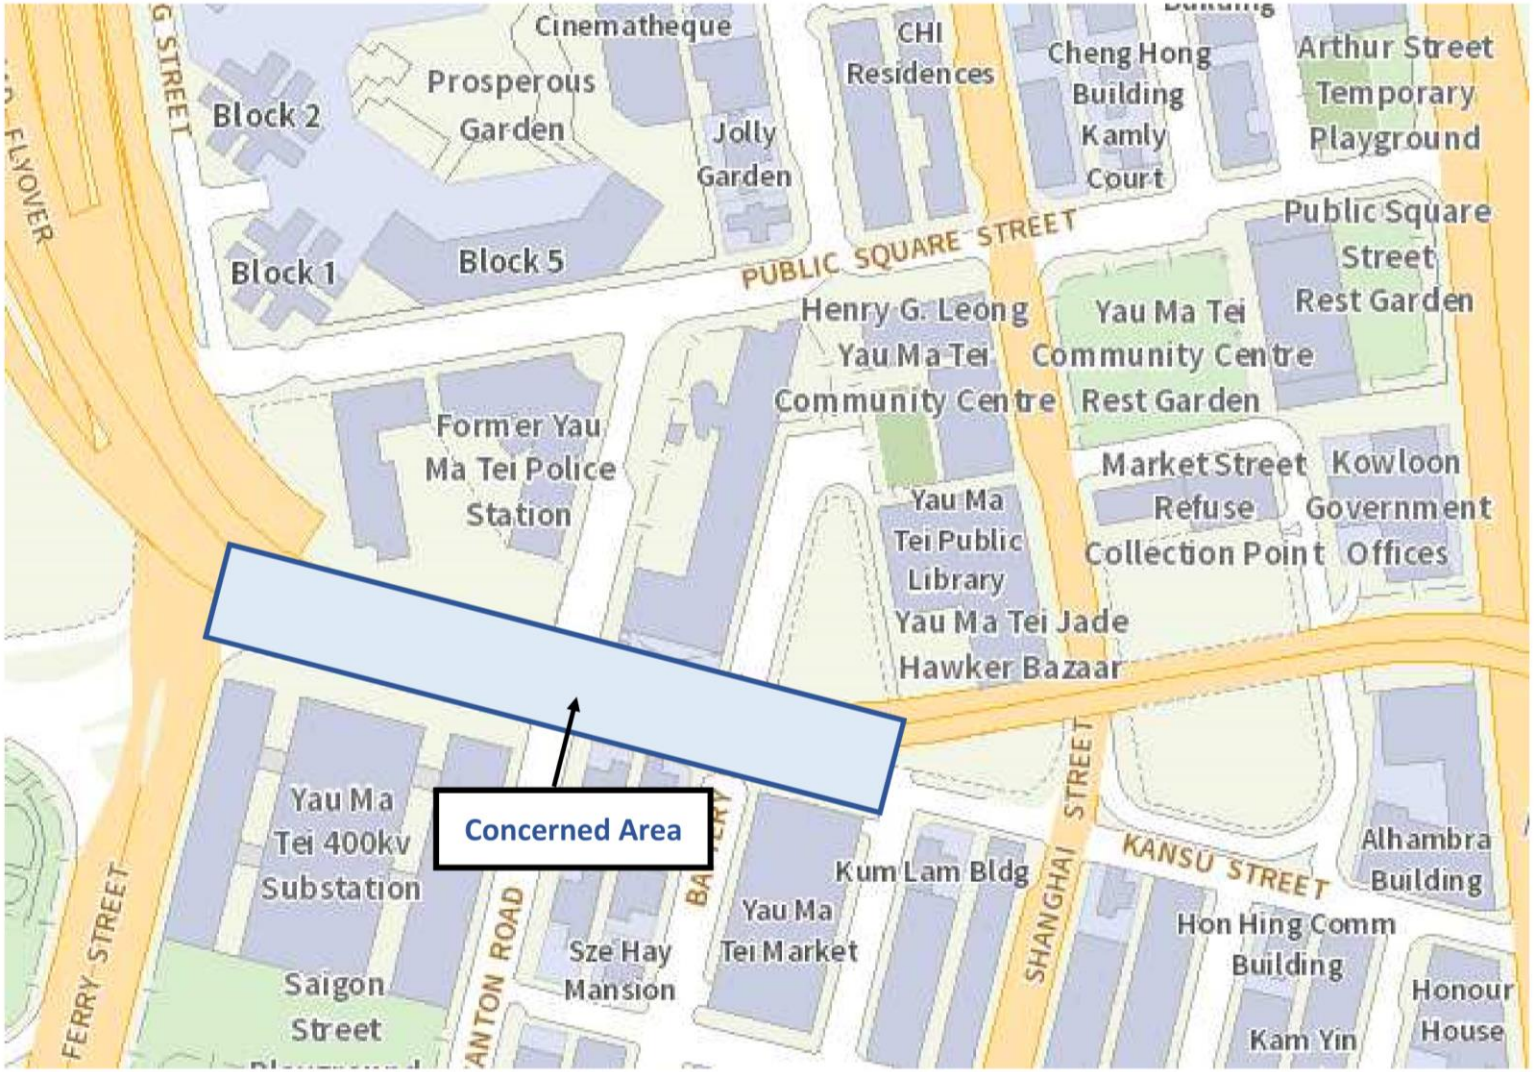
Remark 1: Works location of the concerned area

Actions taken / to be taken	In view of public concerns, the following preventative measures were taken / to be taken: • The Contractor should review the condition of the bunding regularly, and; • Review and ensure the wastewater from site area is properly treated and discharged at the designated discharge point.
Remarks (Shown in next page)	1. Works location of the concerned area 2. Remedial measures taken
