Central Kowloon Route

Central Kowloon Route Contract HY/2014/08

Monthly EM&A Report No. 13

(Period from 1 to 30 April 2019)

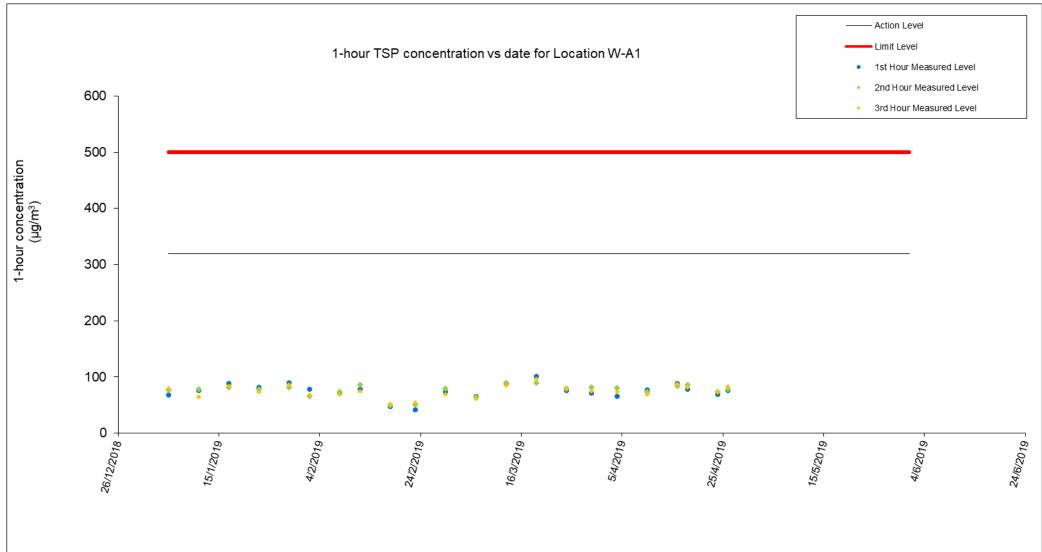
Figure 1: Graphical Illustration of Measured 1-hour TSP ($\mu g/m^3$) Levels at W-A1

1-hour TSP (μg/m³)									
Date	Weather	Start Time	1 st Hour (μg/m ³)	2 nd Hour (μg/m ³)	3 rd Hour (μg/m ³)					
04/04/2019	Sunny	9:18	66	69	66					
10/04/2019	Sunny	10:22	81	85	82					
16/04/2019	Cloudy	11:13	62	64	69					
18/04/2019	Cloudy	9:21	73	65	78					
24/04/2019	Sunny	10:40	74	72	78					
26/04/2019	Sunny	10:31	63	61	73

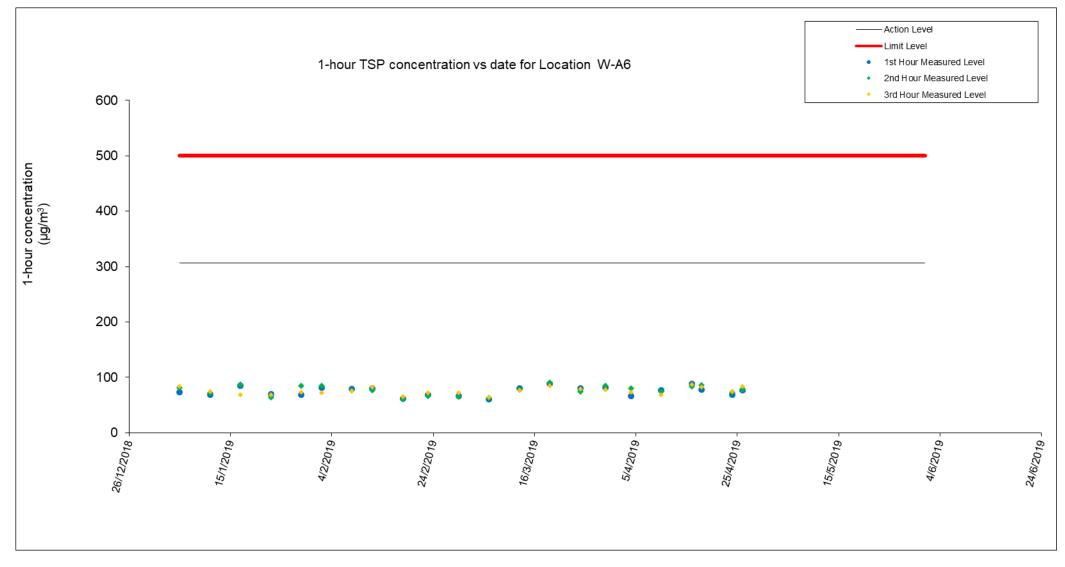
Figure 2: Graphical Illustration of Measured 1-hour TSP (µg/m³) Levels at W-A6

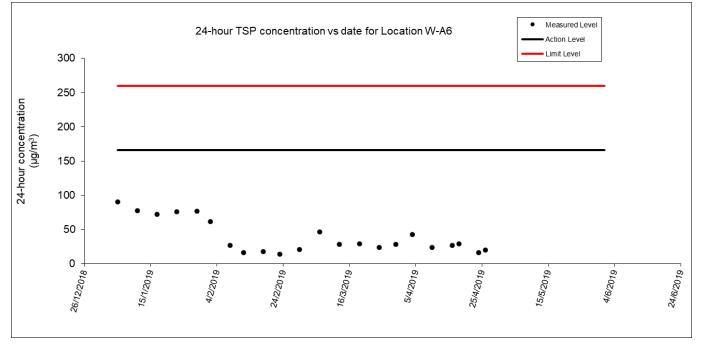
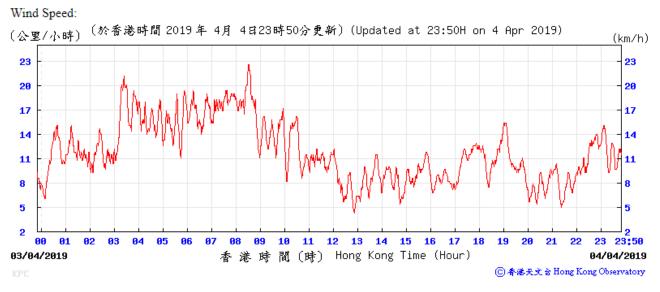
Wind speed data for 4, 5, 10, 11, 16, 17, 18, 19, 24, 25, 26, 27 April 2019

Error was found for wind speed graph for 5/4/2019 from HKO.

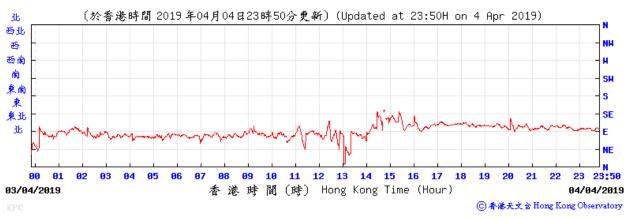
Wind direction data for 4, 5, 10, 11, 16, 17, 18, 19, 24, 25, 26, 27 April 2019

Error was found for wind speed graph for 5/4/2019.

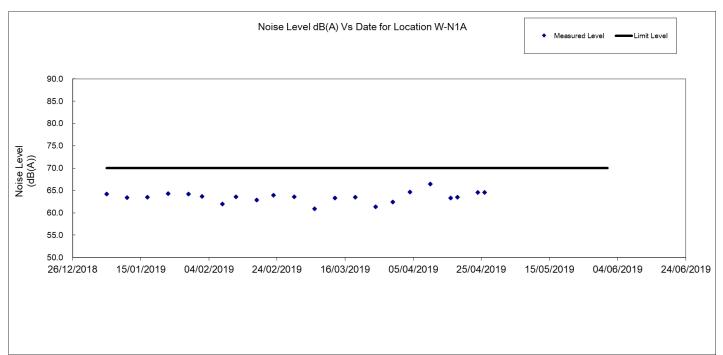
Figure 1: Graphical Illustration of Measured Noise Levels at W-N1A

Date	Weather	Start Time	-	End Time	L _{eq}	L ₁₀	L ₉₀	Wind Speed (m/s)
04/04/2019	Sunny	10:22	-	10:52	66.8	67.7	64.1	3.2
10/04/2019	Sunny	11:25	-	11:55	66.7	67.6	64.5	2.7
16/04/2019	Cloudy	12:25	-	12:55	67.0	67.9	65.4	1.4
18/04/2019	Cloudy	10:57	-	11:27	65.6	66.6	63.7	3.8
24/04/2019	Sunny	11:39	-	12:09	66.3	67.6	64.2	3.0
26/04/2019	Sunny	11:33	-	12:03	67.5	68.8	64.4	3.3

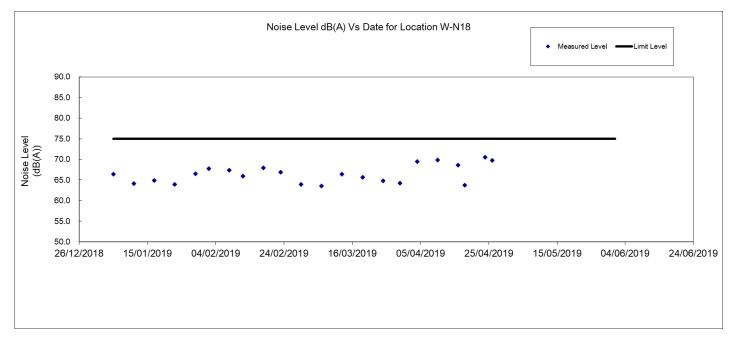
Figure 2: Graphical Illustration of Measured Noise Levels at W-N18

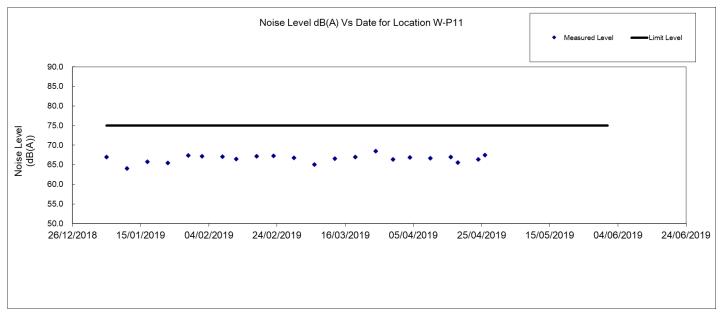
Figure 4: Graphical Illustration of Measured Noise Levels at W-P11
