Central Kowloon Route

Yau Ma Tei West

Contract No. HY/2014/20

September 2022

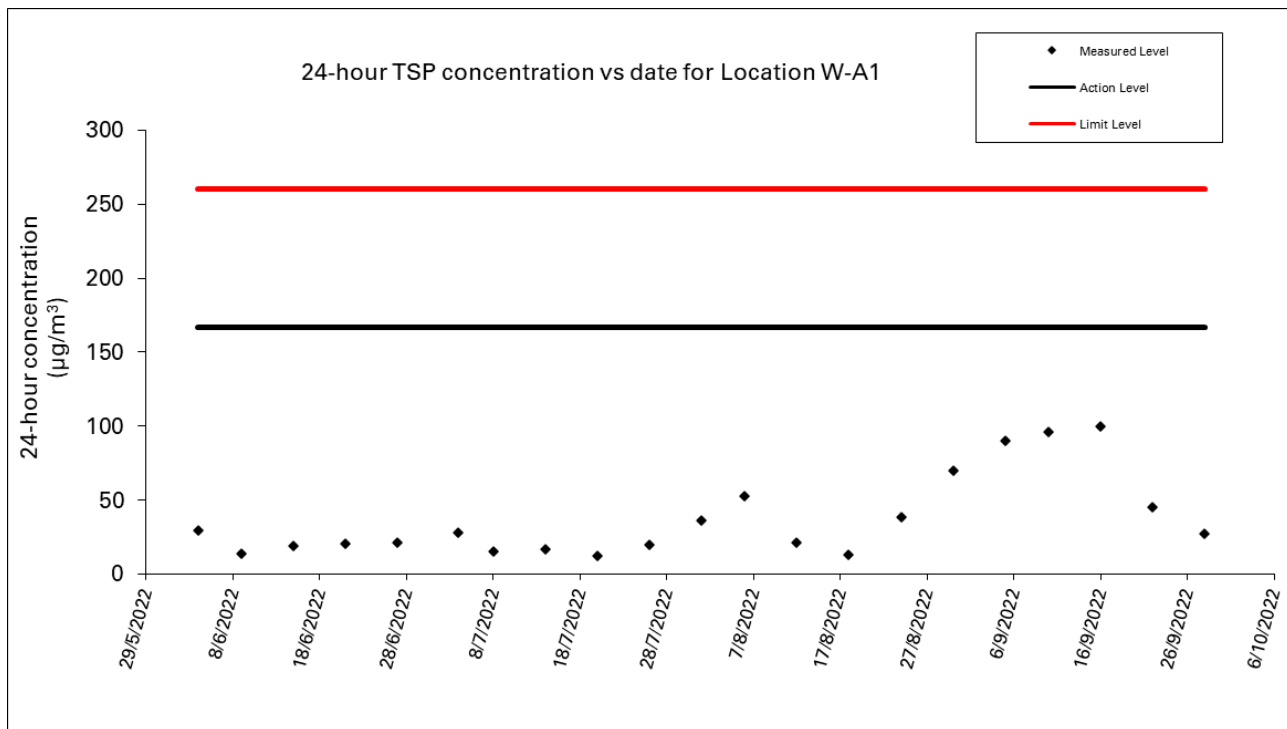
Figure 3: Graphical Illustration of Measured 24-hour TSP ($\mu\text{g}/\text{m}^3$) Levels at W-A1

Location: Yau Ma Tei Catholic Primary School (Hoi Wang Road) (W-A1)
 Monitoring date: 5, 10, 16, 22 and 28 September 2022
 Parameter : TSP 24-hour
 Other Factors Nearby traffic

Start Date	Weather Condition	Elapse Time			Chart Reading			Avg Air Temp (°C)	Avg Atmospheric Pressure (hPa)	Flow Rate (m ³ /min)	Standard Air Volume (m ³)	Filter Weight (g)		Particulate weight (g)	Conc. (µg/m ³)		
		Initial	Final	Actual (min)	Min	Max	Avg					Initial	Final				
5/9/2022	Sunny	6719.9	6743.9	1440.00	39	40	39.5	31.3	1004.3	0.89	1279	2.7265	2.8744	0.1479	116		
10/9/2022	Sunny	6743.9	6767.9	1440.00	38	39	38.5	28.4	1011.4	0.74	1060	2.7775	2.9456	0.1681	159		
16/9/2022	Sunny	6768.2	6792.2	1440.00	46	47	46.5	31.2	1005.3	2.87	4128	2.7557	2.8848	0.1291	31		
22/9/2022	Sunny	6792.2	6816.2	1440.00	38	40	39.0	29.1	1011.3	0.88	1268	2.7761	2.9042	0.1281	101		
28/9/2022	Sunny	6816.2	6840.2	1440.00	47	48	47.5	28.3	1008.1	3.14	4528	2.7632	2.8587	0.0955	21		
Maximum:												159 µg/m ³		Minimum:		21 µg/m ³

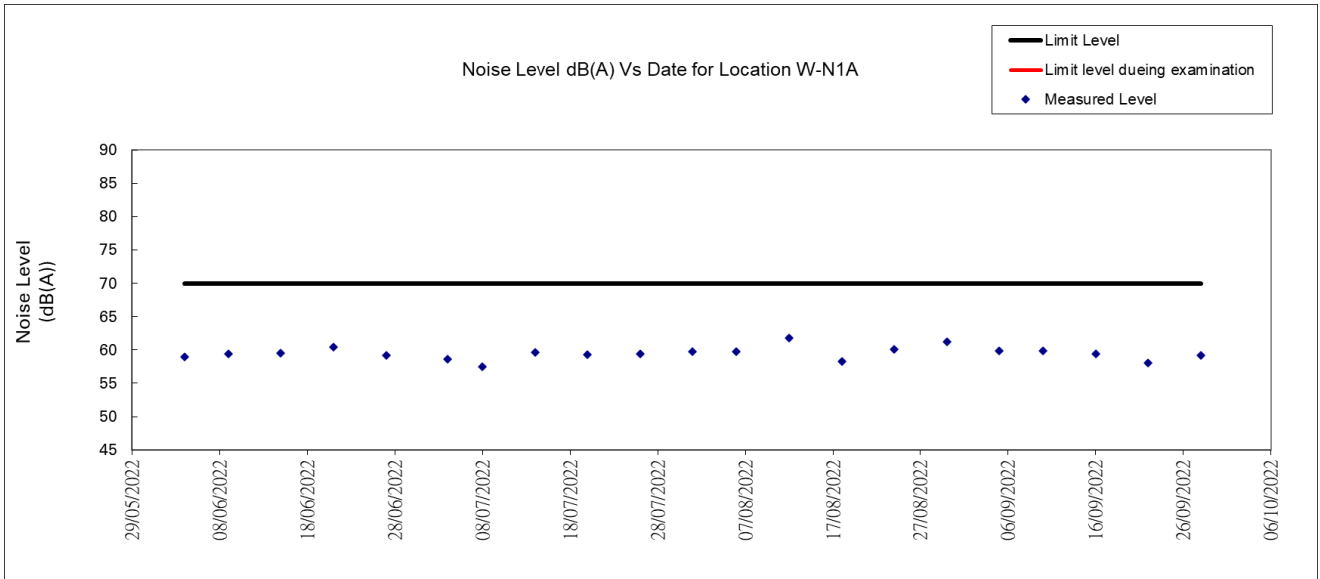
Figure 1: Graphical Illustration of Measured Noise Levels at W-N1A

Date	Weather	Start Time	-	End Time	L_{eq}	L_{10}	L_{90}	Wind speed (m/s)
05/09/2022	Sunny	12:04	-	12:34	66.3	68.0	63.8	2.8
10/09/2022	Sunny	10:23	-	10:53	65.9	66.9	64.4	1.1
16/09/2022	Sunny	13:06	-	13:36	66.7	68.7	64.2	3.3
22/09/2022	Sunny	13:10	-	13:30	67.4	68.5	64.2	4.4
28/09/2022	Sunny	12:16	-	12:46	65.2	67.6	62.7	4.9
