**Central Kowloon Route**

**Kai Tak West**

**Contract No. HY/2014/07**

**April 2020**

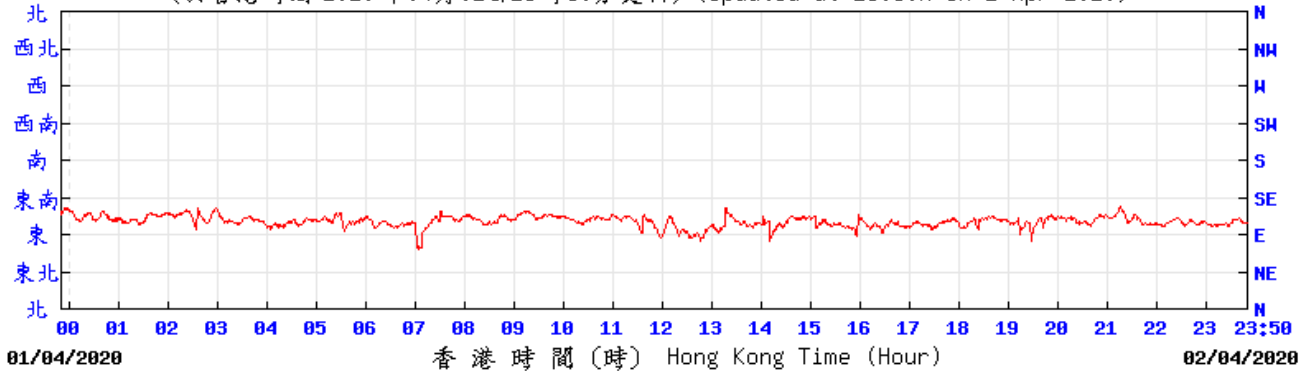
(於香港時間 2020 年04月02日23時50分更新) (Updated at 23:50H on 2 Apr 2020)

## Data of Wind Direction Extracted from Kai Tak Wind Station of the Hong Kong Observatory

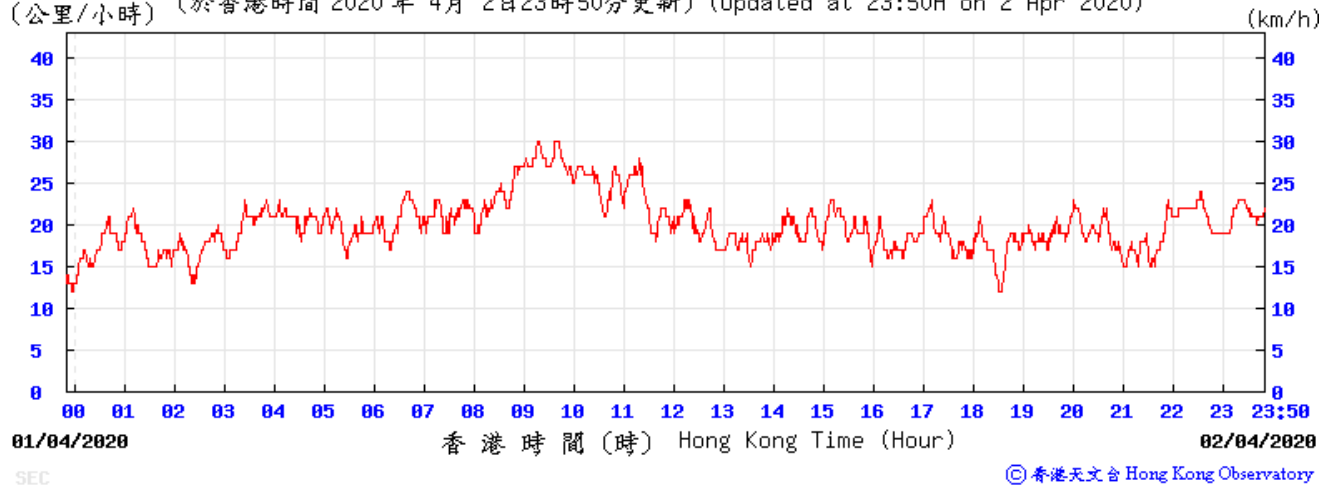
(公里/小時) (於香港時間 2020 年 4 月 2 日 23 時 50 分更新) (Updated at 23:50H on 2 Apr 2020)

### Data of Wind Speed Extracted from Kai Tak Wind Station of the Hong Kong Observatory

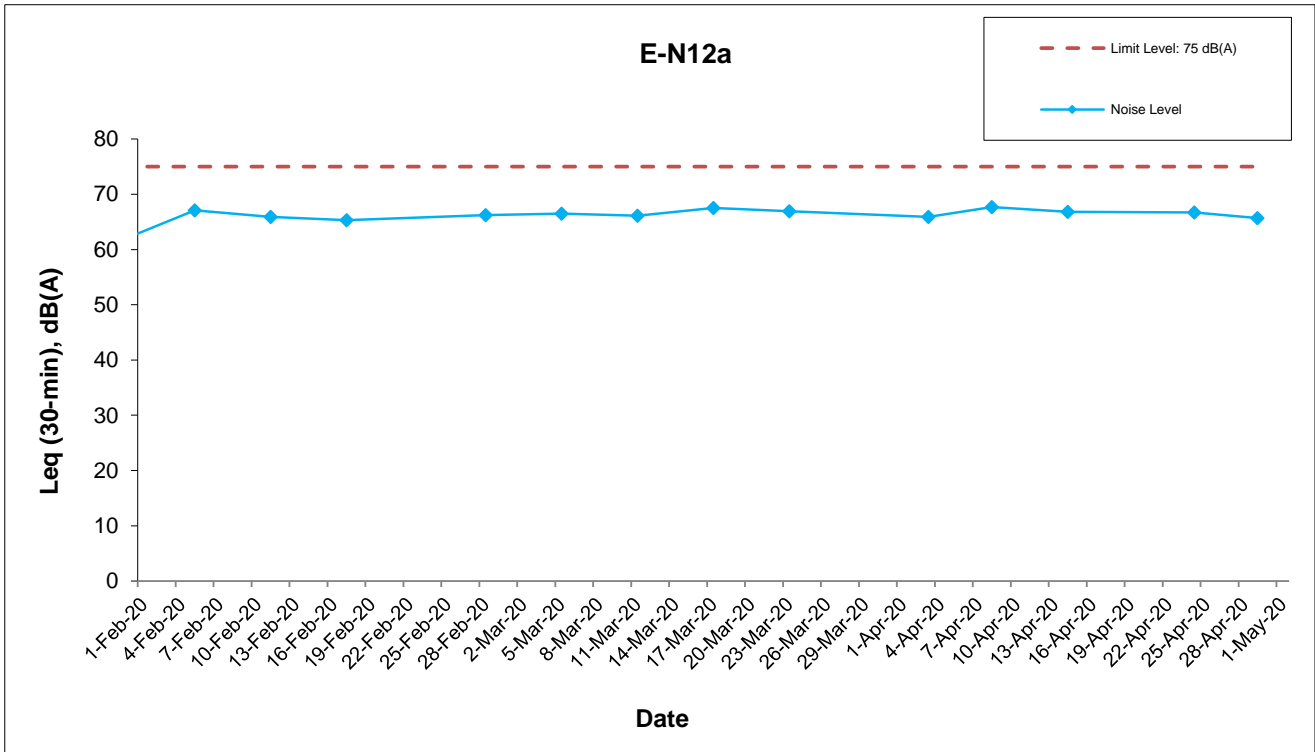
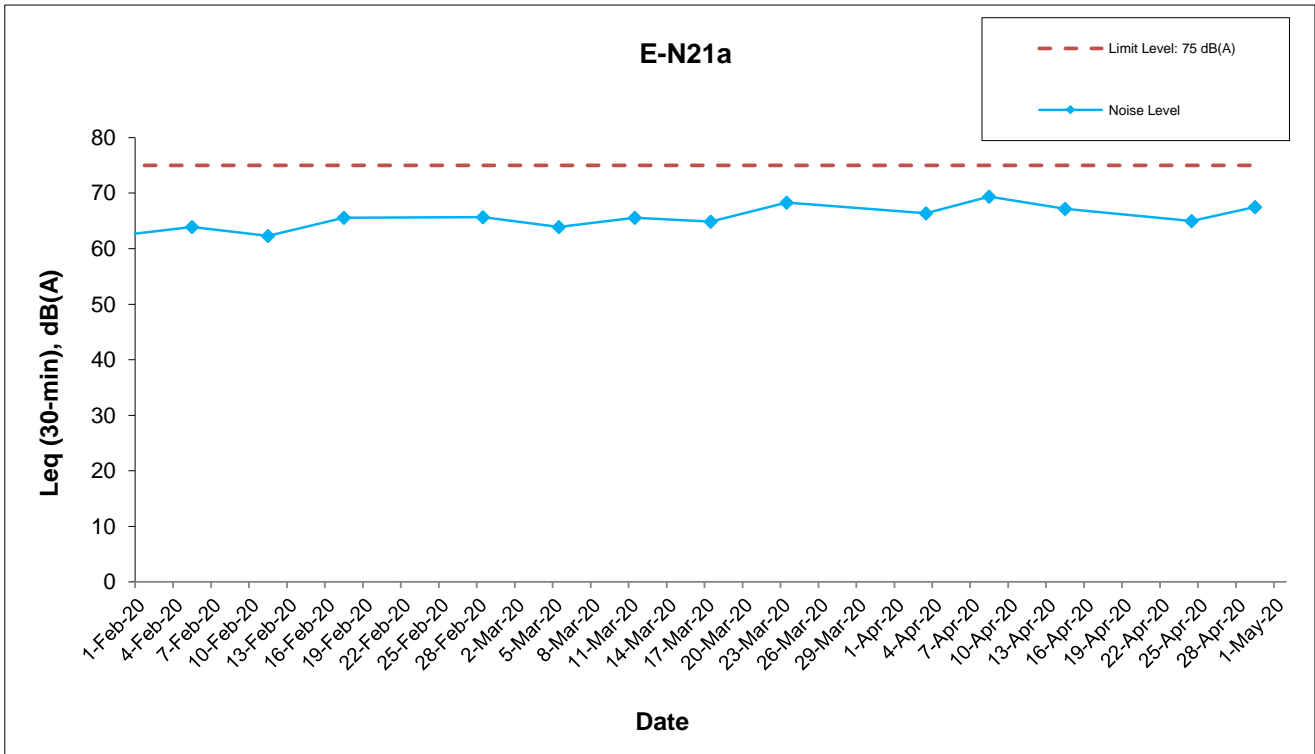
<sup>#</sup> - A correction of +3dB(A) was made to the free field measurement.

<sup>\*</sup> - Limit Level of 70dB(A) applies to education institutes while 65dB(A) applies during school
