Central Kowloon Route

Yau Ma Tei West

April 2021

Monthly EM&A Report No. 27

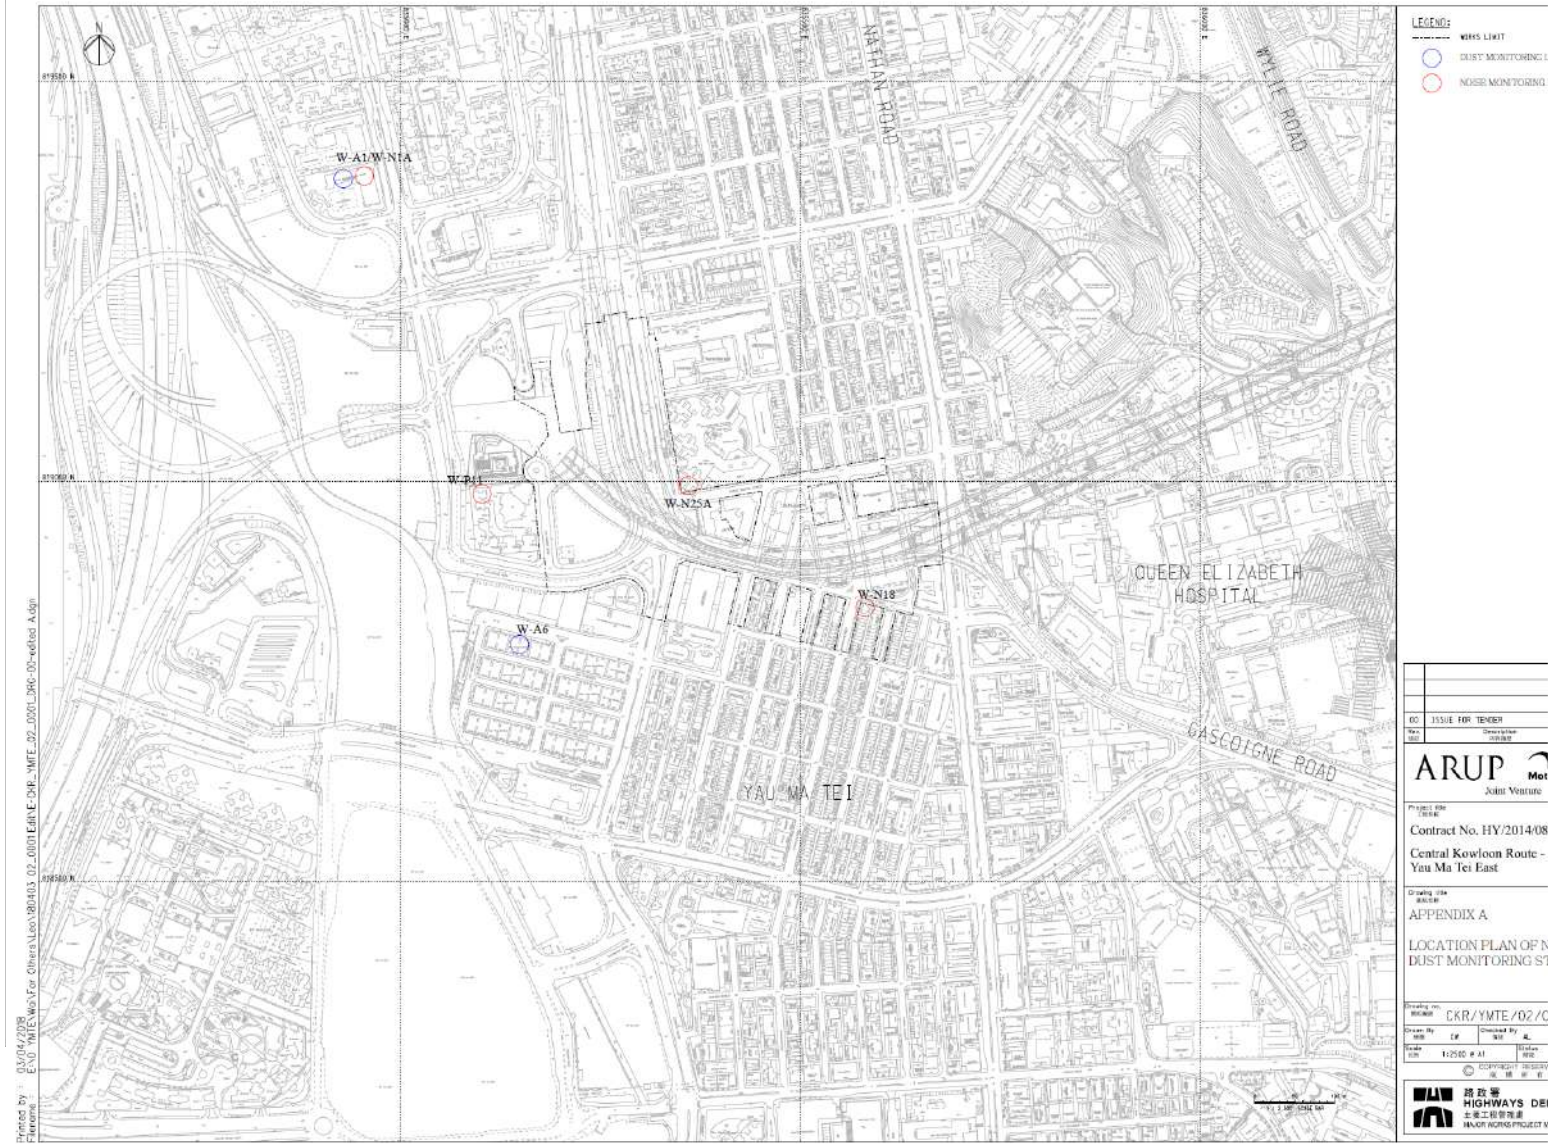
Location Plan of Noise and Air Quality Monitoring Station

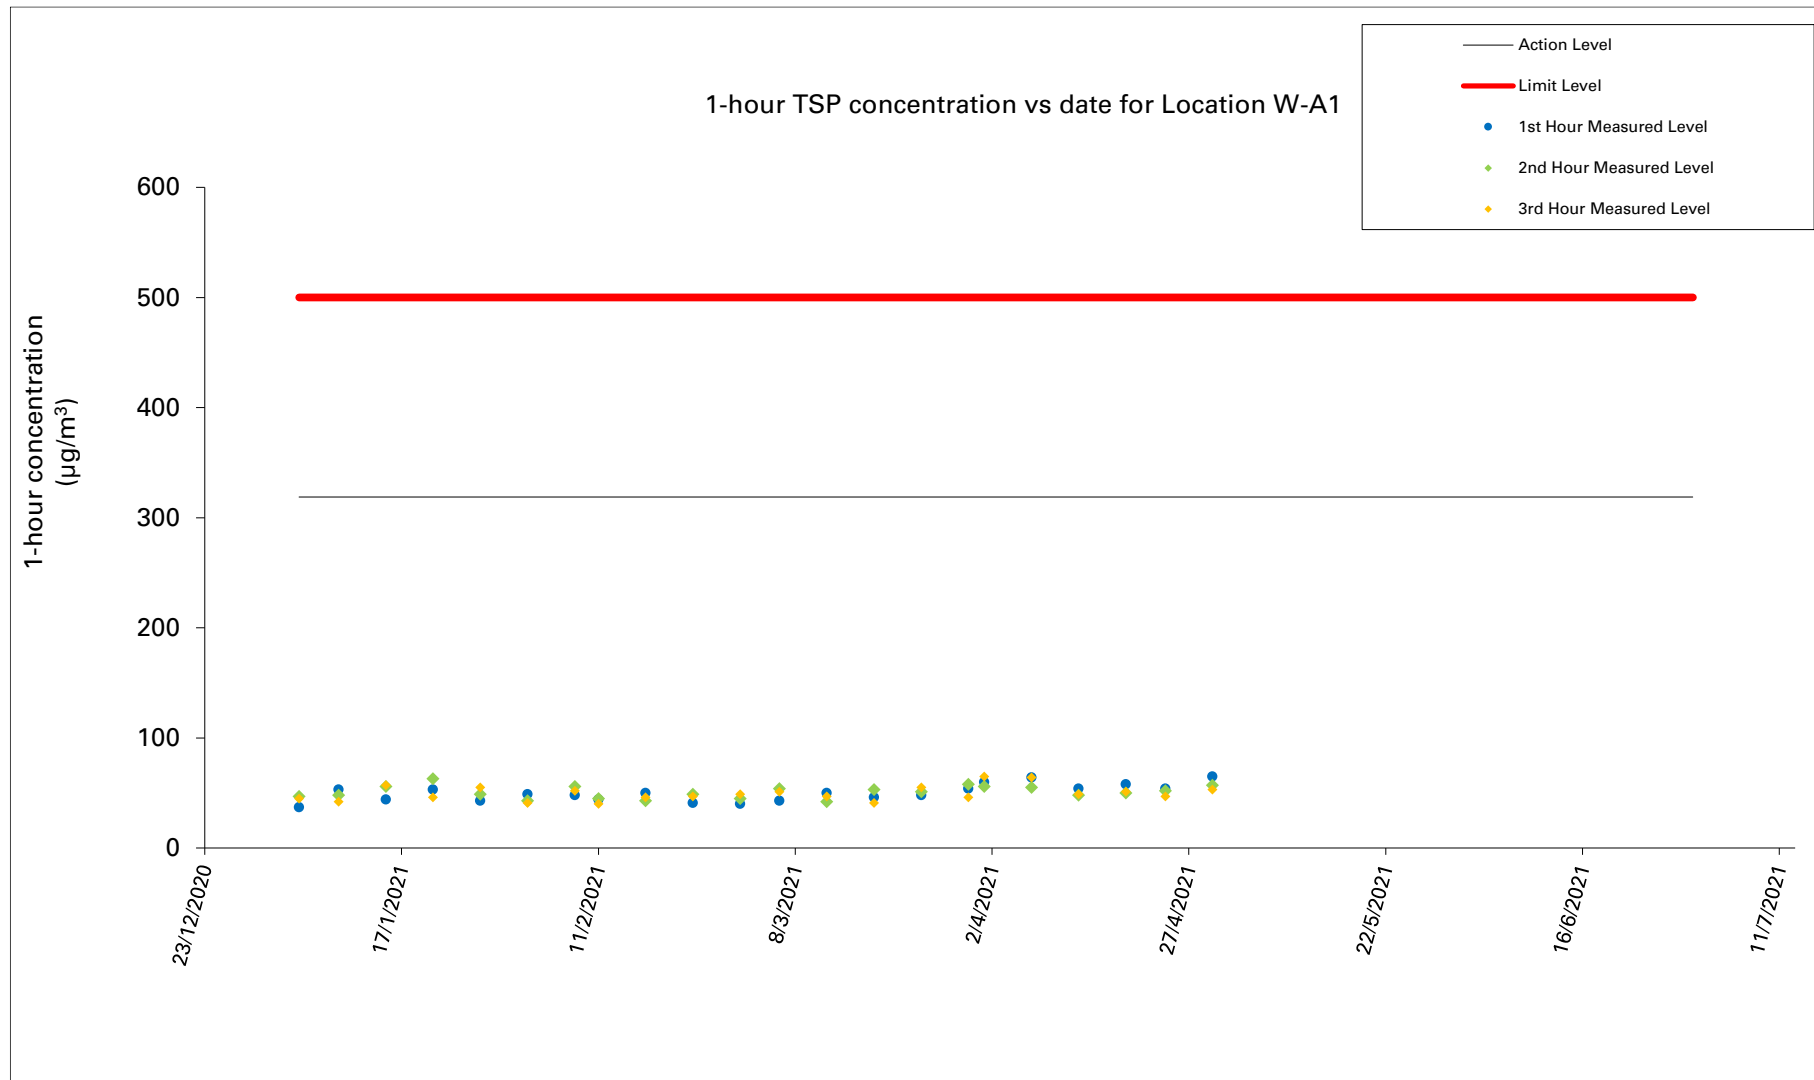
Figure 1: Graphical Illustration of Measured 1-hour TSP ($\mu\text{g}/\text{m}^3$) Levels at W-A1

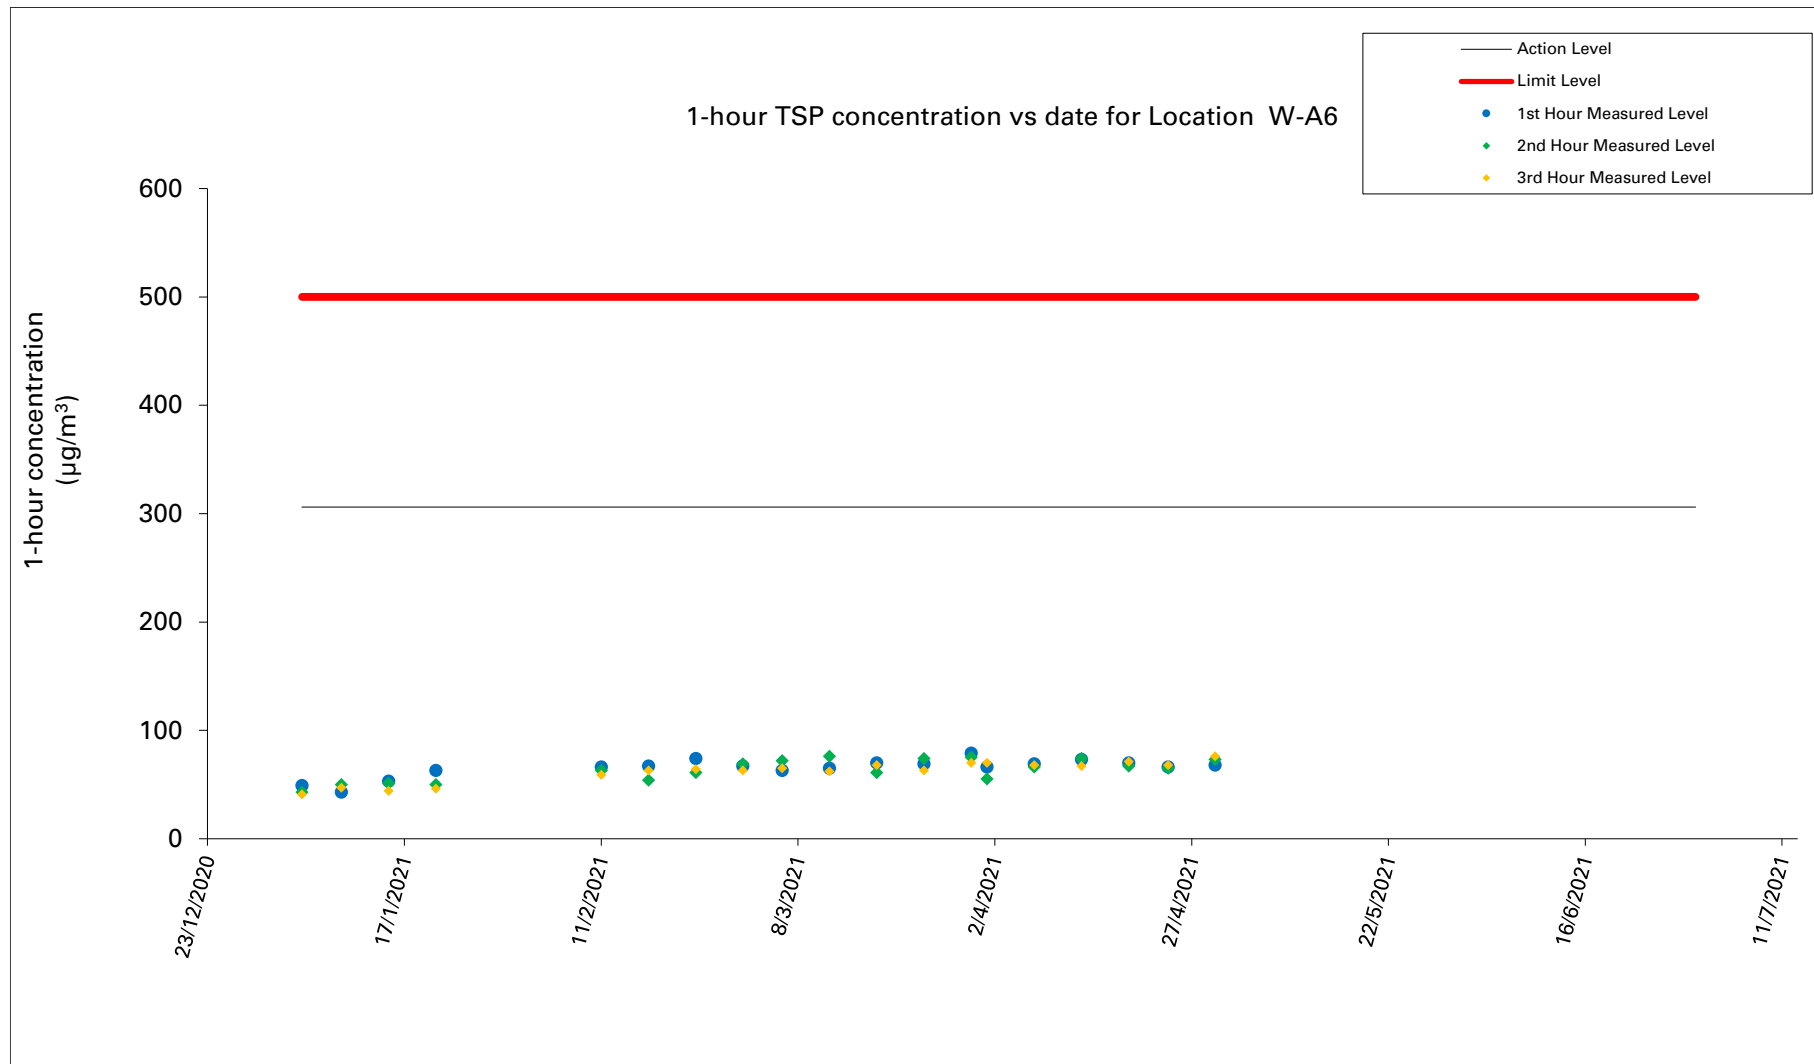
Figure 2: Graphical Illustration of Measured 1-hour TSP ($\mu\text{g}/\text{m}^3$) Levels at W-A6

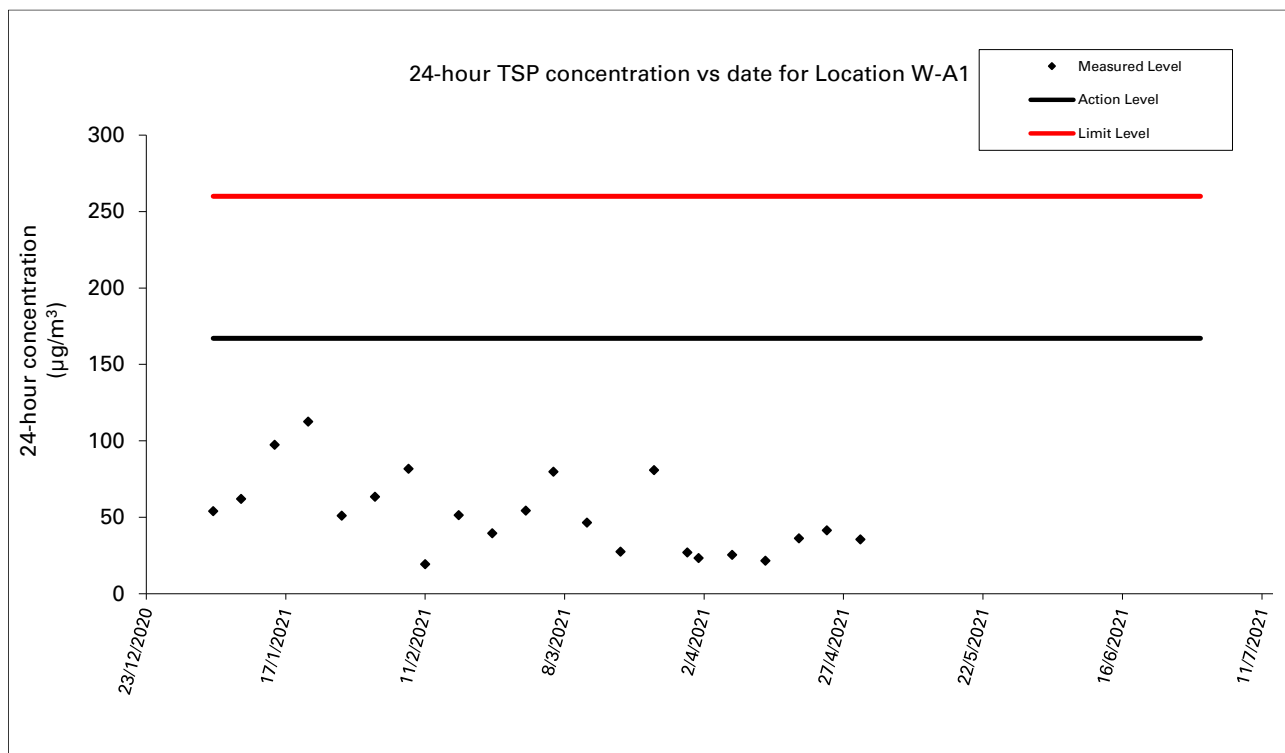
Figure 3: Graphical Illustration of Measured 24-hour TSP ($\mu\text{g}/\text{m}^3$) Levels at W-A1

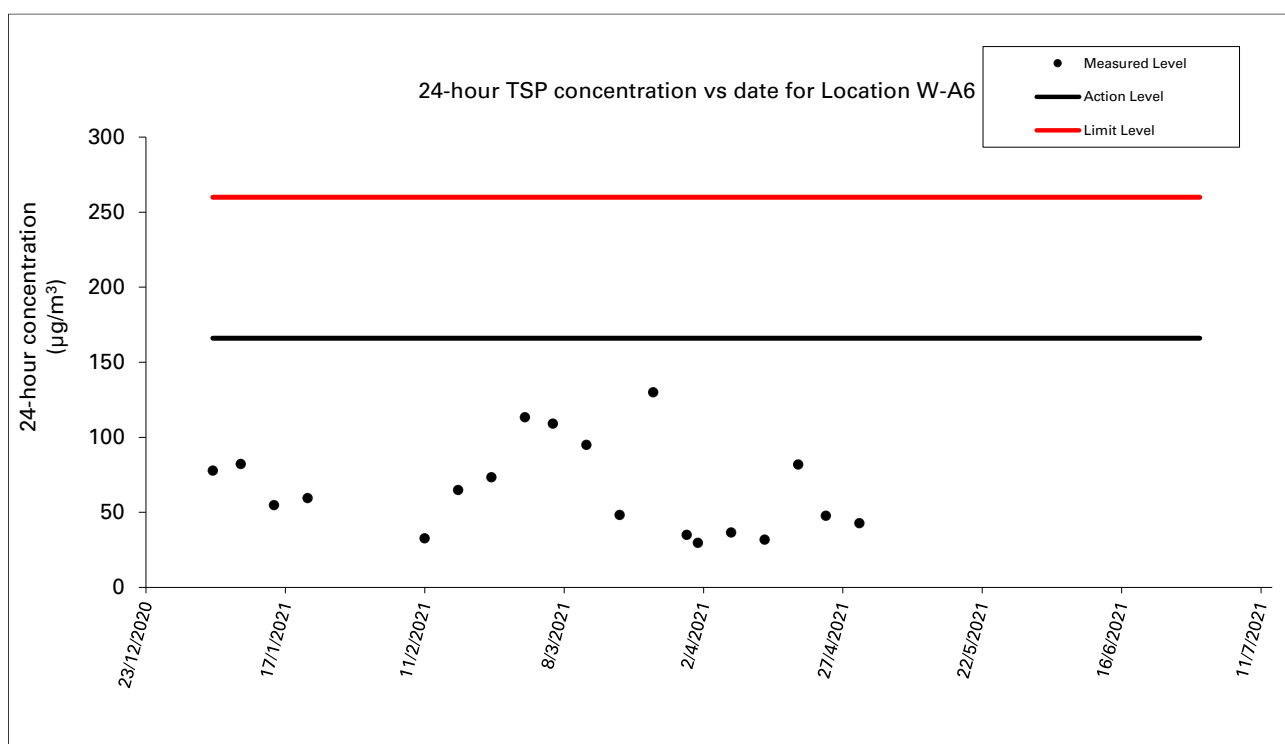
Figure 4: Graphical Illustration of Measured 24-hour TSP ($\mu\text{g}/\text{m}^3$) Levels at W-A6

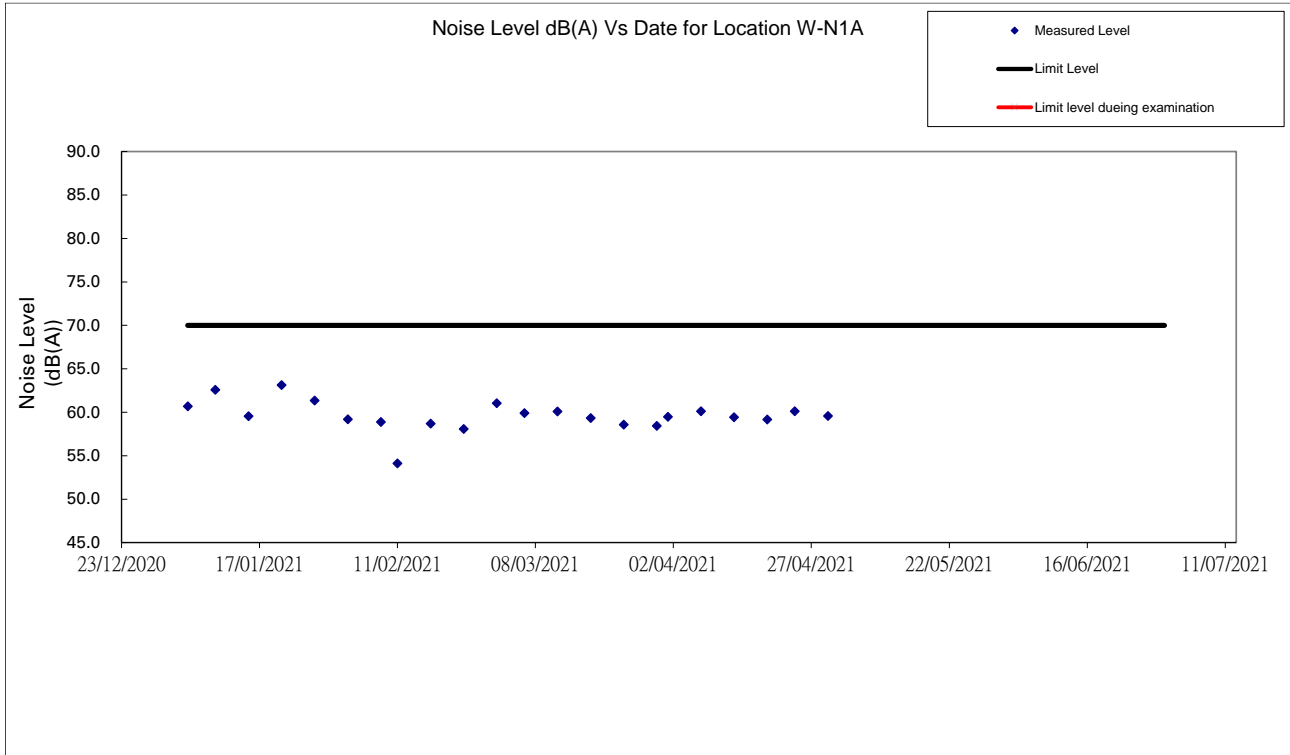
Figure 1: Graphical Illustration of Measured Noise Levels at W-N1A

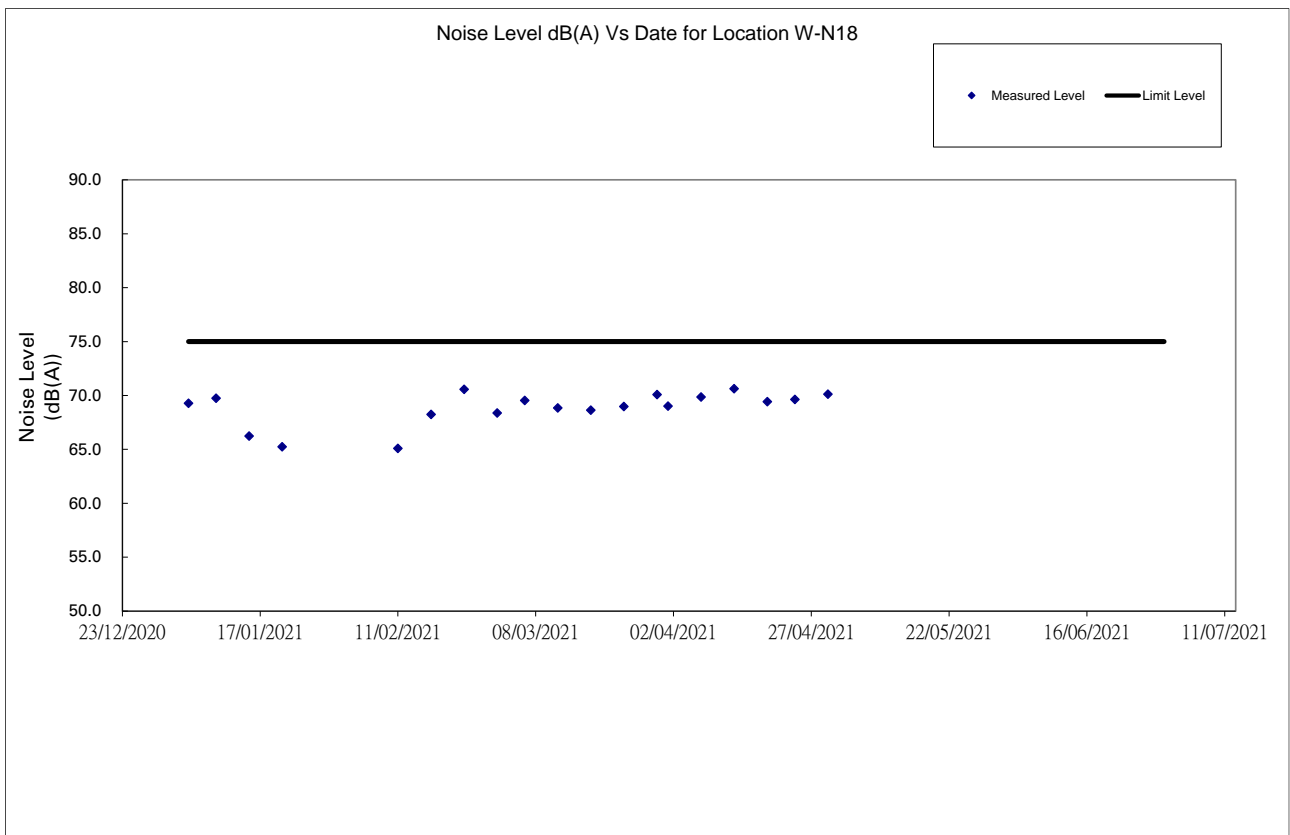
Figure 2: Graphical Illustration of Measured Noise Levels at W-N18

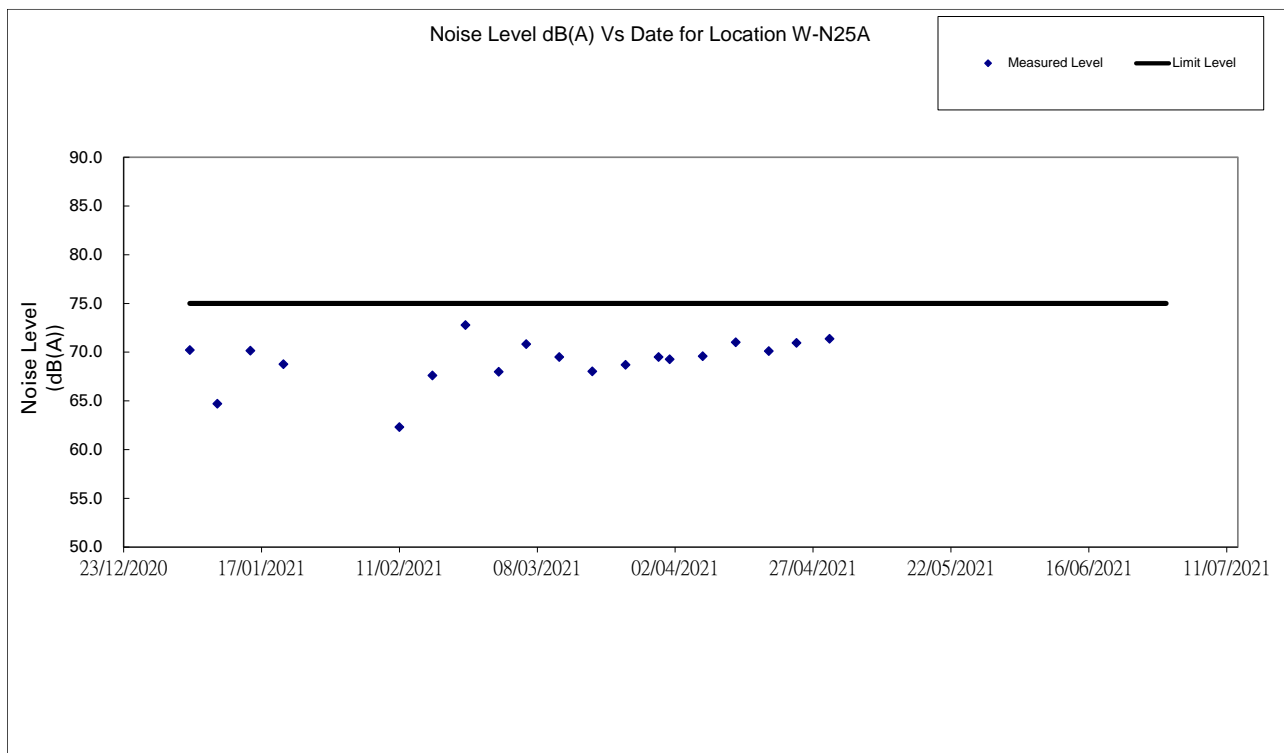
Figure 3: Graphical Illustration of Measured Noise Levels at W-N25A

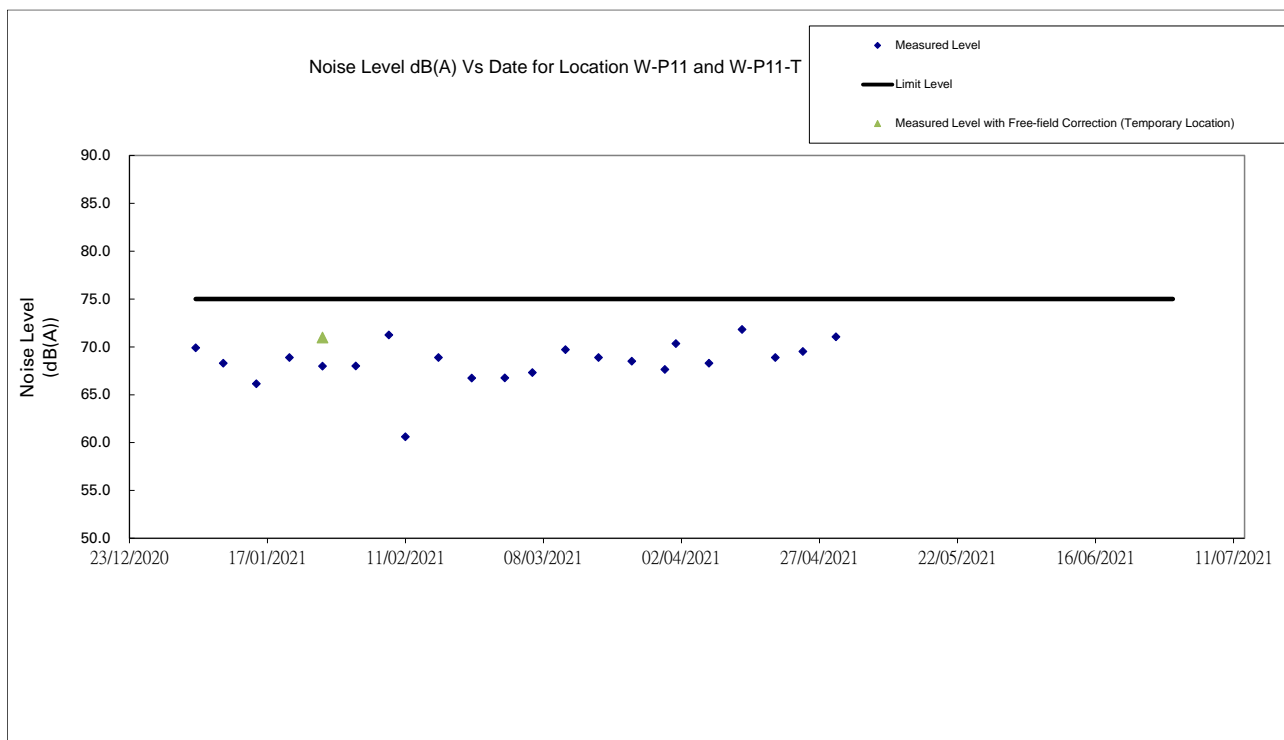
Figure 4: Graphical Illustration of Measured Noise Levels at W-P11
