**Central Kowloon Route**

**Contract No. HY/2014/08**

Monthly EM&A Report No. 93

(Period from 01 to 31 December 2025)

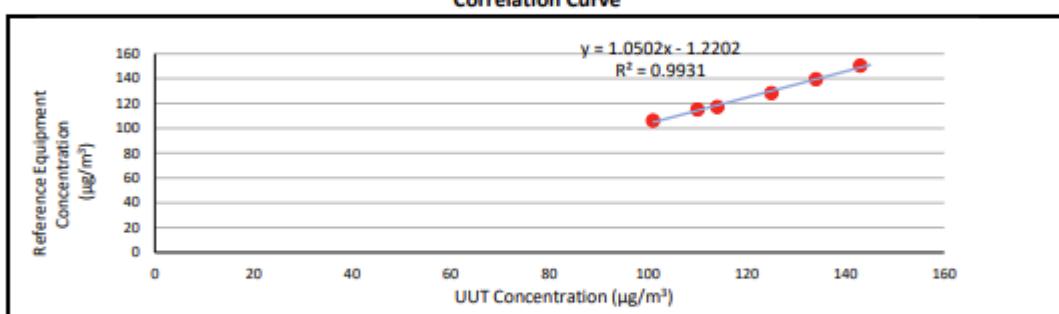
#### Correlation Curve

Particulate Concentration by Reference Equipment ( $\mu\text{g}/\text{m}^3$ ):	126
Particulate Concentration by UUT ( $\mu\text{g}/\text{m}^3$ ):	121
Measuring Time, (min):	60
K Factor = High Volume Sampler / UUT, ( $\mu\text{g}/\text{m}^3$ ):	1.04

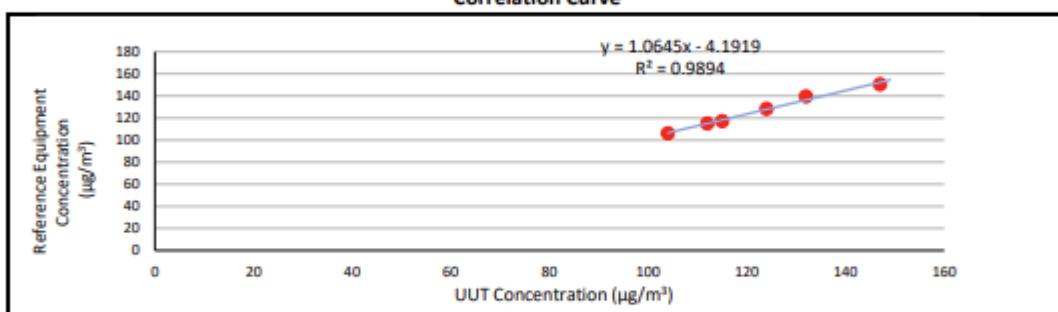
#### Correlation Curve

Particulate Concentration by Reference Equipment ( $\mu\text{g}/\text{m}^3$ ):	126
Particulate Concentration by UUT ( $\mu\text{g}/\text{m}^3$ ):	122
Measuring Time, (min):	60
K Factor = High Volume Sampler / UUT, ( $\mu\text{g}/\text{m}^3$ ):	1.03

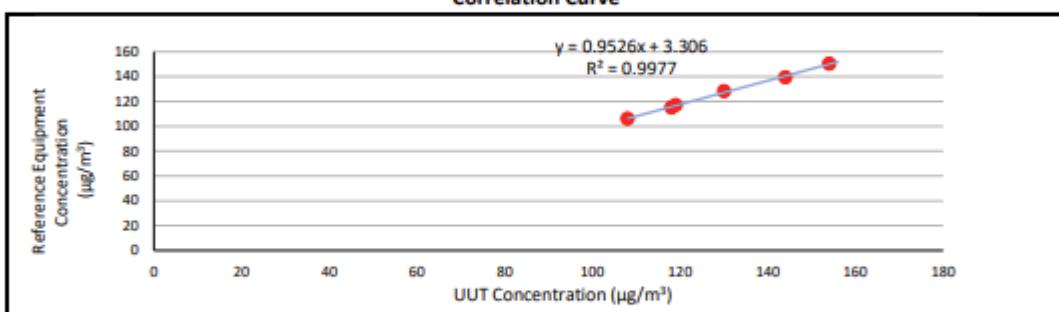
#### Correlation Curve

Particulate Concentration by Reference Equipment ( $\mu\text{g}/\text{m}^3$ ):	126
Particulate Concentration by UUT ( $\mu\text{g}/\text{m}^3$ ):	129
Measuring Time, (min):	60
K Factor = High Volume Sampler / UUT, ( $\mu\text{g}/\text{m}^3$ ):	0.98

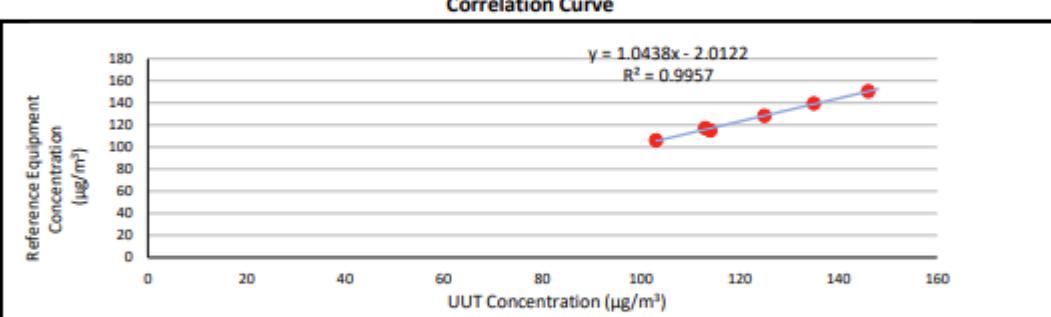
#### Correlation Curve

Particulate Concentration by Reference Equipment ( $\mu\text{g}/\text{m}^3$ ):	126
Particulate Concentration by UUT ( $\mu\text{g}/\text{m}^3$ ):	123
Measuring Time, (min):	60
K Factor = High Volume Sampler / UUT, ( $\mu\text{g}/\text{m}^3$ ):	1.03

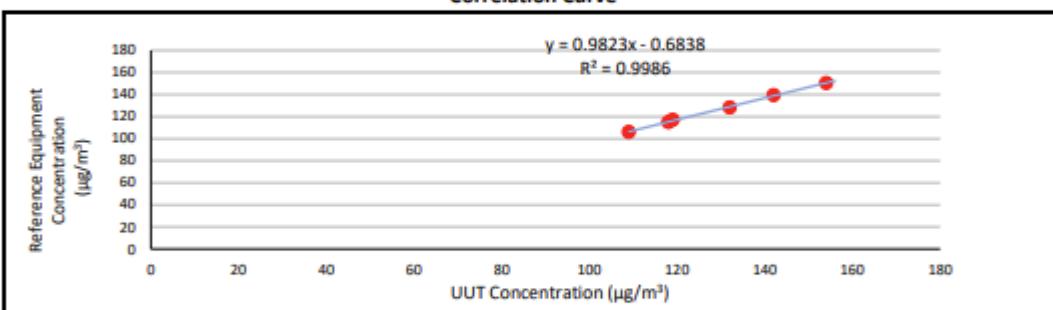
#### Correlation Curve

Particulate Concentration by Reference Equipment ( $\mu\text{g}/\text{m}^3$ ):	126
Particulate Concentration by UUT ( $\mu\text{g}/\text{m}^3$ ):	129
Measuring Time, (min):	60
K Factor = High Volume Sampler / UUT, ( $\mu\text{g}/\text{m}^3$ ):	0.98

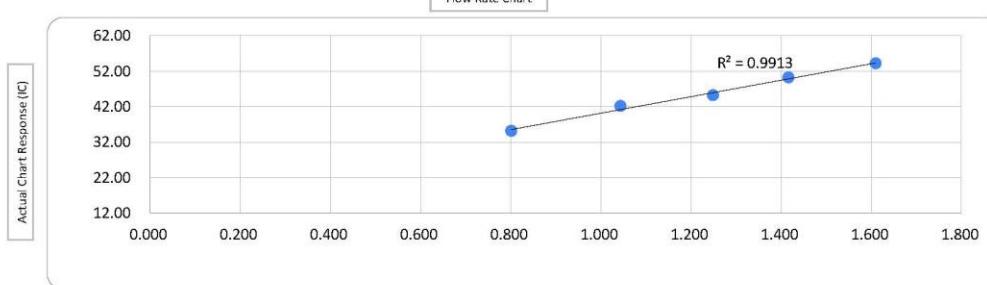
Flow Rate Chart

$m$  = sampler slope  
 $b$  = sampler intercept  
 $T_{std}$  = 298 deg K  
 $P_{std}$  = 760 mm Hg  
 $T_a$  = actual temperature during calibration (deg K)  
 $P_a$  = actual pressure during calibration (mm Hg)

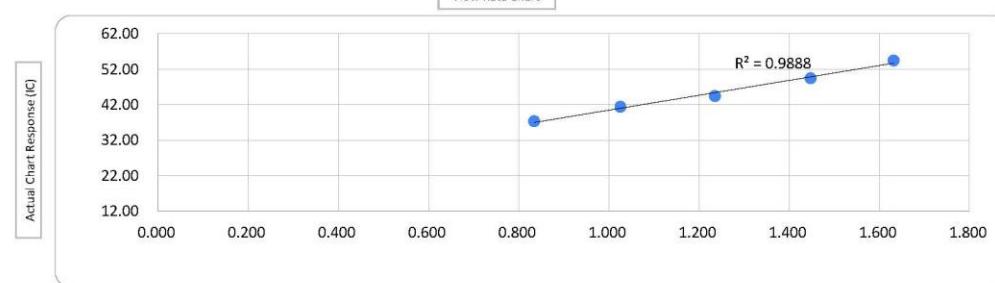
Flow Rate Chart

m = sampler slope  
 b = sampler intercept  
 $T_{std} = 298$  deg K  
 $P_{std} = 760$  mm Hg  
 $T_a$  = actual temperature during calibration (deg K)  
 $P_a$  = actual pressure during calibration (mm Hg)

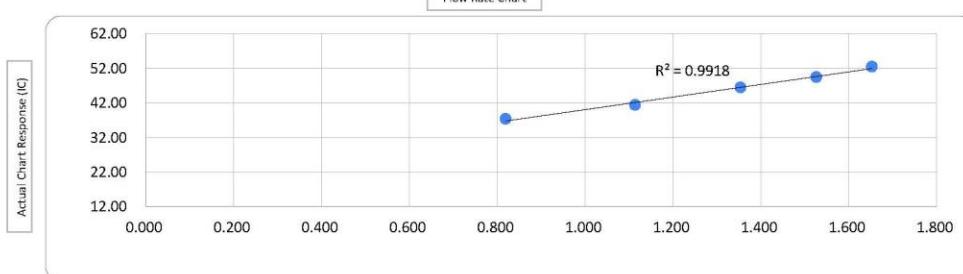
Flow Rate Chart

$m$  = sampler slope  
 $b$  = sampler intercept  
 $T_{\text{Std}} = 298$  deg K  
 $P_{\text{Std}} = 760$  mm Hg  
 $T_a$  = actual temperature during calibration (deg K)  
 $P_a$  = actual pressure during calibration (mm Hg)

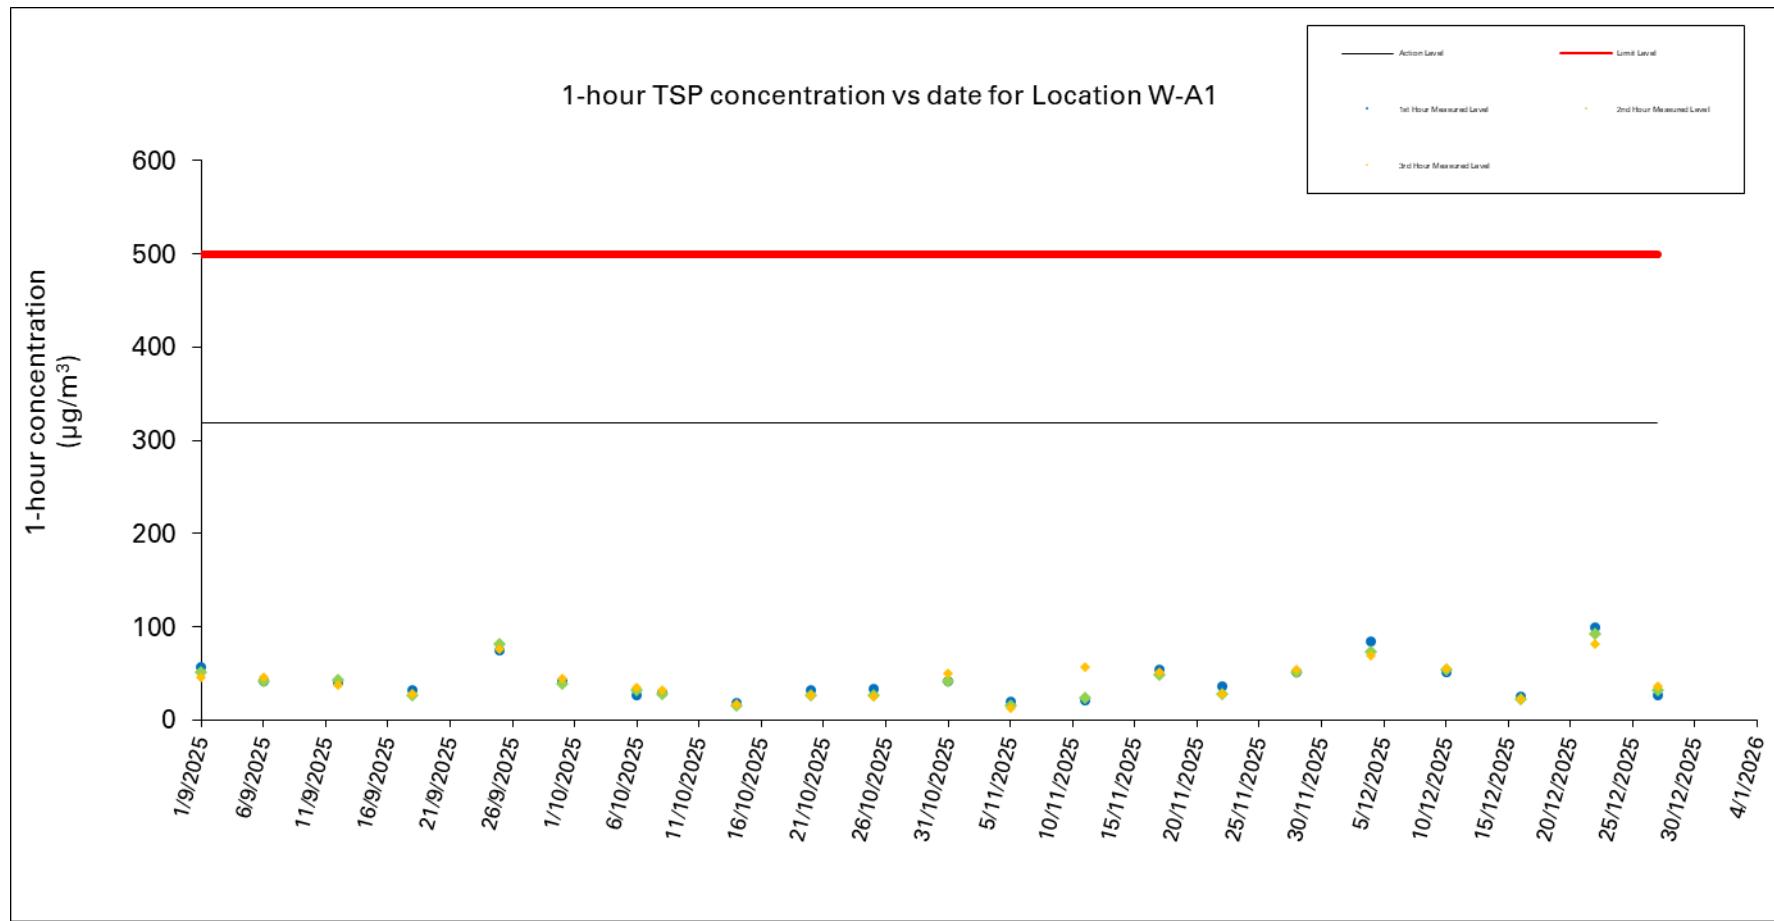
Figure 1: Graphical Illustration of Measured 1-hour TSP ( $\mu\text{g}/\text{m}^3$ ) Levels at W-A1

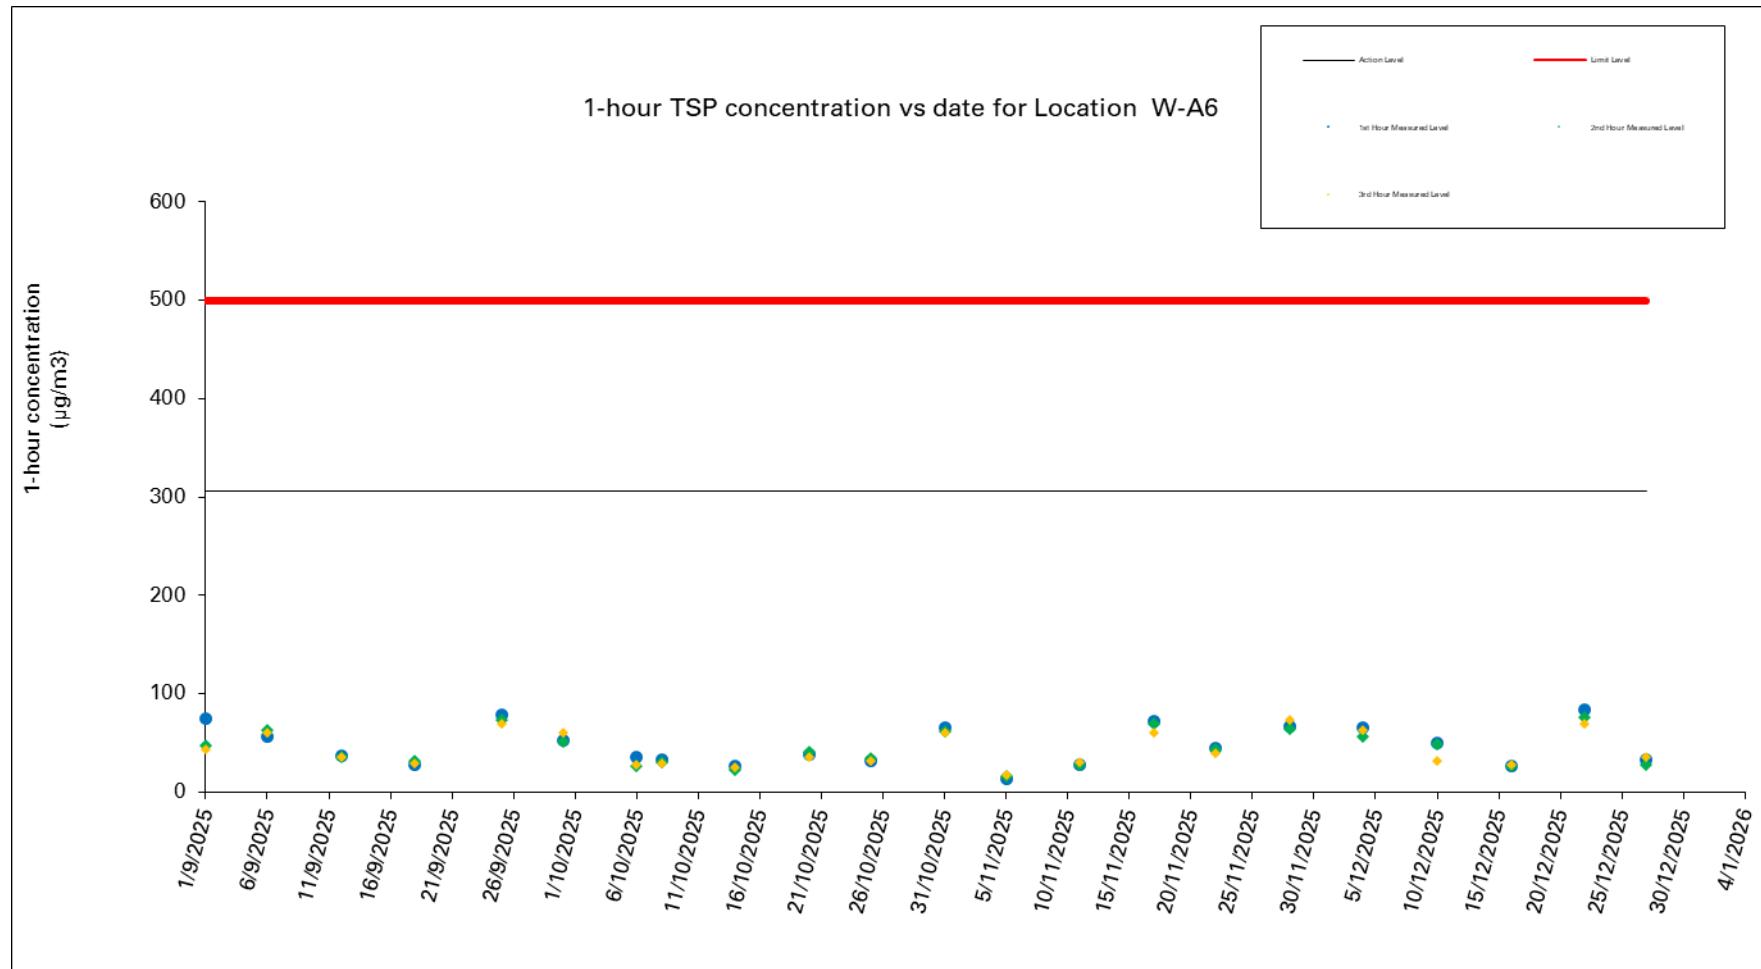
Figure 2: Graphical Illustration of Measured 1-hour TSP ( $\mu\text{g}/\text{m}^3$ ) Levels at W-A6

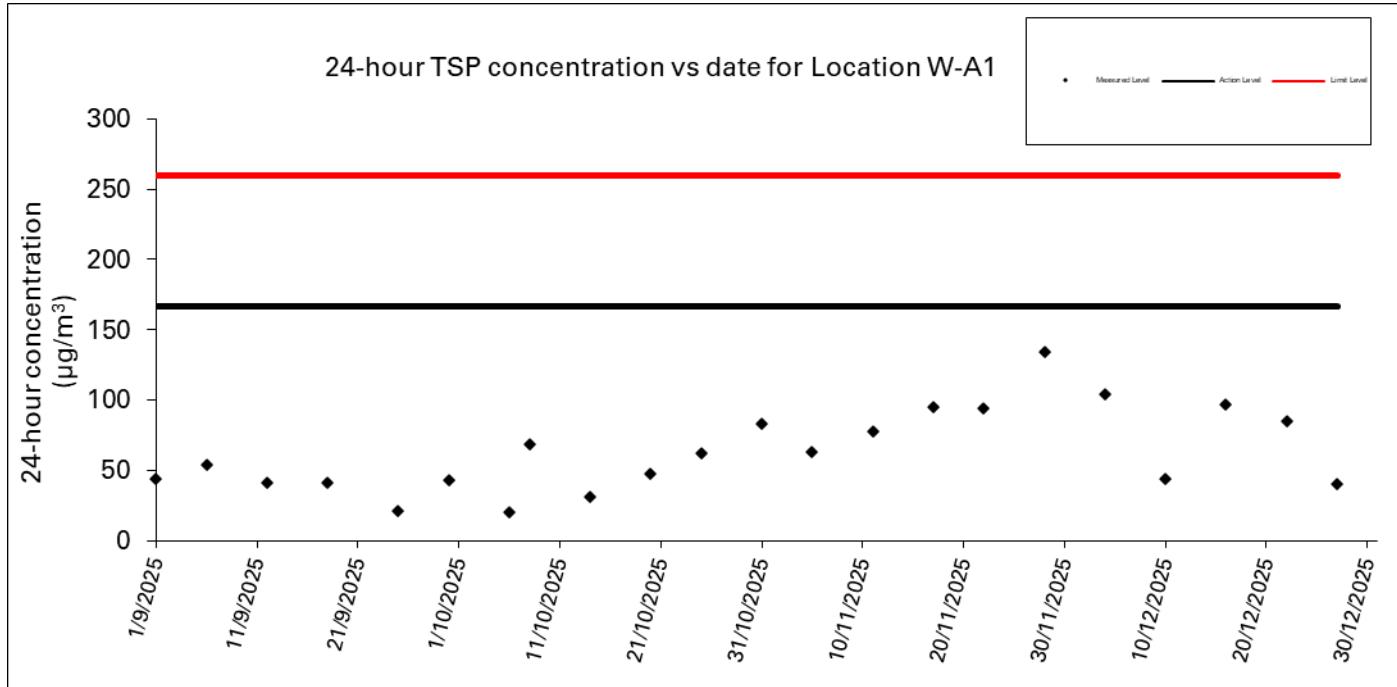
Figure 3: Graphical Illustration of Measured 24-hour TSP ( $\mu\text{g}/\text{m}^3$ ) Levels at W-A1

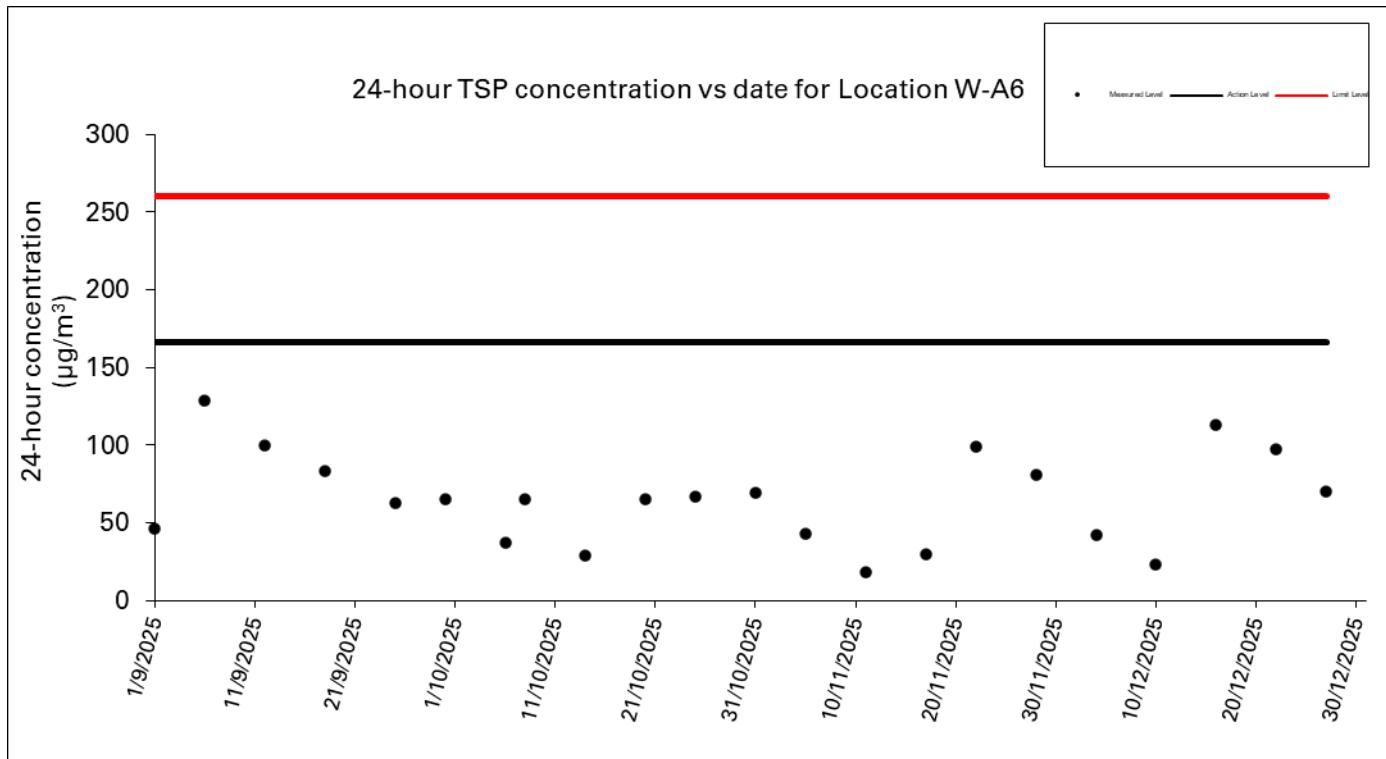
Figure 4: Graphical Illustration of Measured 24-hour TSP ( $\mu\text{g}/\text{m}^3$ ) Levels at W-A6

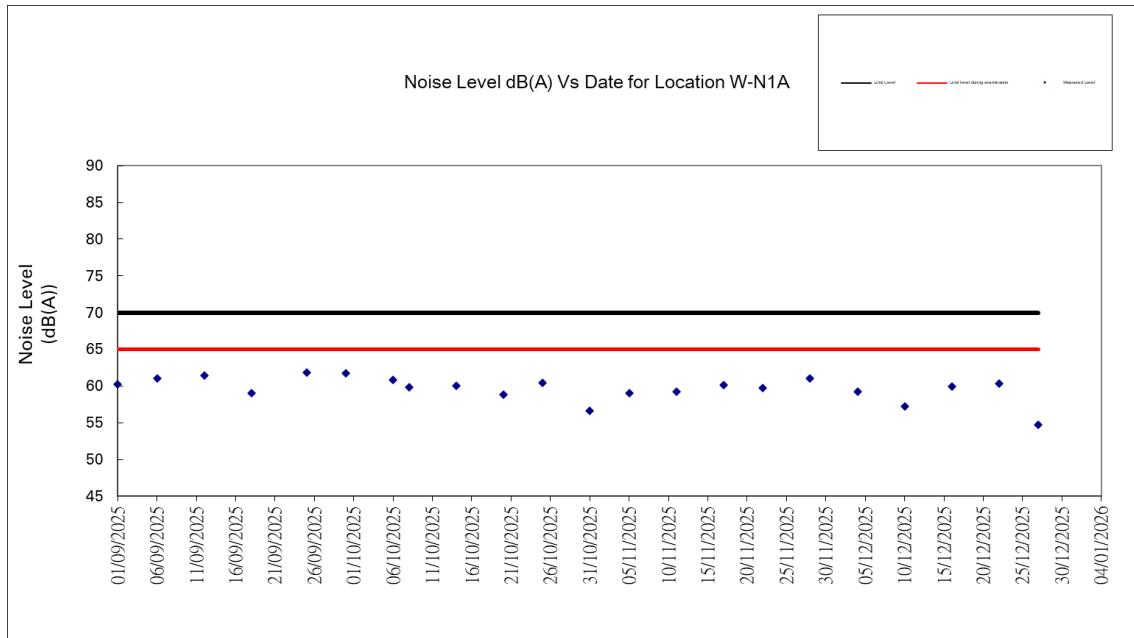
Figure 1: Graphical Illustration of Measured Noise Levels at W-N1A

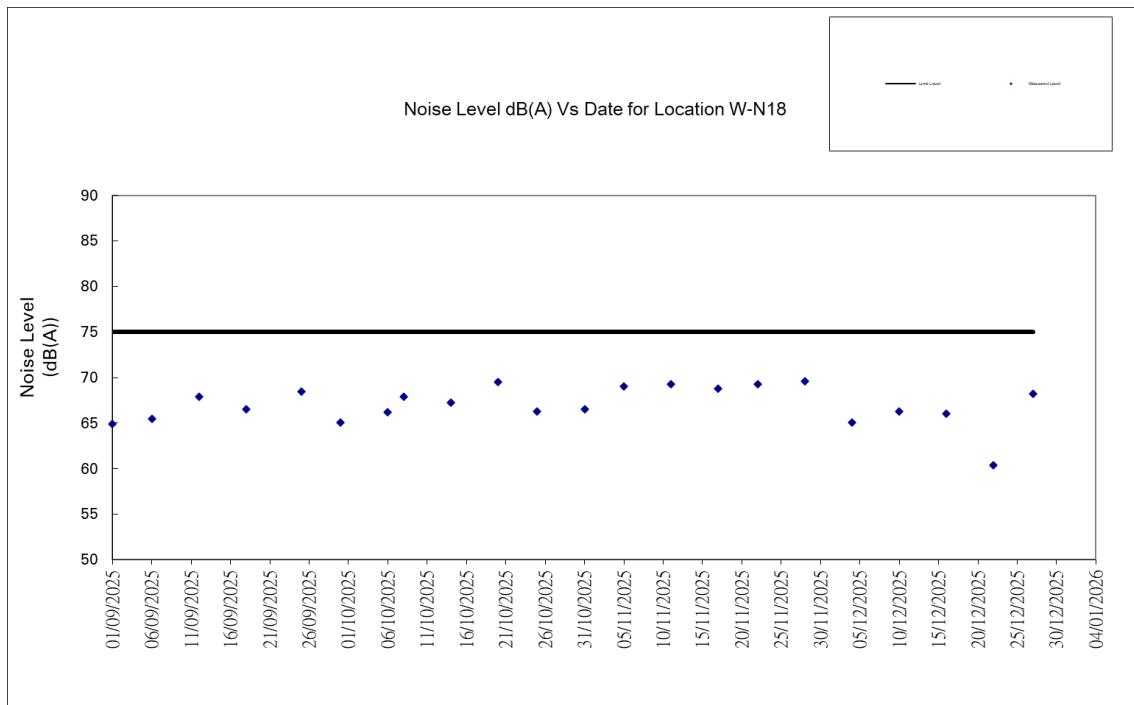
Figure 2: Graphical Illustration of Measured Noise Levels at W-N18

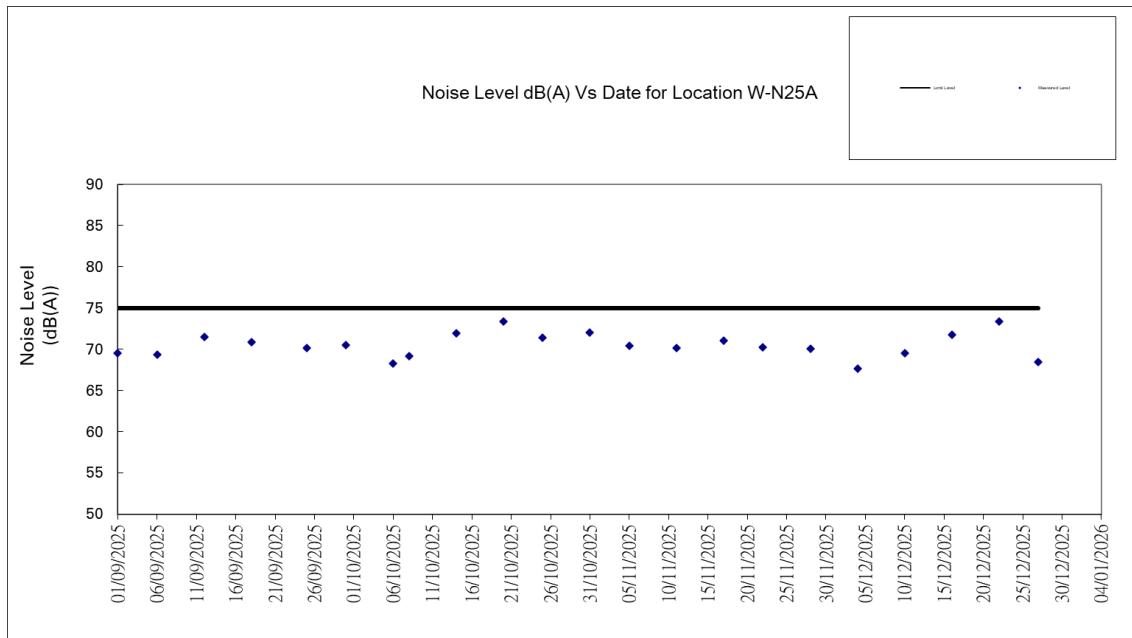
Figure 3: Graphical Illustration of Measured Noise Levels at W-N25A

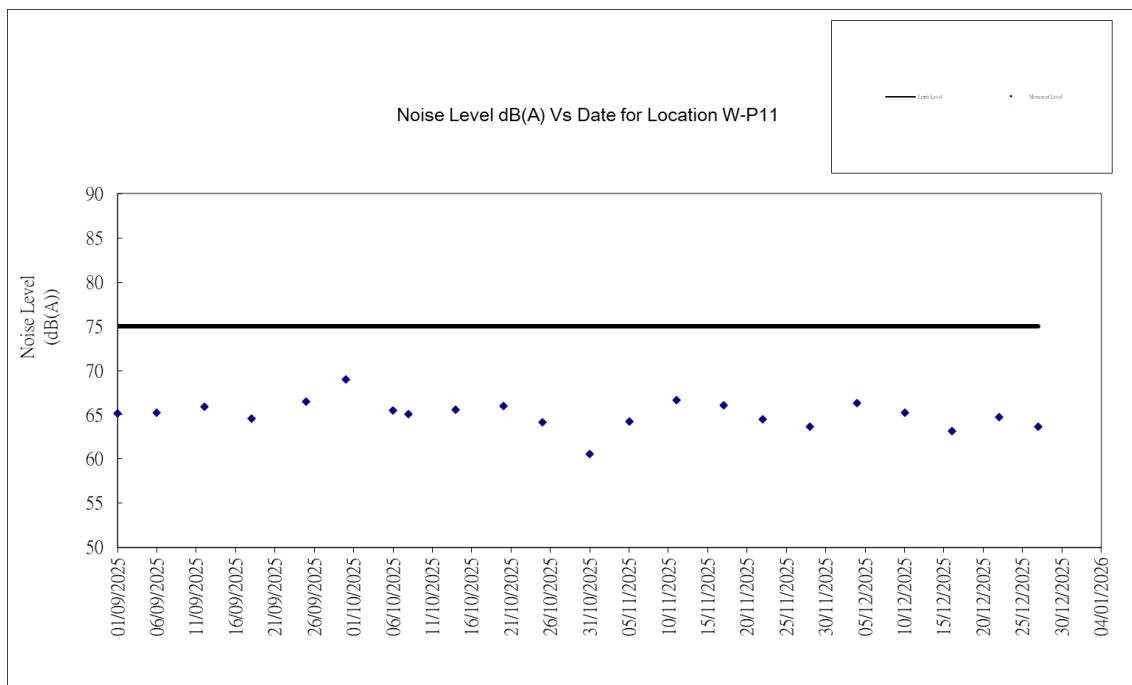
Figure 4: Graphical Illustration of Measured Noise Levels at W-P11
