**Central Kowloon Route**

**Kai Tak West**

**Contract No. HY/2014/07**

**Central Kowloon Route**  
**Works Contract HY/2014/07 –**  
**Central Kowloon Route – Kai Tak West**  
**Monthly EM&A Report for February 2020**

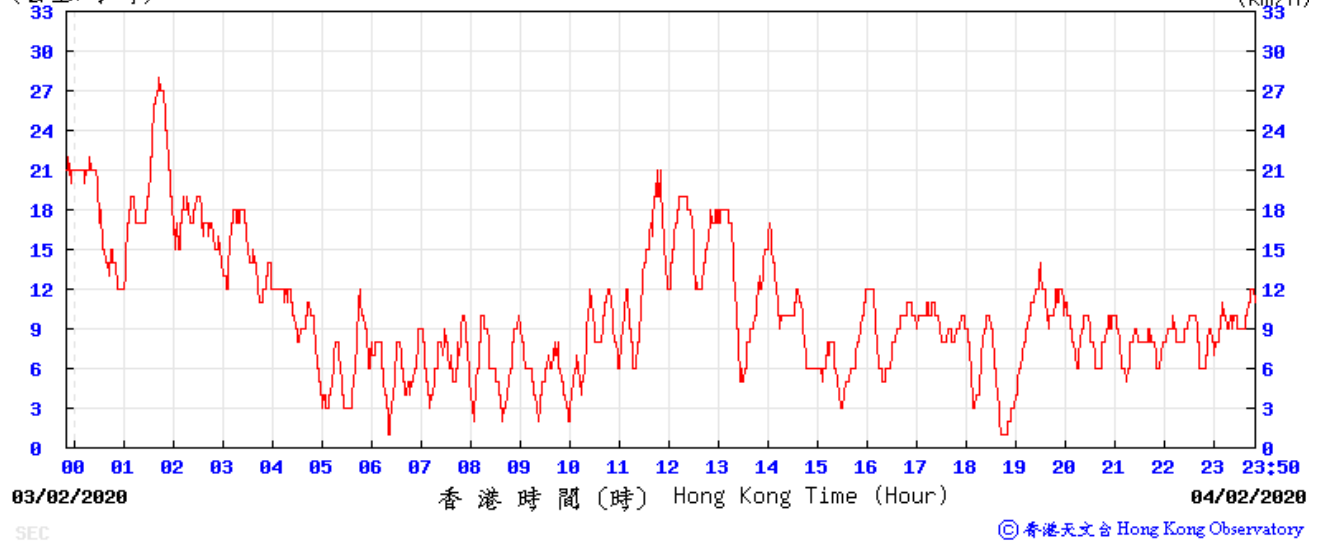
(公里/小時) (於香港時間 2020 年 2 月 4 日 23 時 50 分更新) (Updated at 23:50H on 4 Feb 2020)

### Data of Wind Speed Extracted from Kai Tak Wind Station of the Hong Kong Observatory

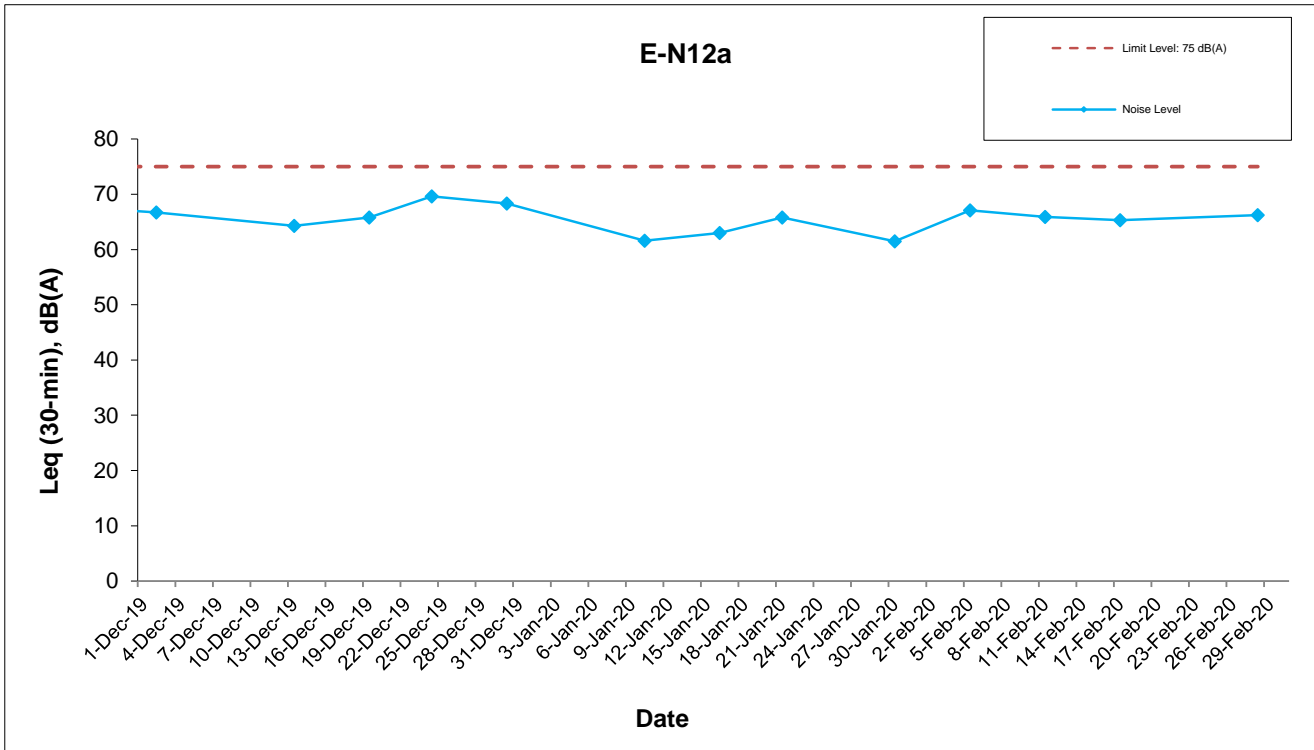
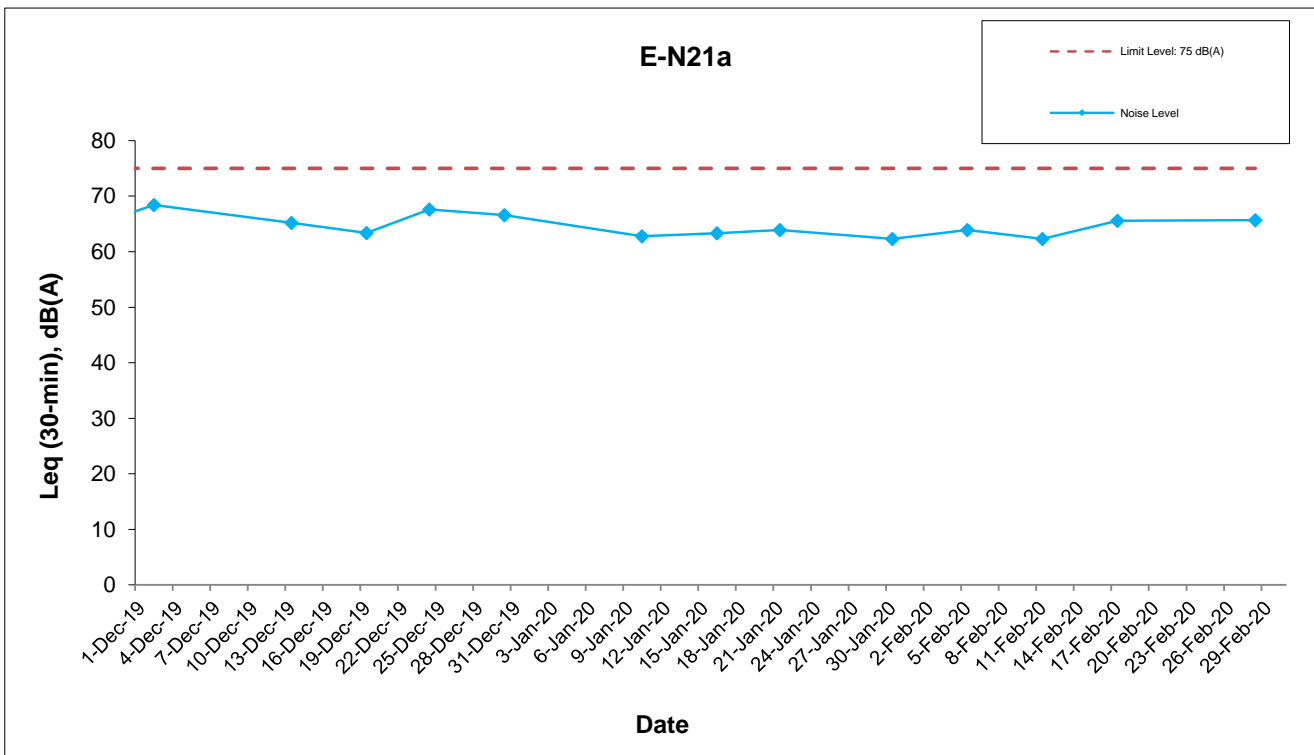
<sup>++</sup> - Free field measurement

<sup>\*</sup> - Limit Level of 70dB(A) applies to education institutes while 65dB(A) applies during school
