**Central Kowloon Route**

**Yau Ma Tei East**

**Contract No. HY/2014/08**

Monthly EM&A Report No. 22

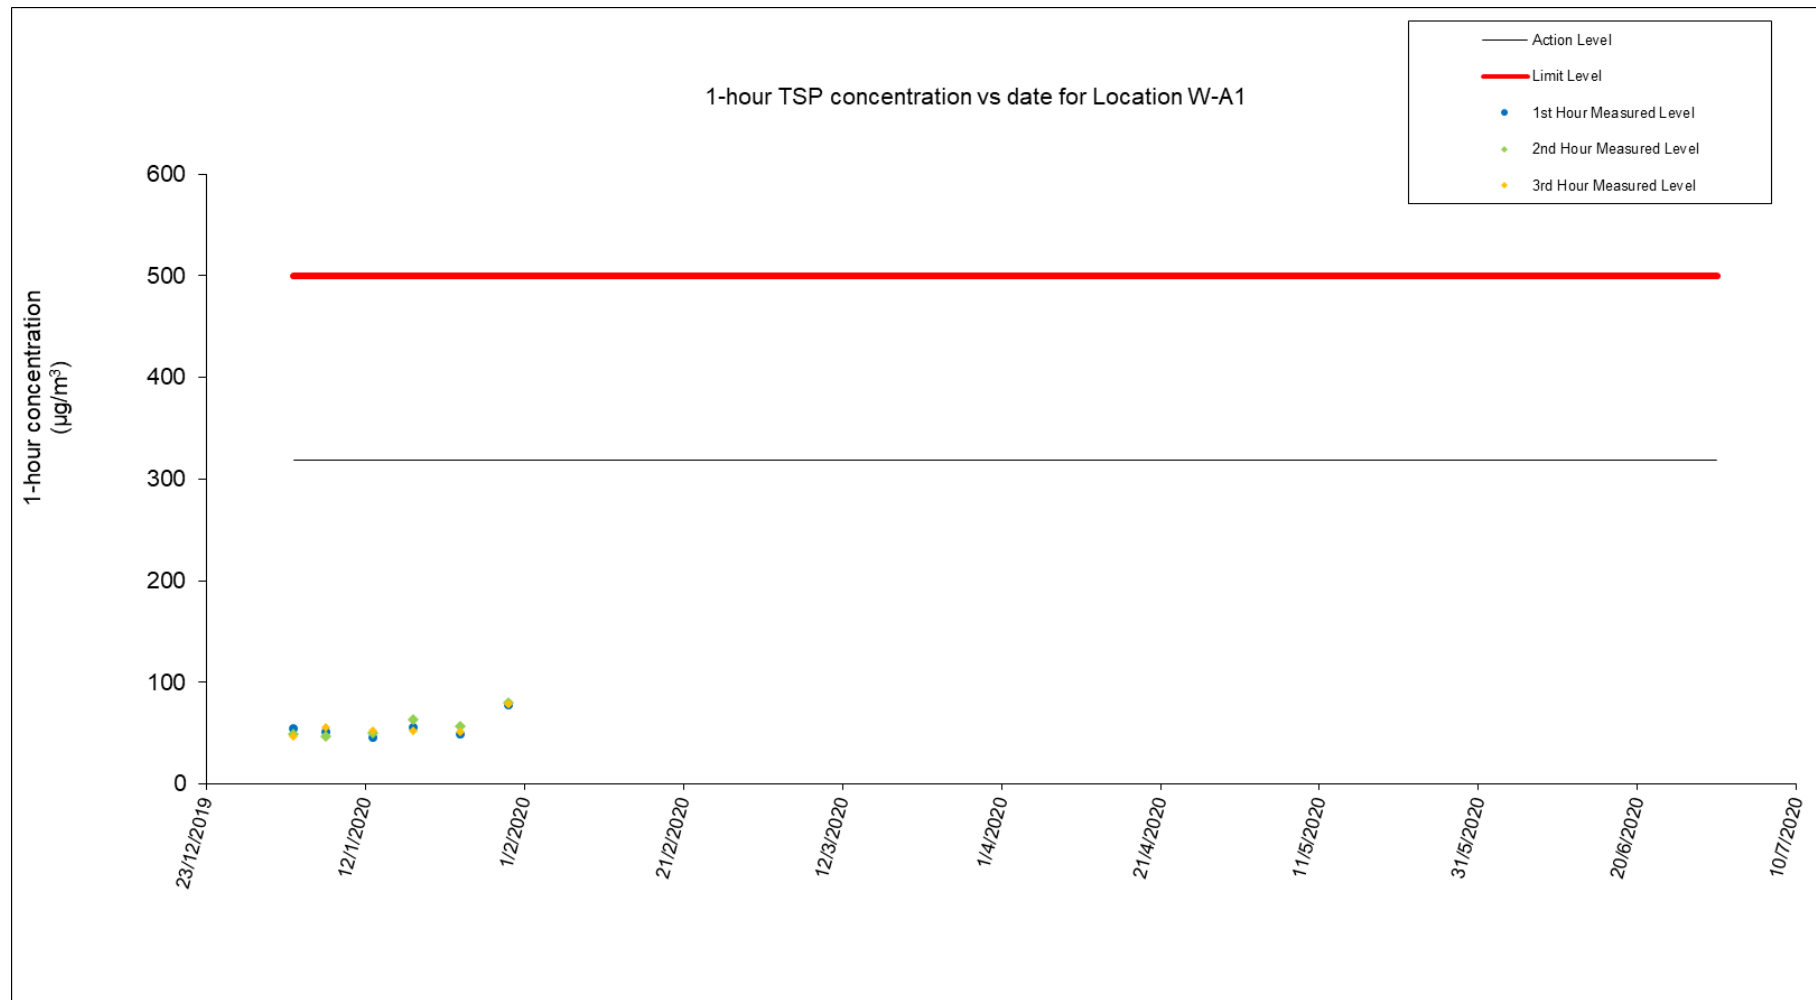
Figure 1: Graphical Illustration of Measured 1-hour TSP ( $\mu\text{g}/\text{m}^3$ ) Levels at W-A1

3.6.3. The results for 1-hour TSP and 24-hour TSP are summarized in Table 3.7 and Table 3.8. The measurement data and details of influencing factors such as weather conditions and site observation are presented in Appendix L.

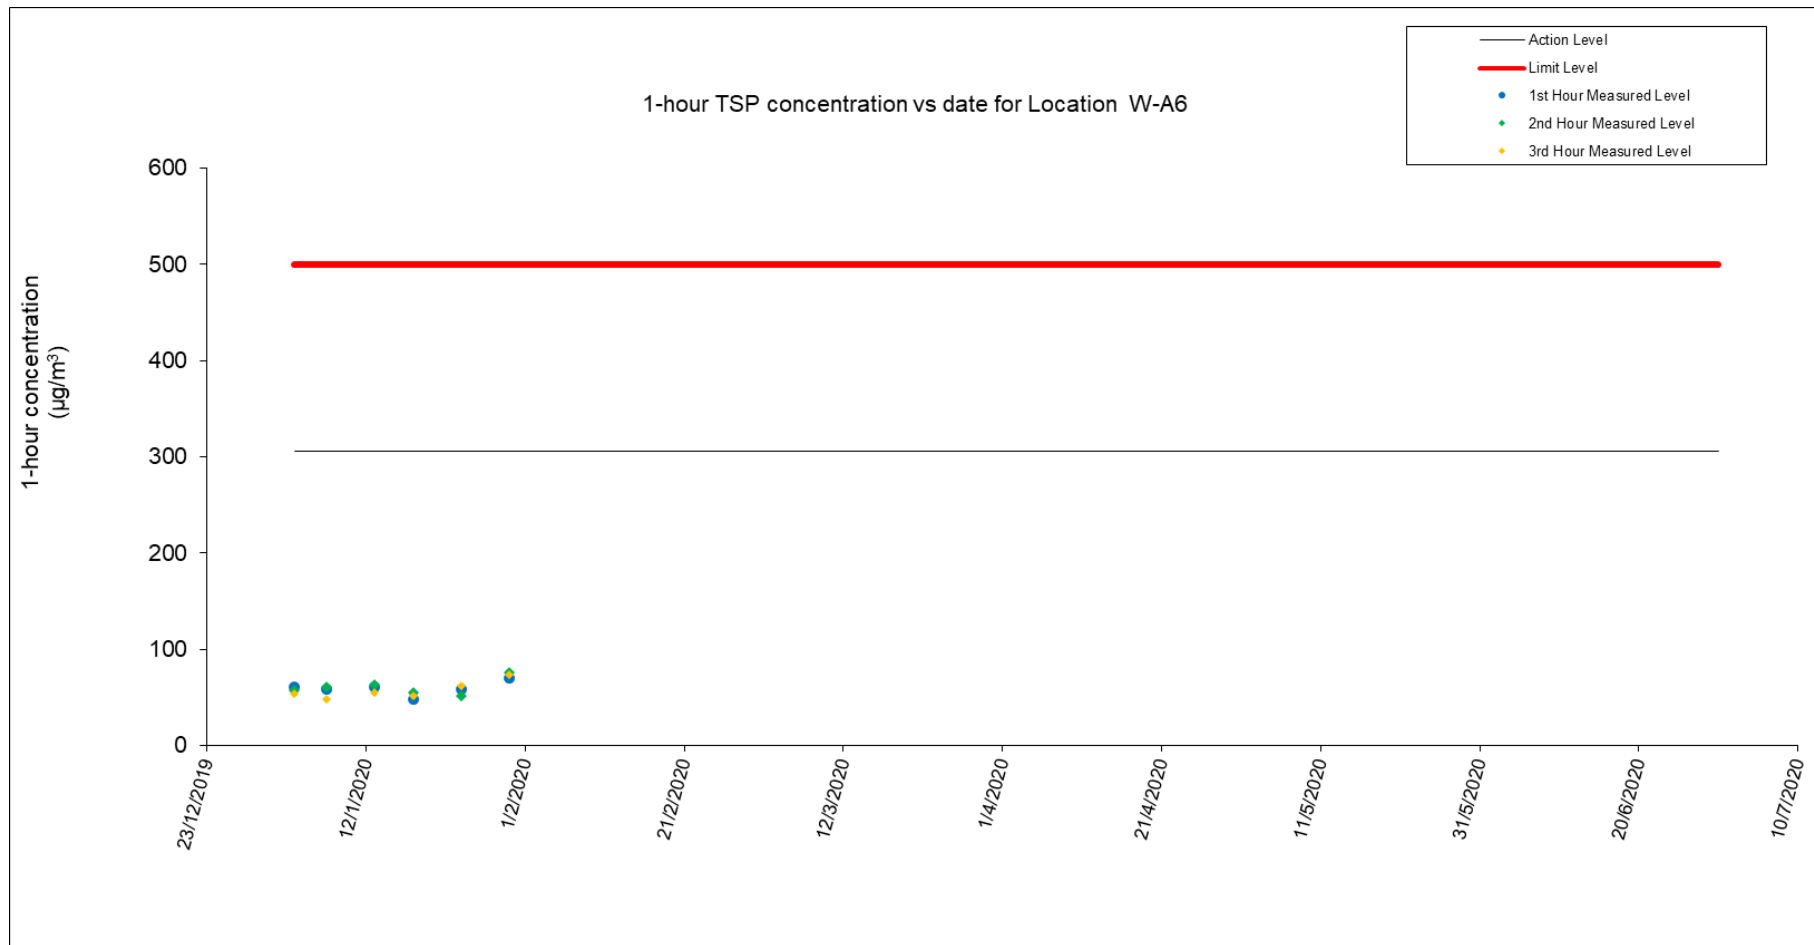
Figure 2: Graphical Illustration of Measured 1-hour TSP ( $\mu\text{g}/\text{m}^3$ ) Levels at W-A6

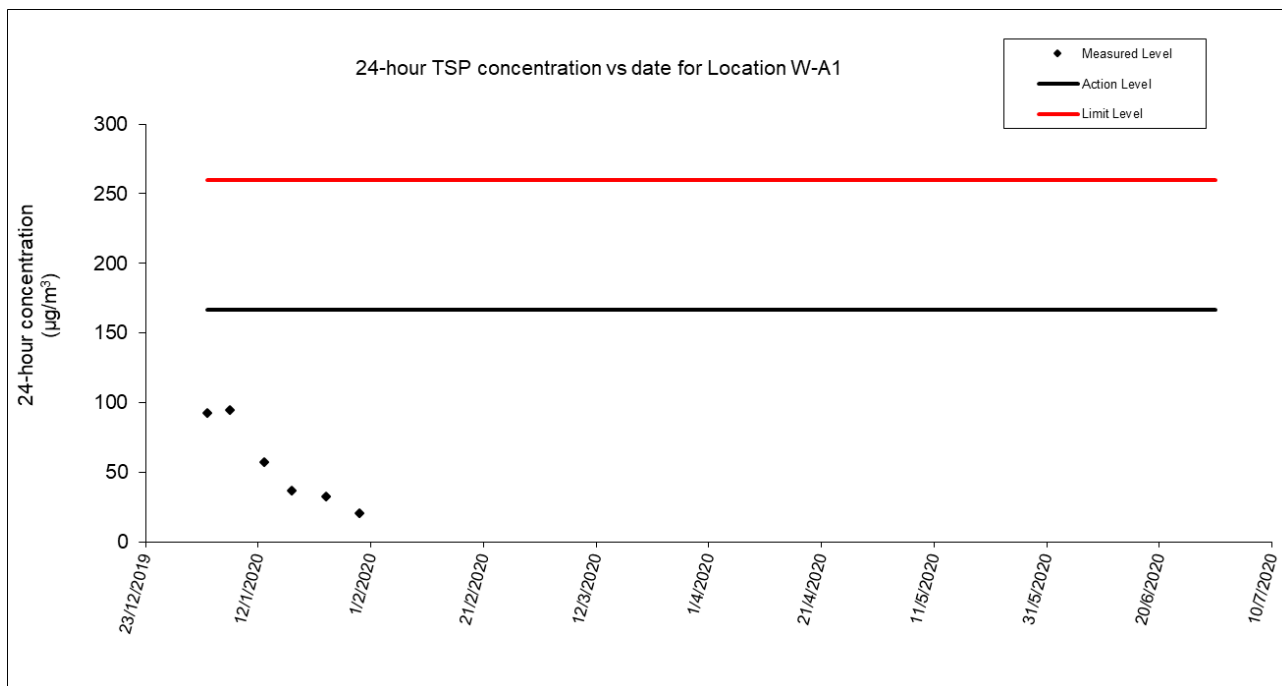
Figure 3: Graphical Illustration of Measured 24-hour TSP ( $\mu\text{g}/\text{m}^3$ ) Levels at W-A1

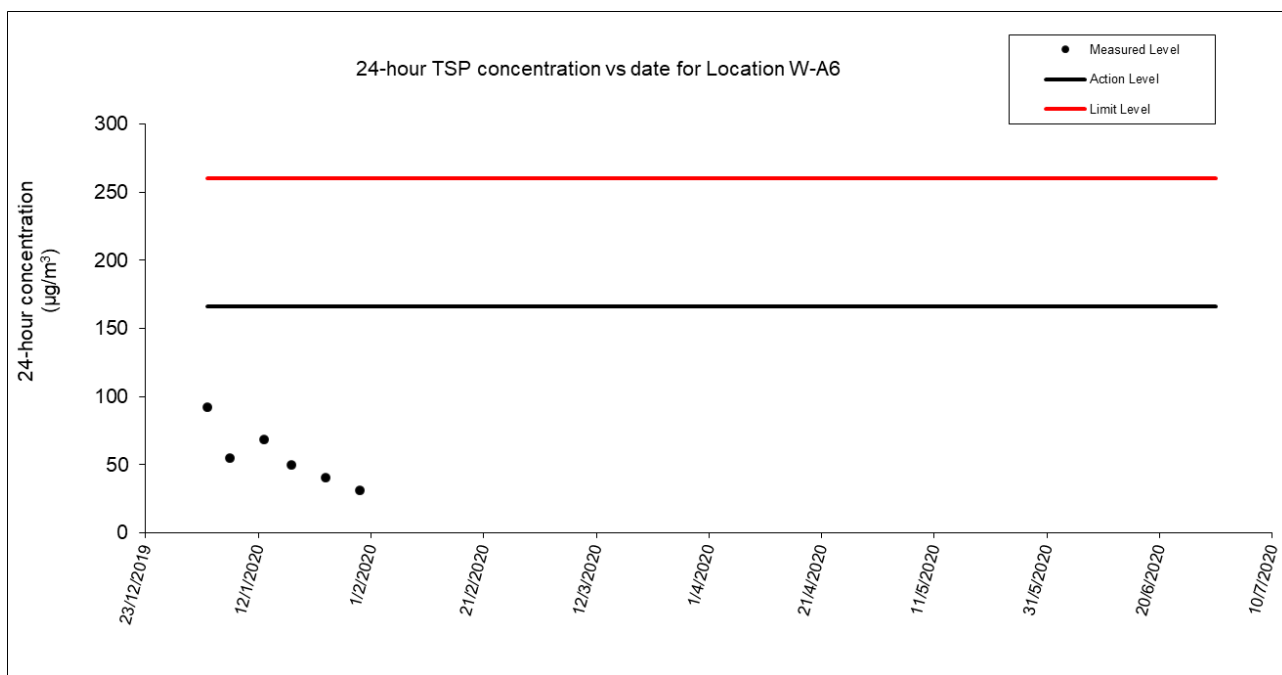
Figure 4: Graphical Illustration of Measured 24-hour TSP ( $\mu\text{g}/\text{m}^3$ ) Levels at W-A6

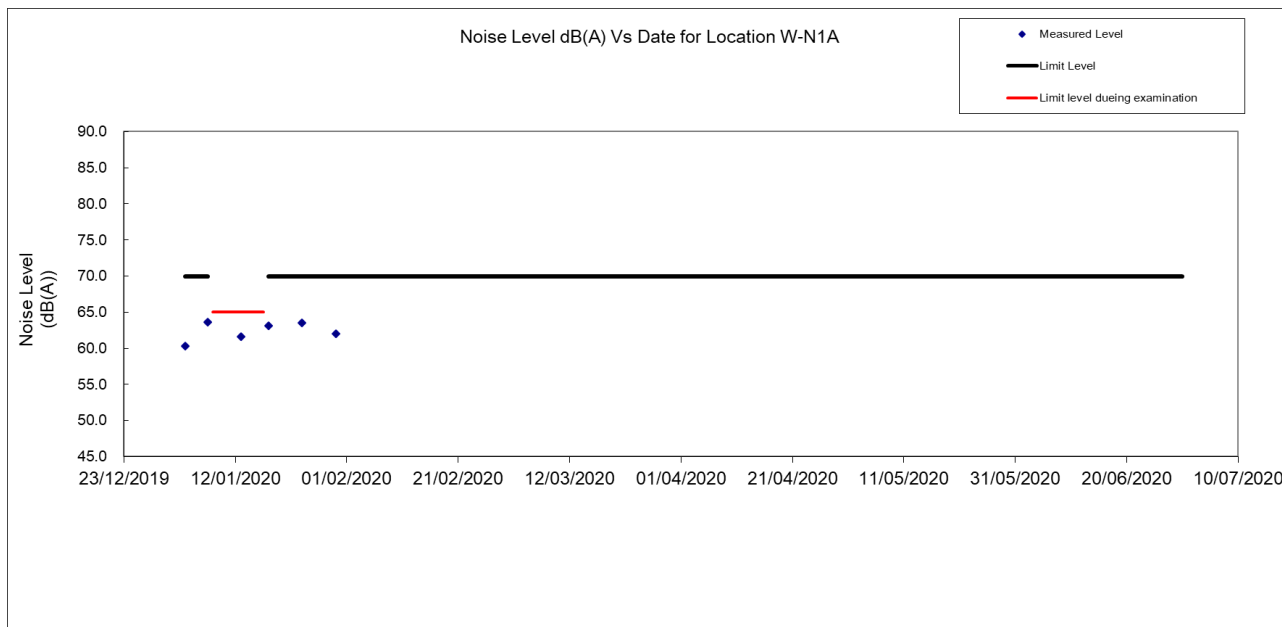
Figure 1: Graphical Illustration of Measured Noise Levels at W-N1A

Remark: Limit level was 65 dB(A) during examination period from 9 to 14 January 2020 at W-N1A.

- Remarks:
- # If works are to be carried out during restricted hours, the conditions stipulated in the construction noise permit by the Noise Control Authority have to be followed.
  - Limit level was 65 dB(A) during examination period from 9 to 14 January 2020 at W-N1A.

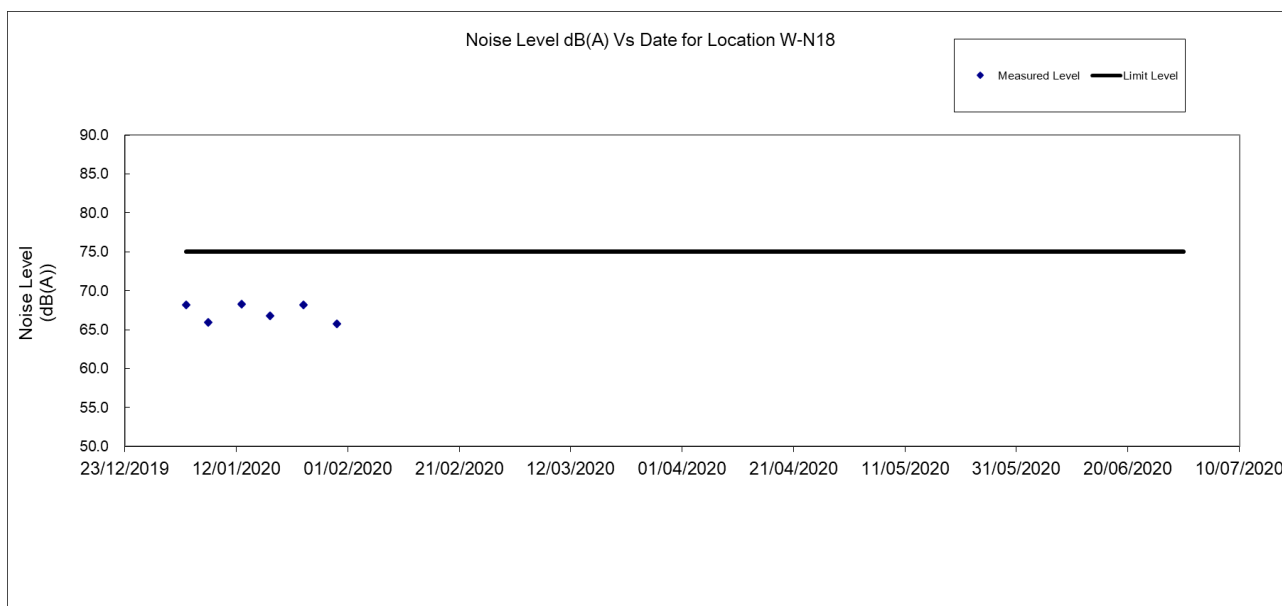
Figure 2: Graphical Illustration of Measured Noise Levels at W-N18

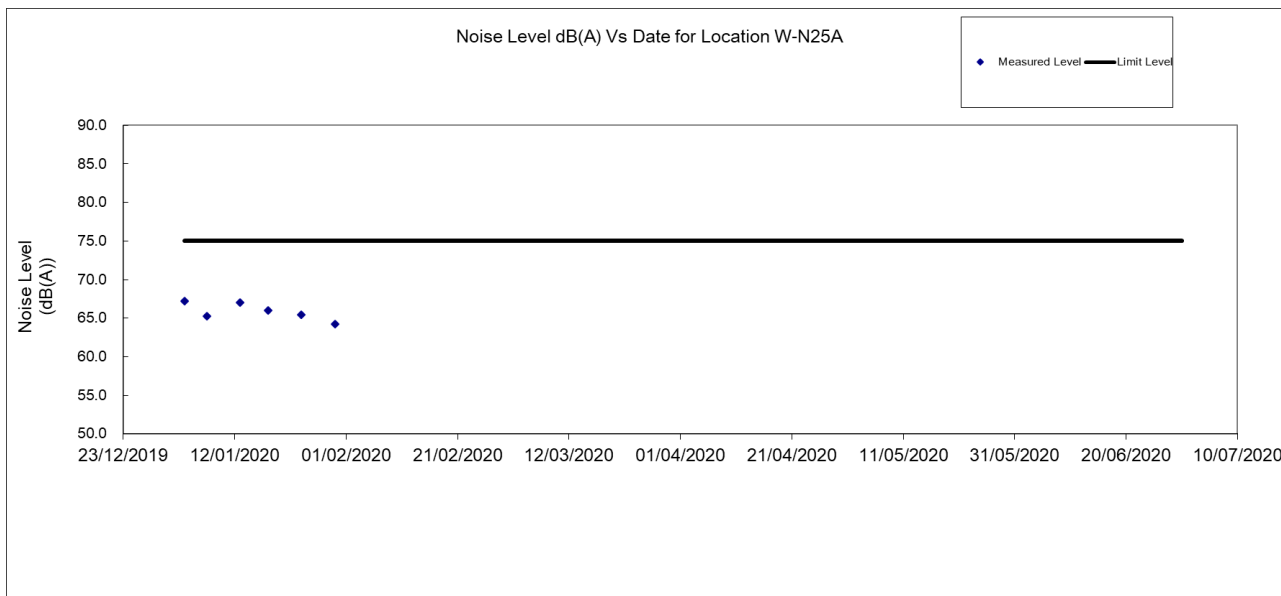
Figure 3: Graphical Illustration of Measured Noise Levels at W-N25A

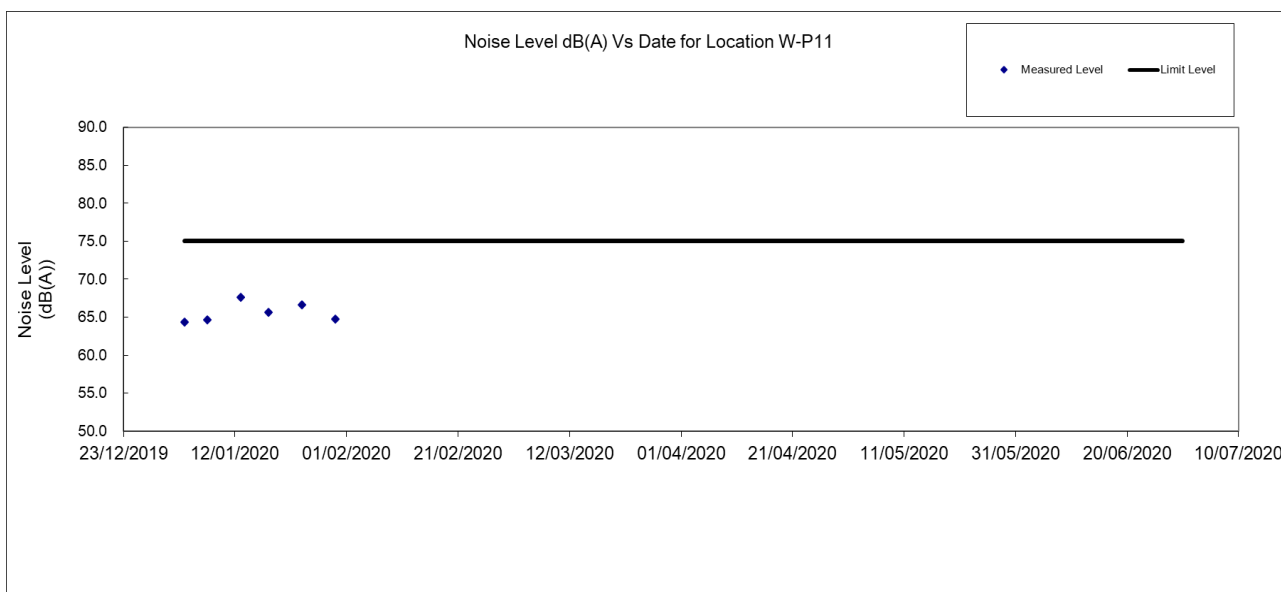
Figure 4: Graphical Illustration of Measured Noise Levels at W-P11
