Central Kowloon Route

Yau Ma Tei West

Contract No. HY/2014/20

Independent Environmental Checker Verification

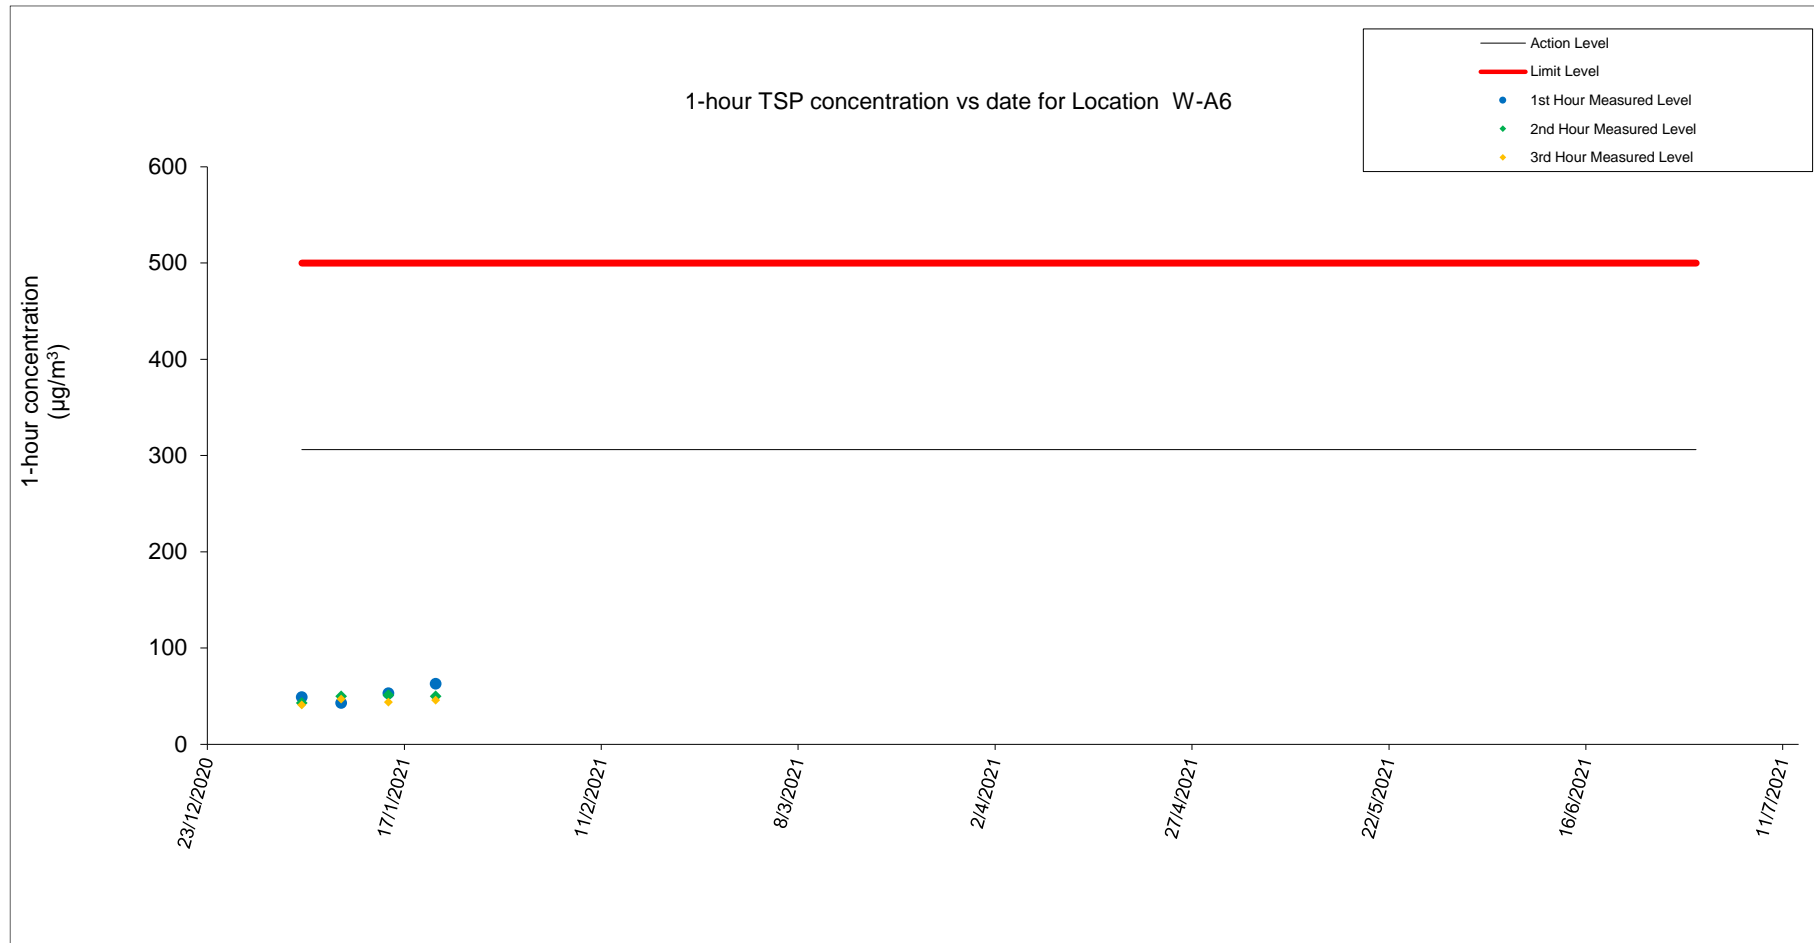
Figure 2: Graphical Illustration of Measured 1-hour TSP ($\mu\text{g}/\text{m}^3$) Levels at W-A6

Remark: 1-hour TSP monitoring at W-A6 was temporarily suspended from 27 January 2021 to 9 February 2021 as this station was located inside the specified area of lock down due to COVID-19.

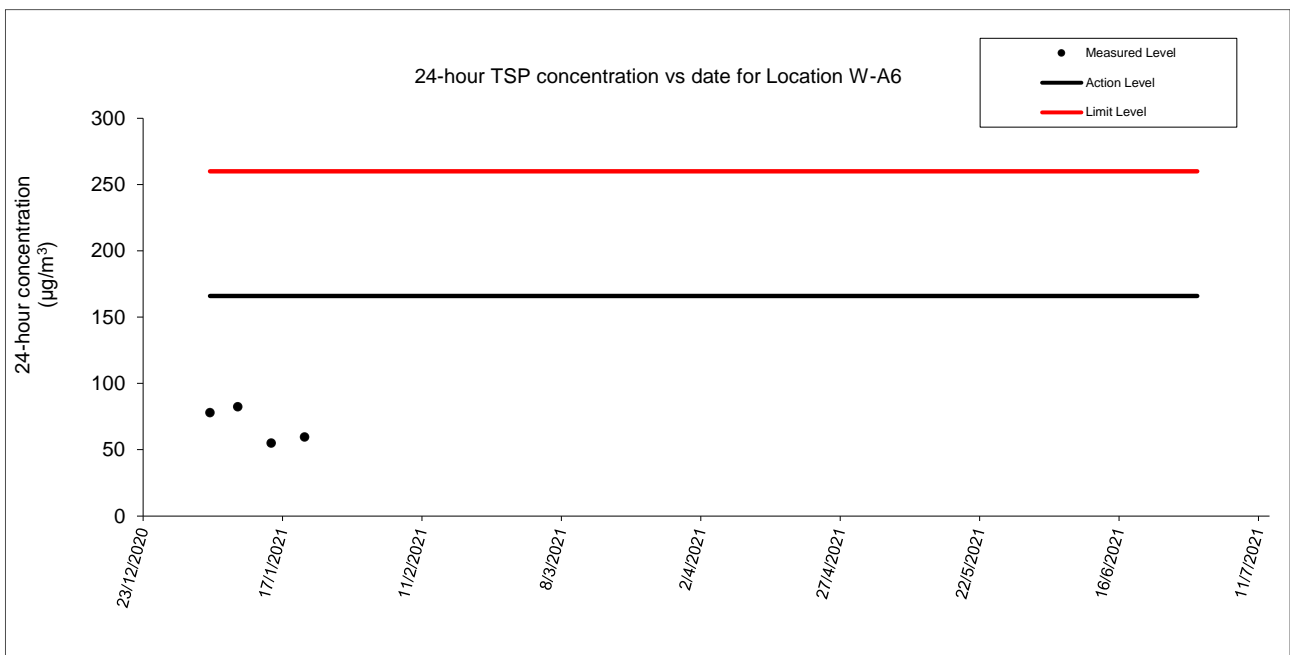
Figure 4: Graphical Illustration of Measured 24-hour TSP ($\mu\text{g}/\text{m}^3$) Levels at W-A6

Remark: 24-hour TSP monitoring at W-A6 was temporarily suspended from 27 January 2021 to 9 February 2021 as this station was located inside the specified area of lock down due to COVID-19.

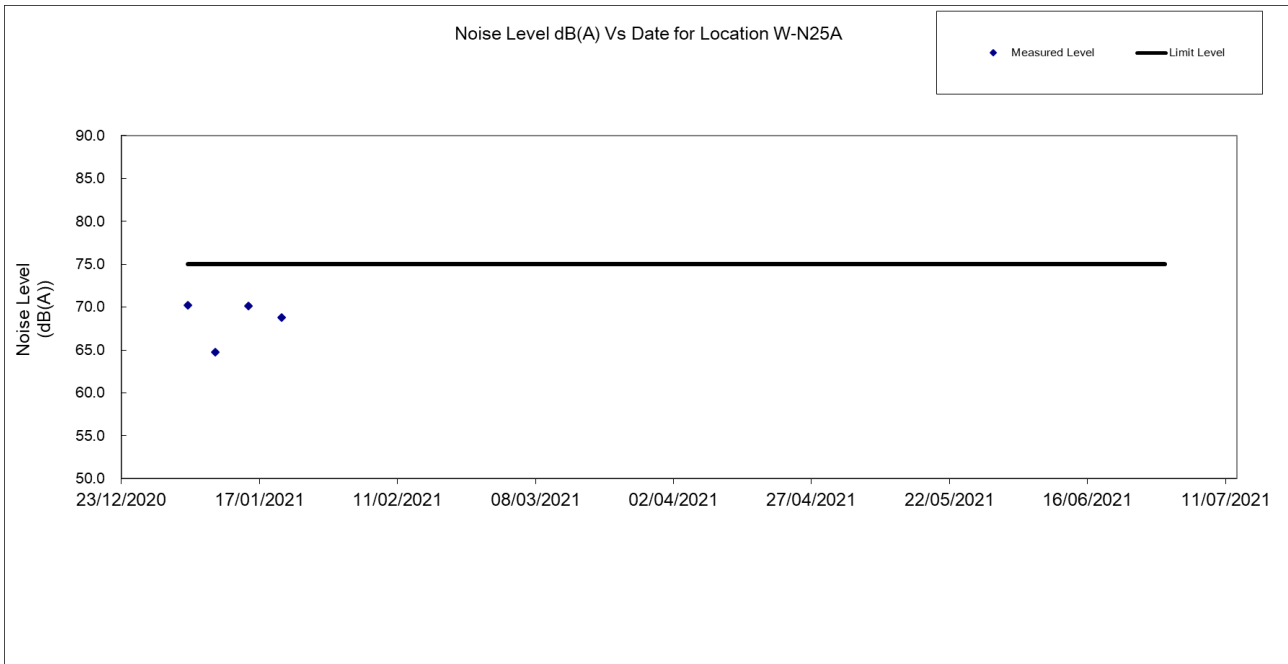
Figure 3: Graphical Illustration of Measured Noise Levels at W-N25A

Remark; Noise monitoring at W-N25A/W-N25A-T were temporarily suspended from 27 January 2021 to 9 February 2021 as these stations were located inside or in proximity to the specified areas of lock down due to COVID-19.

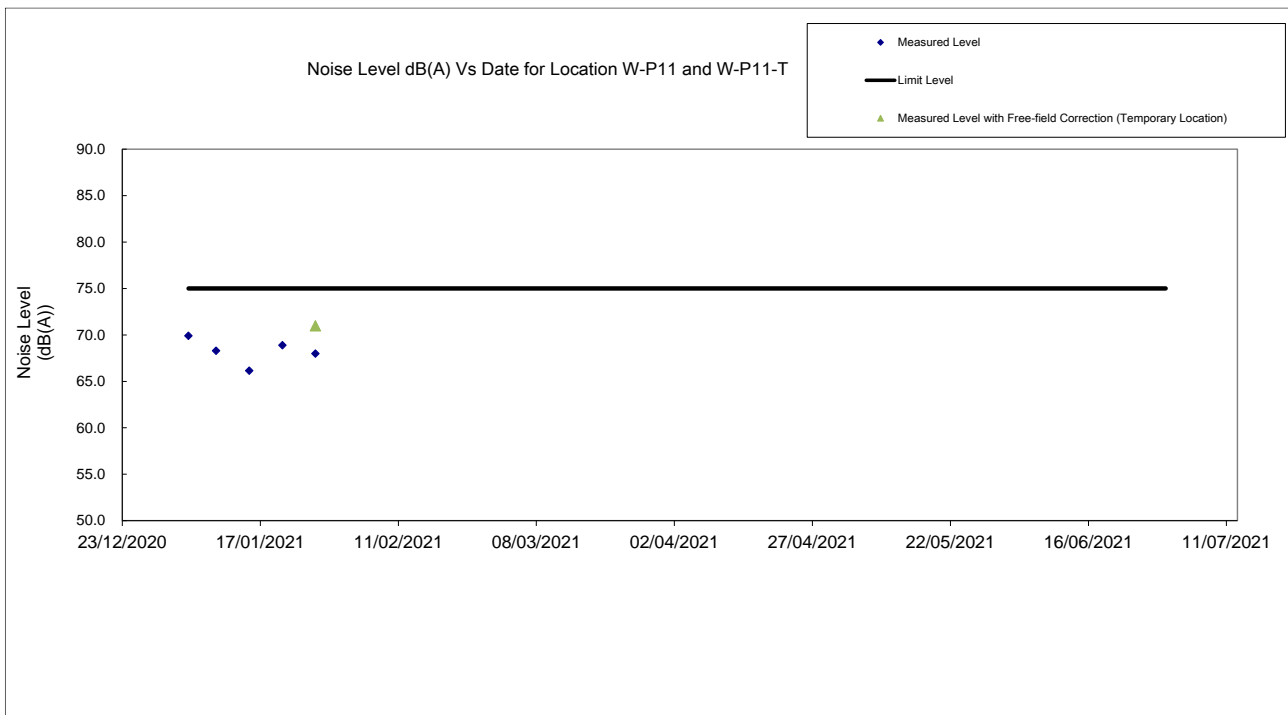
Figure 4: Graphical Illustration of Measured Noise Levels at W-P11

Remark: Noise monitoring at the Coronation Tower 1 (W-P11) was temporarily suspended on 27 January 2021 due to a case of novel coronavirus infection at the Coronation Circle on 17 January 2021. A temporary alternative noise monitoring location, W-P11-T was used on 27 January 2021. A correction of +3dB(A) was made to the free field measurement for W-P11-T.
