**Central Kowloon Route**

**Yau Ma Tei East**

**Contract No. HY/2014/08**

Monthly EM&A Report No. 4

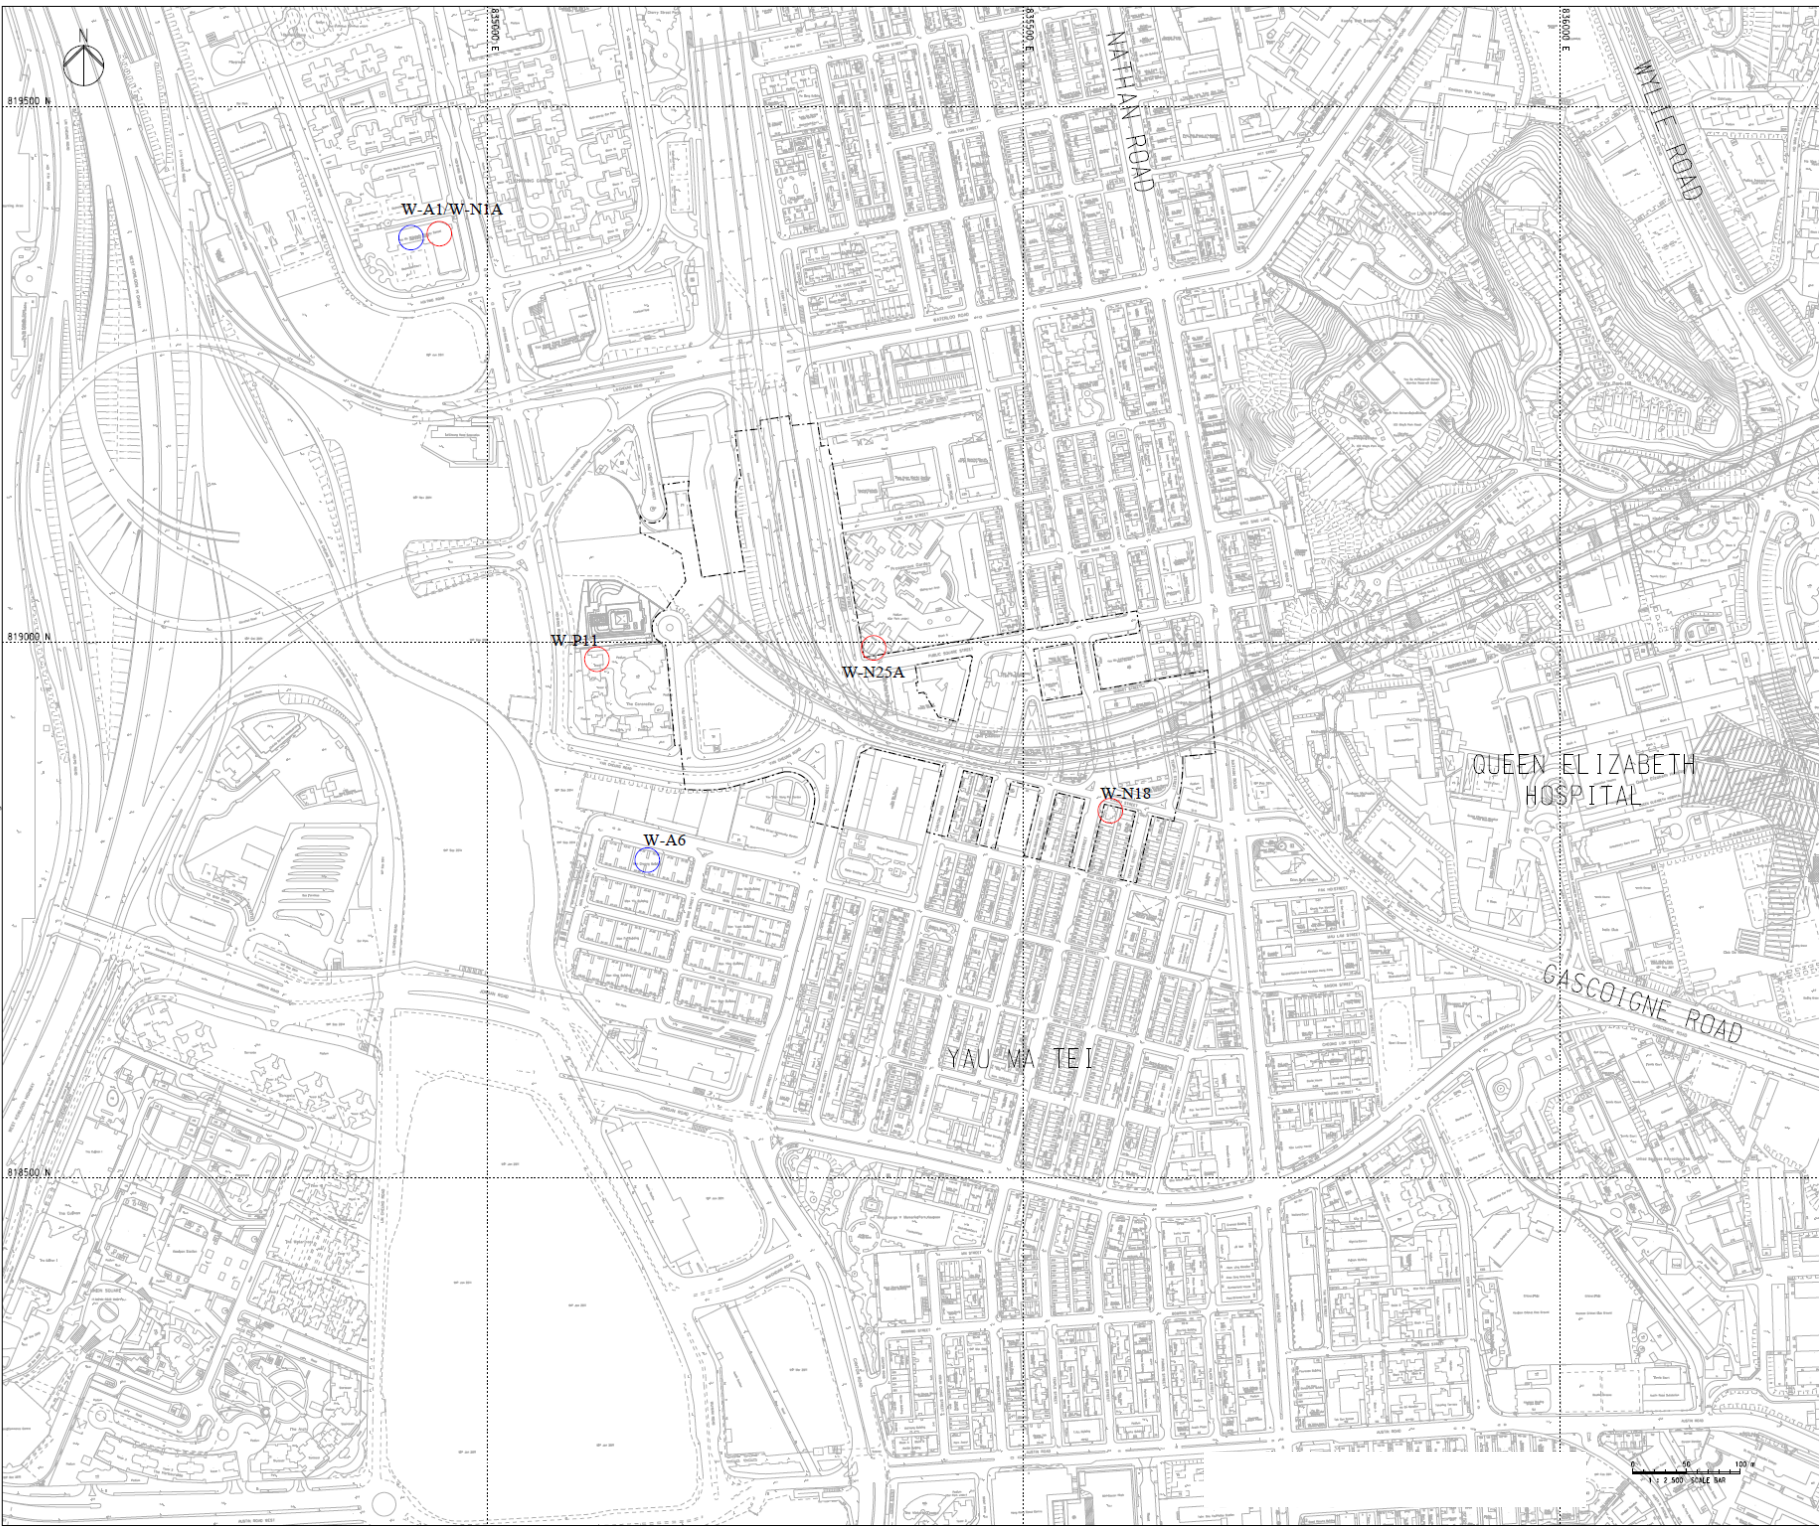
## Location Plan of Noise and Air Quality Monitoring Station

3.4.1. During the site visit, both of the original proposed dust monitoring locations were rejected due to the condition at The Coronation was not favorable for monitoring and the access was declined by the management office of Hong Kong Community College (HKCC) of PolyU. Two alternative air monitoring stations Yau Ma Tei Catholic Primary School (Hoi Wang Road) and Man Cheong Building had been proposed by ET and approved by IEC. 2 designated air monitoring locations were identified and agreed with IEC and EPD. Details of air monitoring stations are described in Table 3.3. The location plan of air quality monitoring stations is shown in Appendix K.
