**Central Kowloon Route**

**Yau Ma Tei West**

**Contract No. HY/2014/20**

**July 2021**

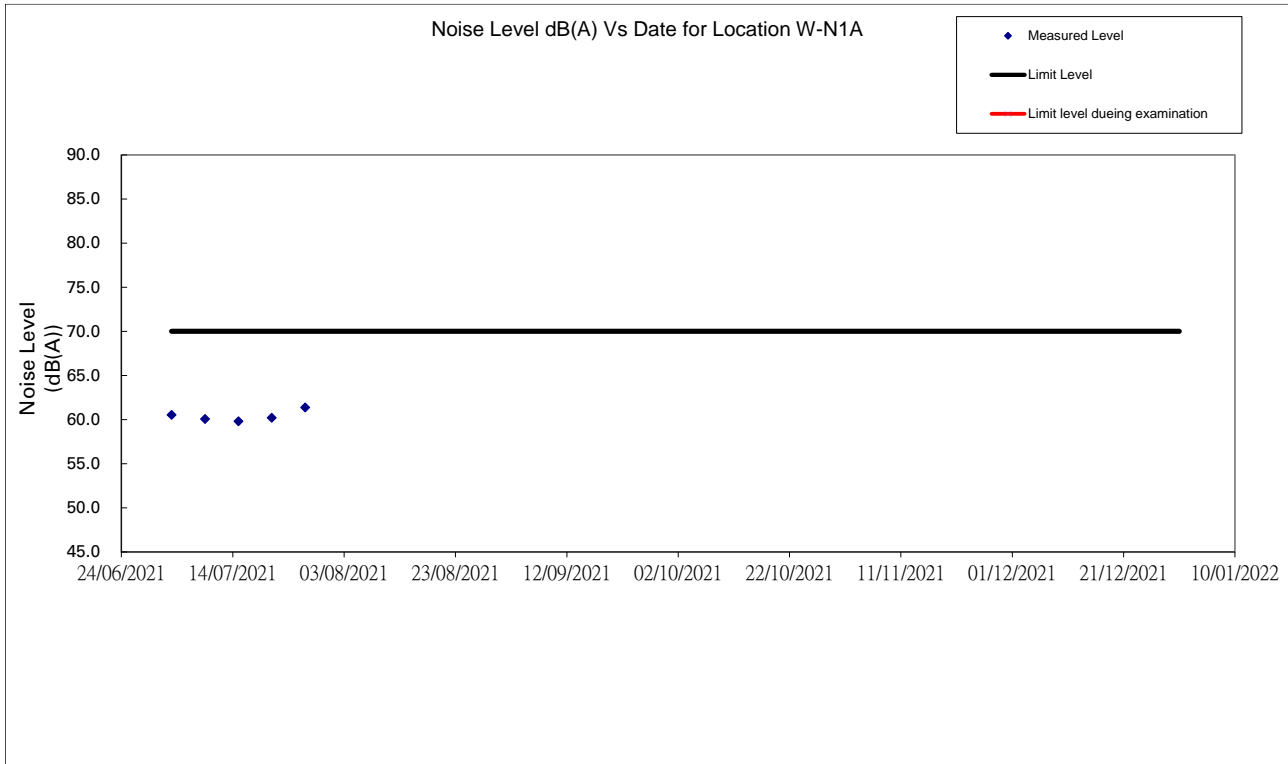
Figure 1: Graphical Illustration of Measured Noise Levels at W-N1A

Remark: No examination was at W-N1A in the reporting month so limit levels for all monitoring days were 70 dB(A).
