Central Kowloon Route

Yau Ma Tei East

Contract No. HY/2014/08

Document/~~Plan~~ to be ~~Certified~~/ Verified: Monthly EM&A Report No.88 (July 2025)

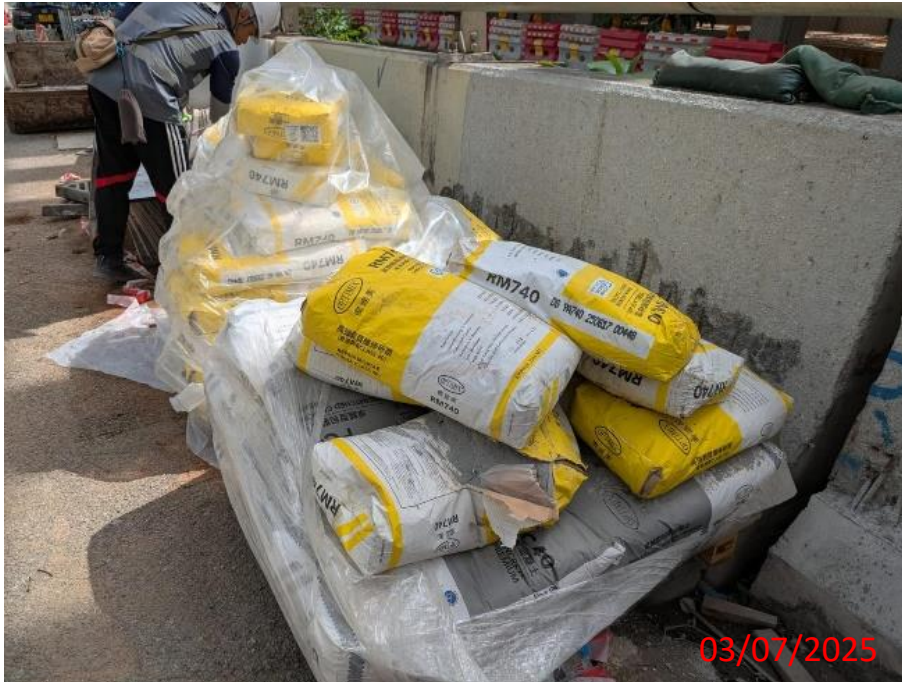
Remark 5: Record of deficiency observed on 3 July 2025 and the respective rectification record

At Zone 3, opened cement on site should be properly covered.
