**Central Kowloon Route**

**Yau Ma Tei East**

**Contract No. HY/2014/08**

Monthly EM&A Report No. 48

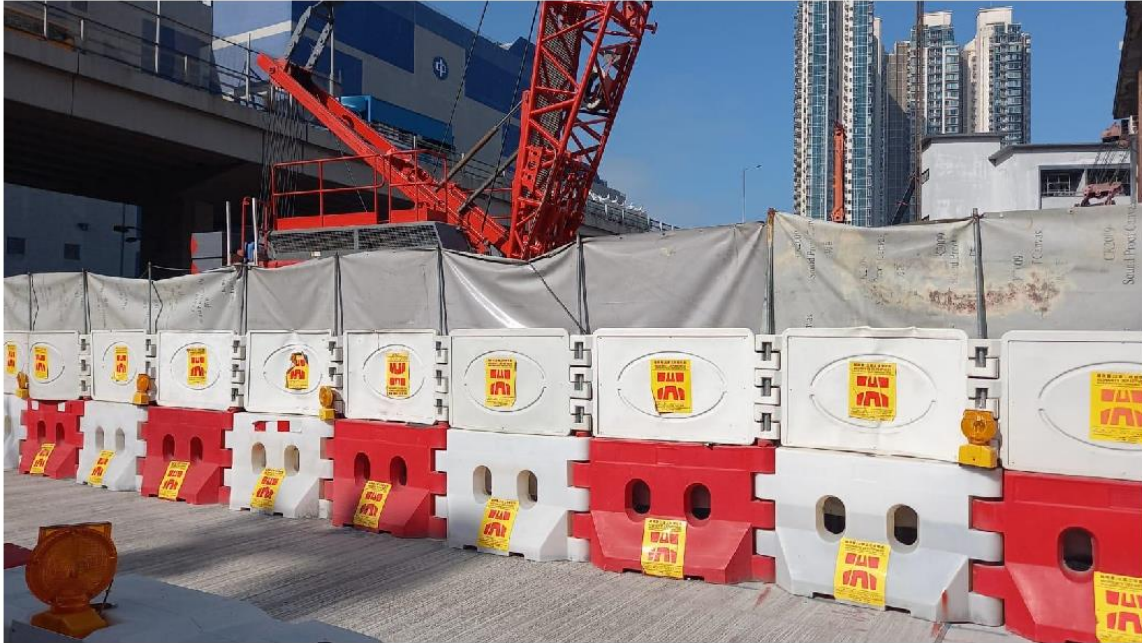
**Figure A: Noise Barrier Mat**

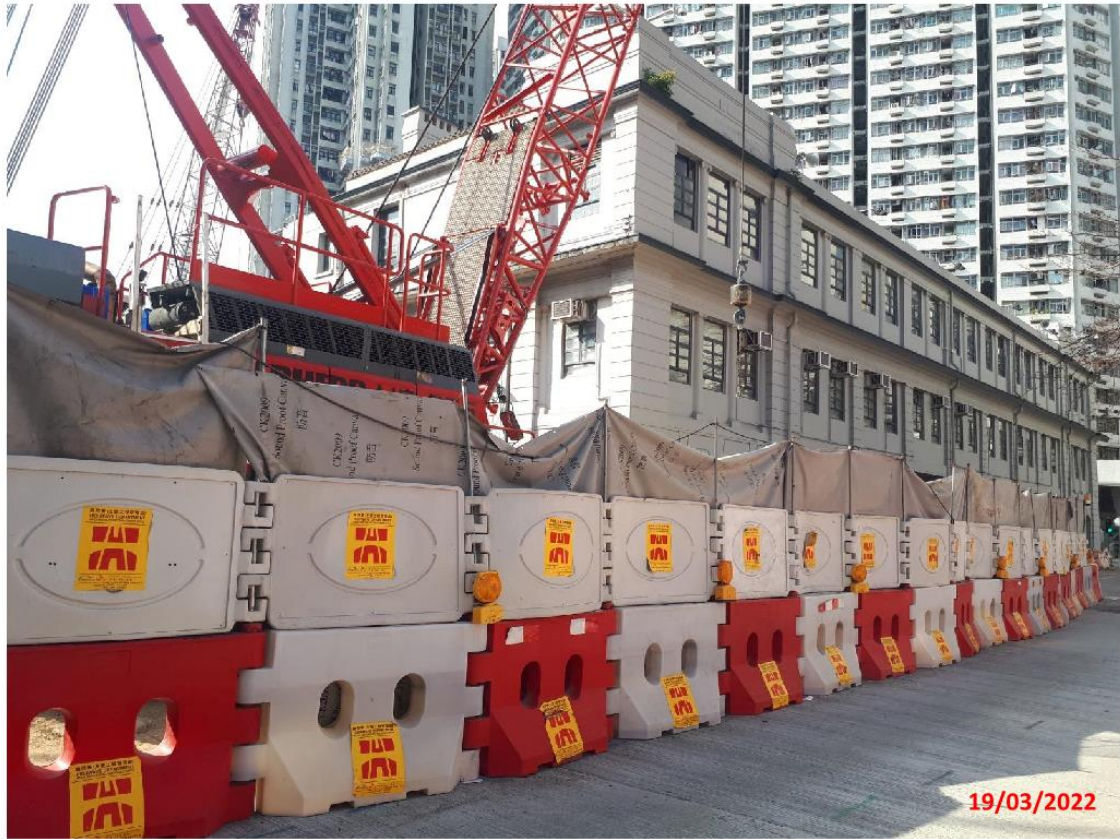
**Figure A1 Noise barrier mat erected along site boundary**
