**Central Kowloon Route**

**Yau Ma Tei West**

**Contract No. HY/2014/20**

Monthly EM&A Report No. 50

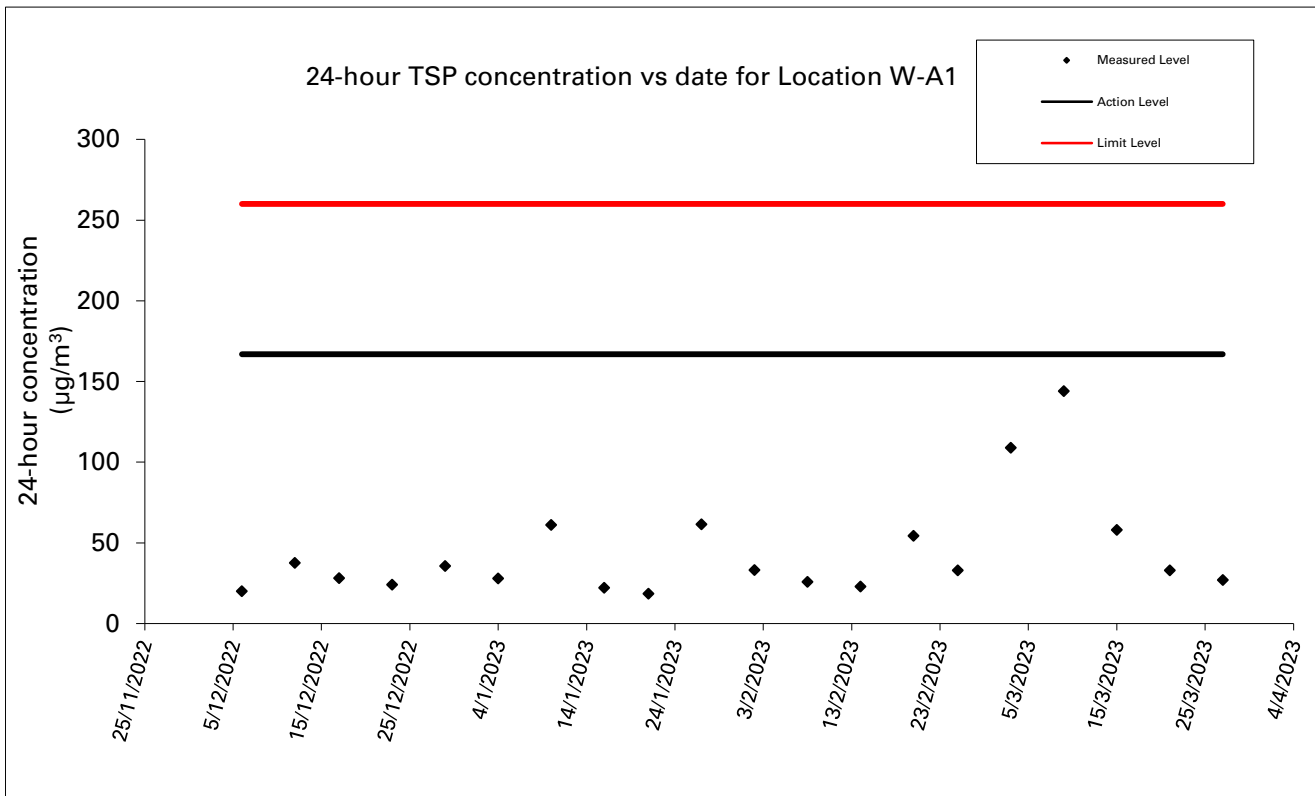
Figure 3: Graphical Illustration of Measured 24-hour TSP ( $\mu\text{g}/\text{m}^3$ ) Levels at W-A1

Location: Yau Ma Tei Catholic Primary School (Hoi Wang Road) (W-A1)  
 Monitoring date: 3, 9, 15, 21 and 27 March 2023  
 Parameter : TSP 24-hour  
 Other Factors Nearby traffic
