Central Kowloon Route

Yau Ma Tei West

Contract No. HY/2014/20

November 2023

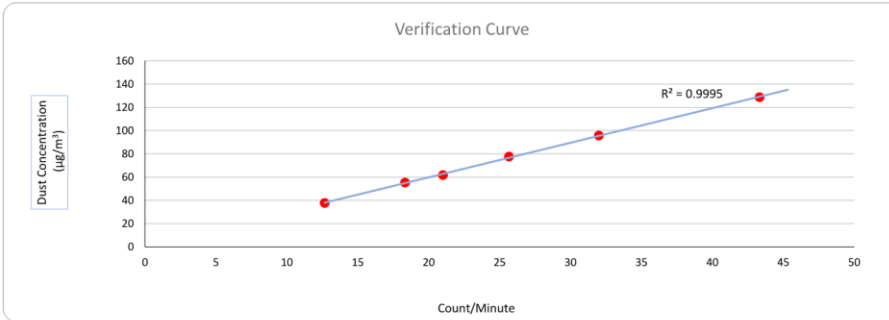
Linear Regression of y on x

Slope, K factor:	2.9749	Intercept:	0.2715	*Correlation Coefficient, R:	0.9998
Verification Test Result: <u>Strong Correlation, Results were accepted.</u>			* If the Correlation Coefficient, R is <0.5. Checking and Re-verification are required.

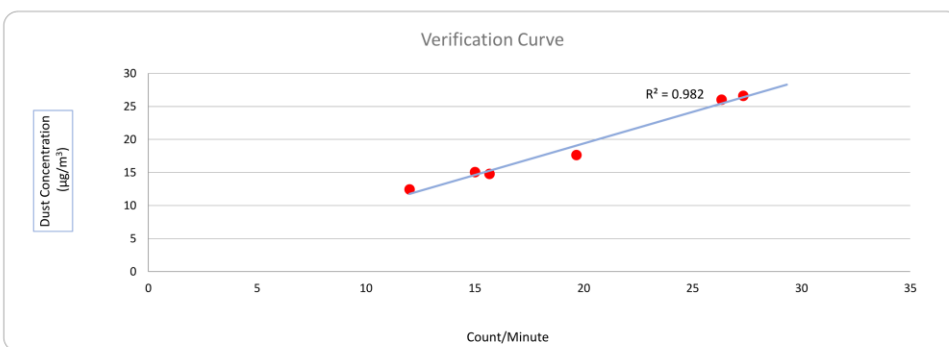
Linear Regression of y on x

Slope, K factor:	0.9545	Intercept:	0.2986	*Correlation Coefficient, R:	0.9910
Verification Test Result: Strong Correlation, Results were accepted.				* If the Correlation Coefficient, R is <0.5. Checking and Re-verification are required.

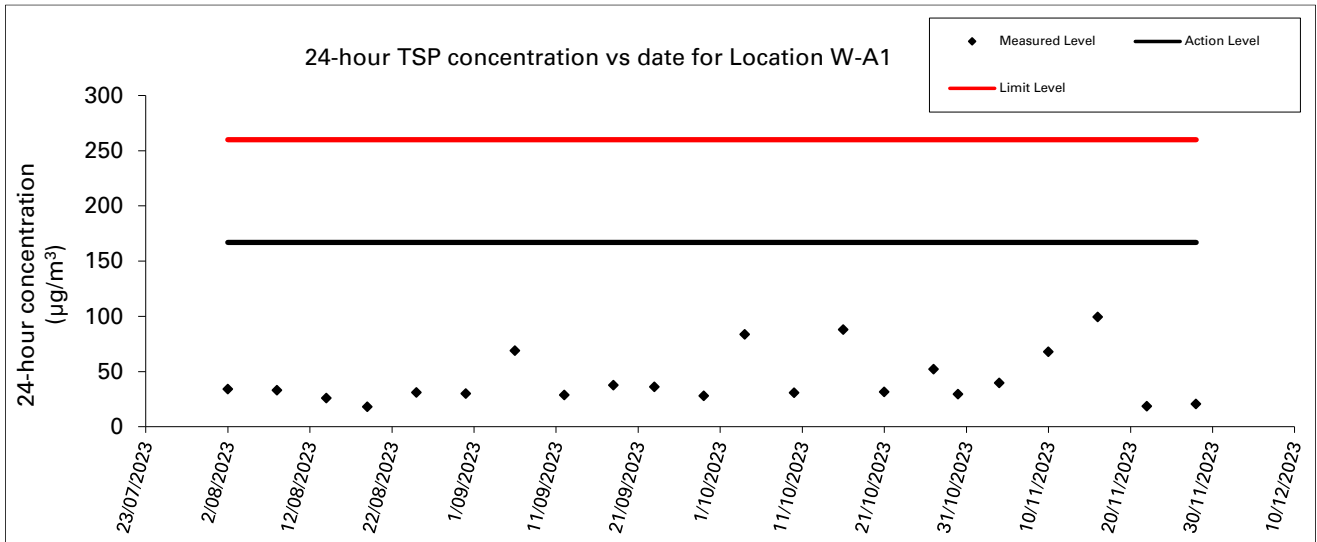
Figure 3: Graphical Illustration of Measured 24-hour TSP ($\mu\text{g}/\text{m}^3$) Levels at W-A1

Location: Yau Ma Tei Catholic Primary School (Hoi Wang Road) (W-A1)
 Monitoring date: 4, 10, 16, 22 and 28 November 2023
 Parameter : TSP 24-hour
 Other Factors Nearby traffic

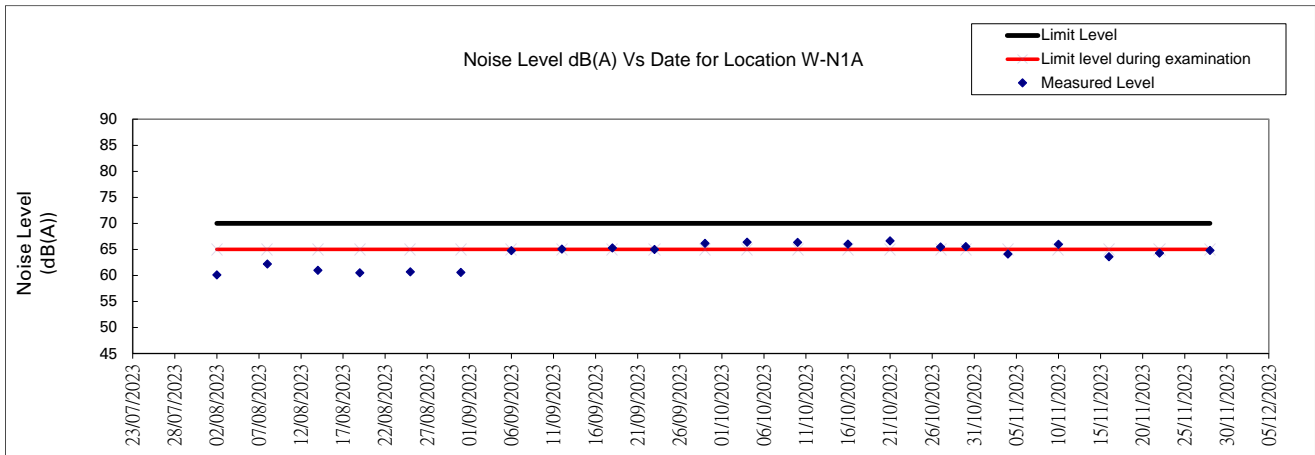
Figure 1: Graphical Illustration of Measured Noise Levels at W-N1A

Date	Weather	Start Time - End Time	L_{eq}	L_{10}	L_{90}	Wind speed (m/s)	Limit level
04/11/2023	Fine	11:22 - 11:52	64.8	69.5	60.3	1.4	75.0
10/11/2023	Fine	11:23 - 11:15	68.3	70.4	65.5	2.5	75.0
16/11/2023	Fine	11:24 - 11:54	65.0	73.4	59.1	3.5	75.0
22/11/2023	Fine	11:26 - 13:30	68.9	71.0	65.3	2.8	75.0
28/11/2023	Fine	11:32 - 12:02	64.6	71.2	59.3	3.6	75.0
