Central Kowloon Route

Yau Ma Tei West

Contract No. HY/2014/20

September 2021

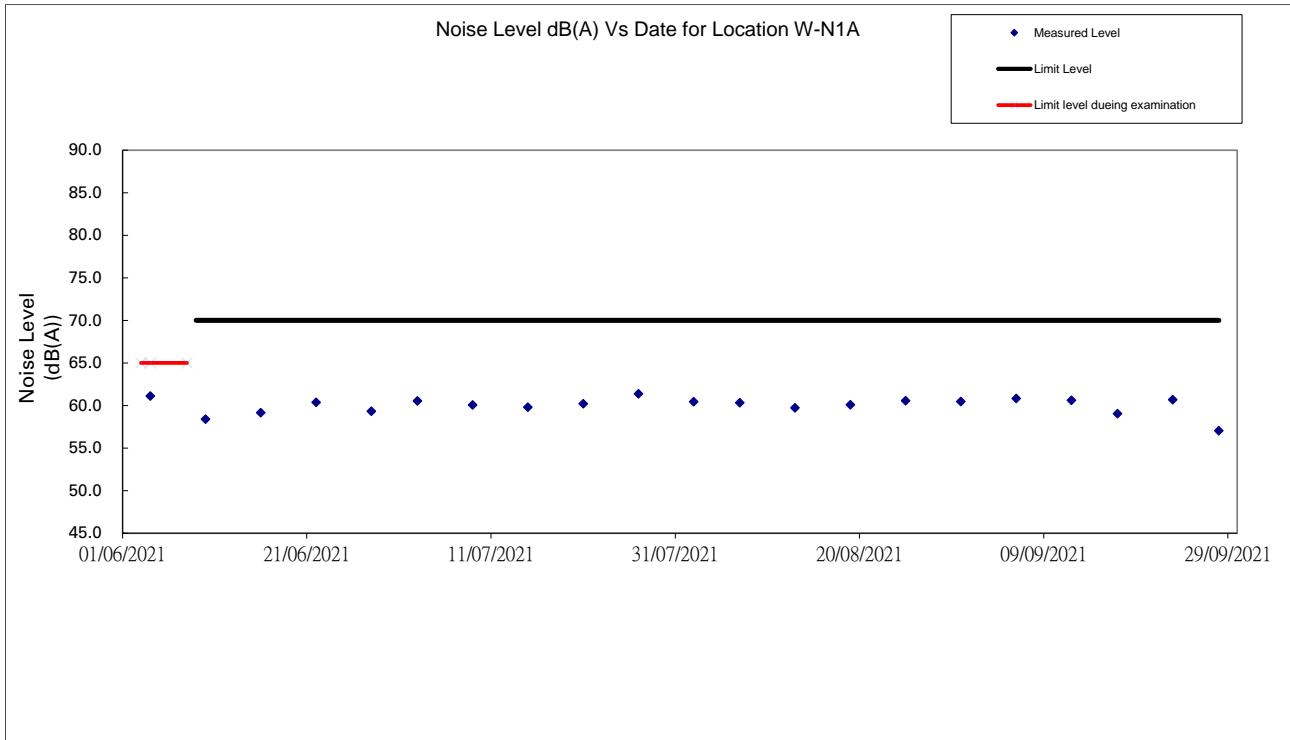
Figure 1: Graphical Illustration of Measured Noise Levels at W-N1A

Remark: No examination was at W-N1A in the reporting month so limit levels for all monitoring days were 70 dB(A).
