Central Kowloon Route

Yau Ma Tei West

Contract No. HY/2014/20

September 2023

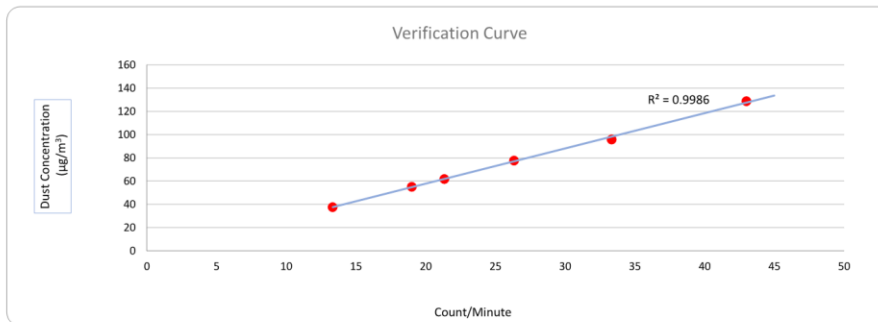
Linear Regression of y on x

Slope, K factor:	3.0313	Intercept:	-2.8495	*Correlation Coefficient, R:	0.9993
Verification Test Result: Strong Correlation, Results were accepted.			* If the Correlation Coefficient, R is <0.5. Checking and Re-verification are required.

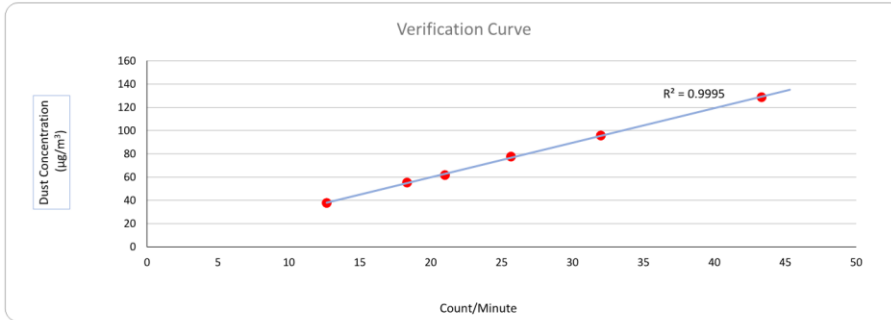
Linear Regression of y on x

Slope, K factor:	2.9749	Intercept:	0.2715	*Correlation Coefficient, R:	0.9998
Verification Test Result: <u>Strong Correlation, Results were accepted.</u>			* If the Correlation Coefficient, R is <0.5. Checking and Re-verification are required.

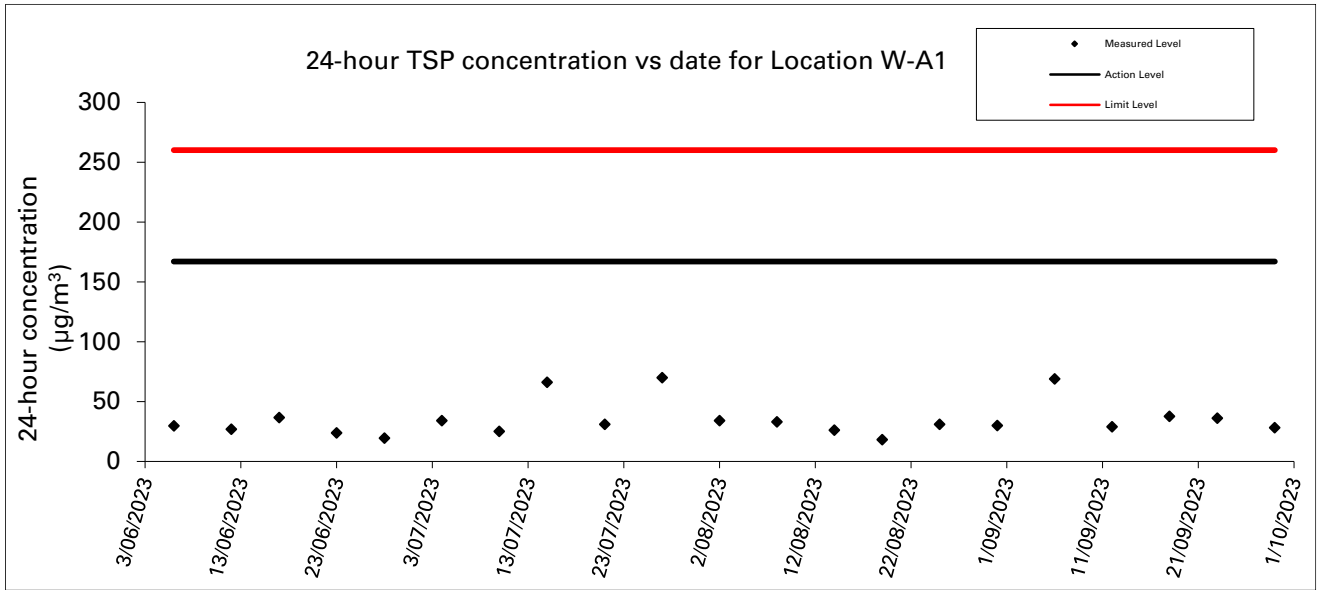
Figure 3: Graphical Illustration of Measured 24-hour TSP ($\mu\text{g}/\text{m}^3$) Levels at W-A1

Location: Yau Ma Tei Catholic Primary School (Hoi Wang Road) (W-A1)
 Monitoring date: 6, 12, 18, 23 and 29 September 2023
 Parameter : TSP 24-hour
 Other Factors Nearby traffic

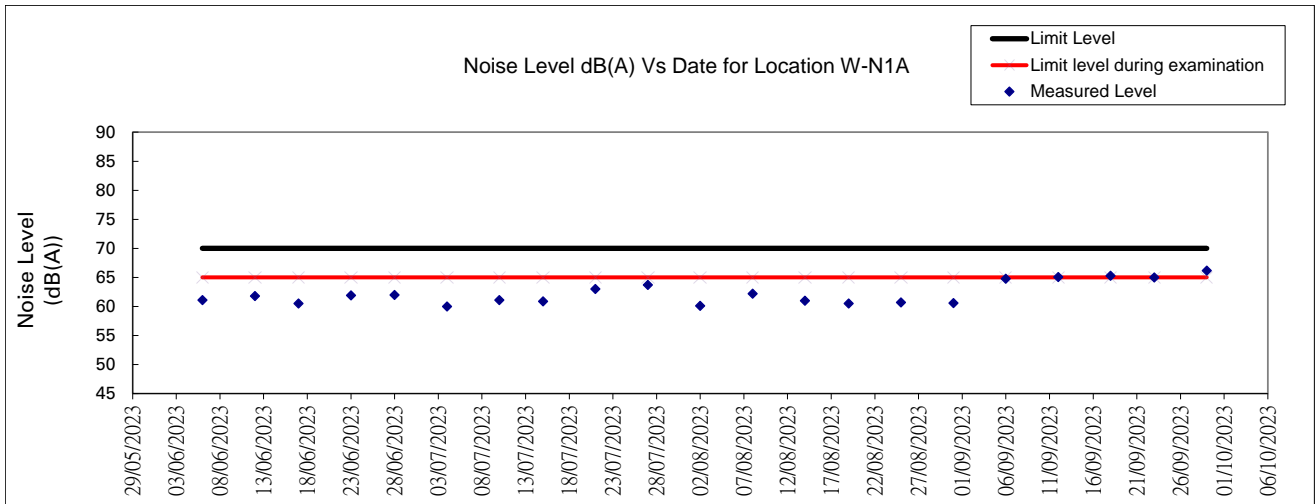
Figure 1: Graphical Illustration of Measured Noise Levels at W-N1A

Date	Weather	Start Time - End Time	L_{eq}	L_{10}	L_{90}	Wind speed (m/s)
06/09/2023	Fine	11:33 - 12:03	63.9	69.8	55.4	3.1
12/09/2023	Fine	11:37 - 12:07	68.3	70.4	65.5	4.7
18/09/2023	Fine	11:35 - 12:05	64.9	69.4	55.2	2.2
23/09/2023	Fine	11:40 - 12:10	68.9	71.0	65.3	4.4
29/09/2023	Fine	11:41 - 12:11	63.8	70.0	56.0	3.6
