Central Kowloon Route

Yau Ma Tei West

Contract No. HY/2014/20

Monthly EM&A Report No. 39

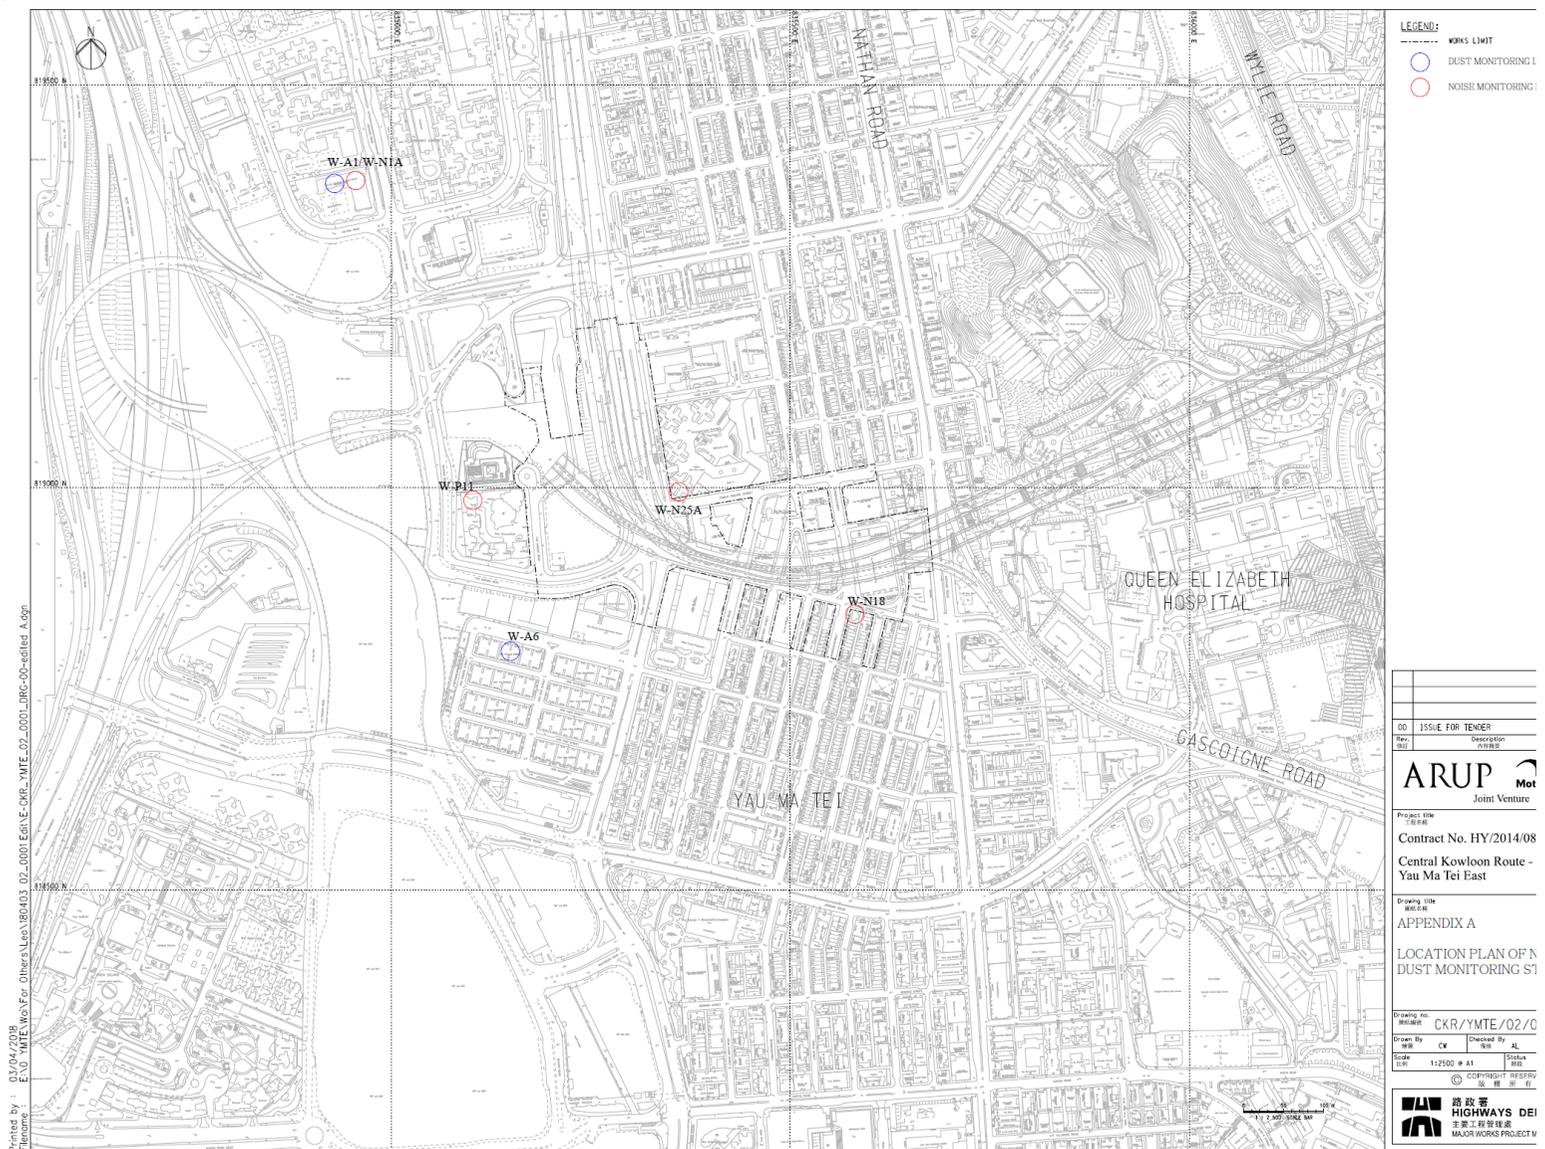
Location Plan of Noise and Air Quality Monitoring Station

LEGEND:
 - - - - - WORKS LIMIT
 ○ DUST MONITORING
 ○ NOISE MONITORING
